**CONSERVATION OF THE SWEDISH WARSHIP
VASA
FROM 1628**

Birgitta Håfors

2nd edition 2010

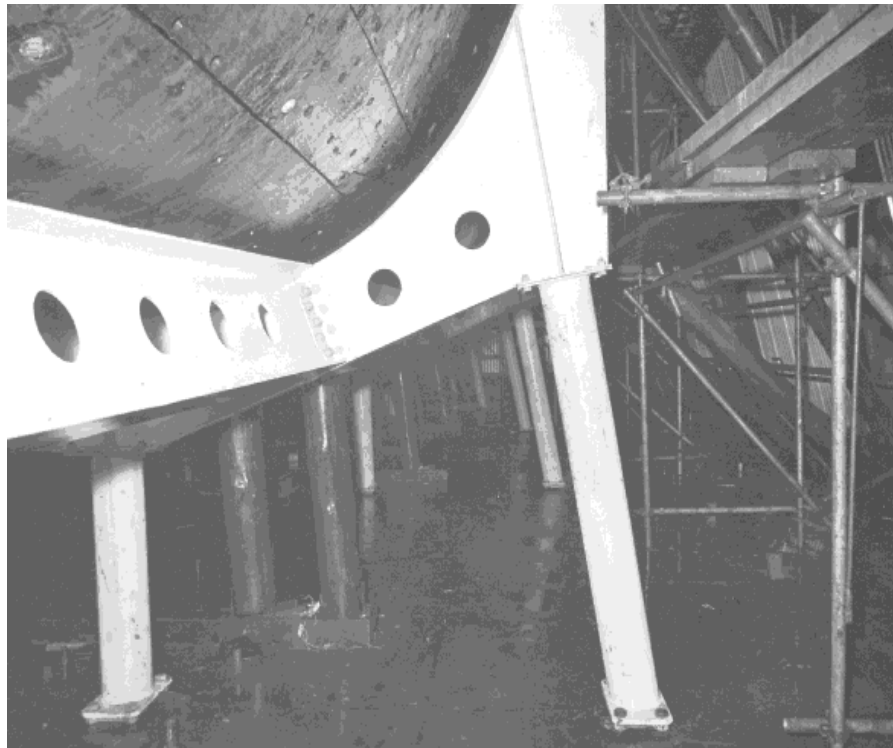
Figure 3-12 The newly mounted cradle showing a gap to the ship's side (photo: Göran Sallstedt)

Since the exact shape of the shipsides was not known, the cradle was made somewhat wider than would have been necessary. The gap between the elements of the cradle and the ship was filled with units consisting of wedges. To achieve a suitable support for the ship, wedges could be taken away or added to a unit (figures 3-13 and 3-14). Manoeuvring the wedges also allowed for some flexibility when adjusting the position of bolt holes to get a bolt through a series of structural elements (figure 3-15).

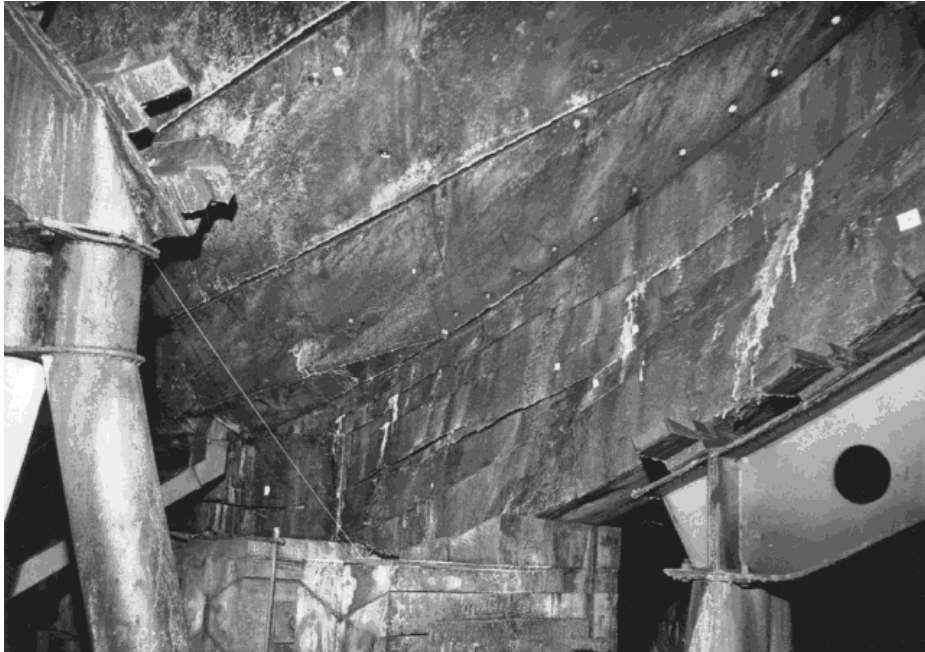
Figure 3-13 The gap between the elements of the cradle and the ship's side has been filled with wedges (photo: Sven Bengtsson)

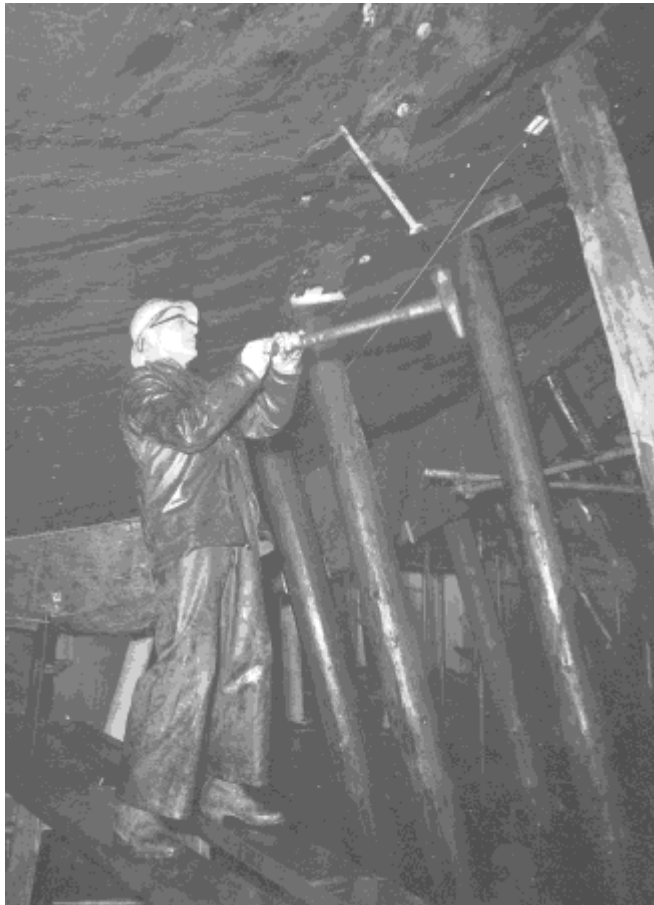
Figure 3-15 Inserting bolts into the original bolt holes (photo: Göran Sallstedt)

In September 1962 (73), Lundström reported to the Board of the Vasa that the work of replacing corroded bolts had been started. He also reported that 8600 bolts made of a durable material were needed for the Vasa hull.

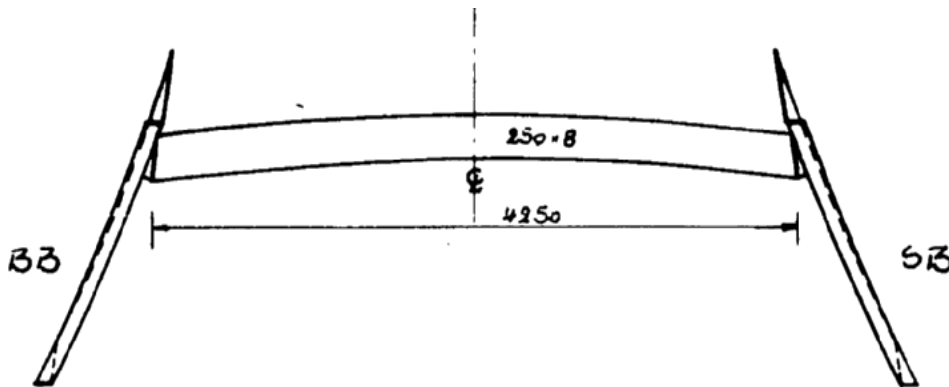
The enlargement of the pontoon superstructure created enough space to rebuild the stern of the Vasa. The stern of the ship was however badly damaged, in fact broken away from the rest of the hull. A reinforcement of the stern construction was therefore needed. In order to accomplish this, a three-limbed construction was designed with one transverse beam and two beams that were connected perpendicular to the first one about midway between their ends (figure 3-16). The beams were made of stainless steel, 8 mm thick. The transverse beam was 4250 mm long while the two connected beams measured 5600 and 4500 mm respectively.

Figure 3-16 Steel construction for reinforcing the stern part of the hull, SSHM, construction drawing No 218, detail, 22-5-1970, E Hoffmann

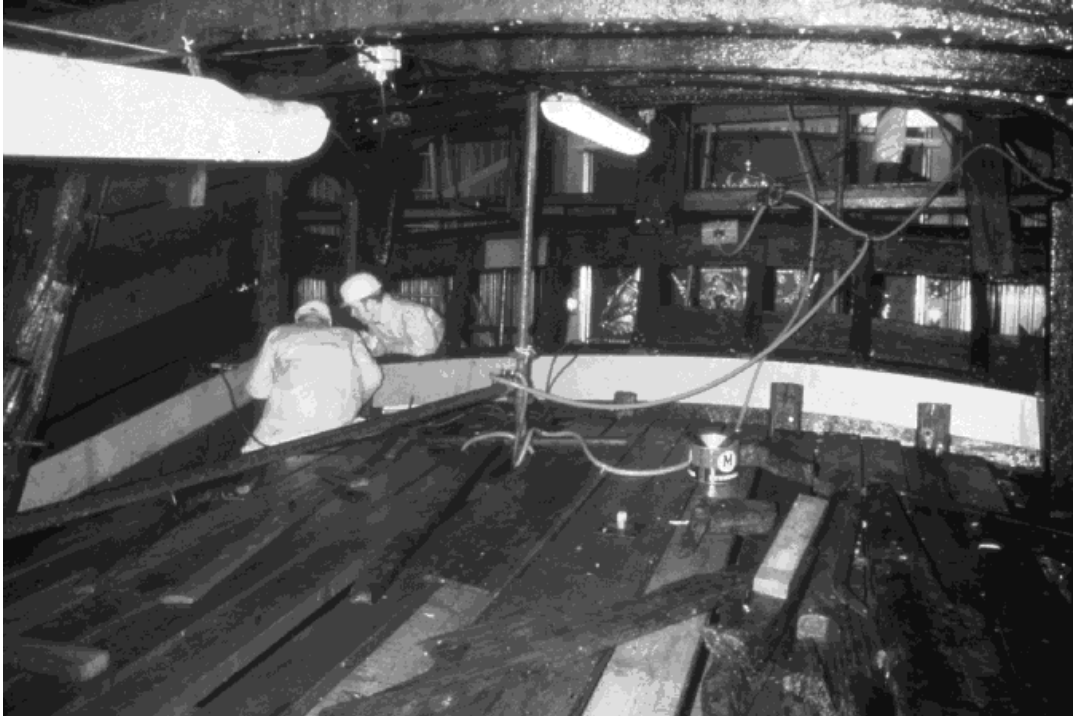
The starboard and portside leg of each construction were fastened to ribs in the main part of the hull and covered by the outer planking (figures 3-17 and 3-18). Thus the steel constructions create two shelves for the protruding parts of the stern (93).

Figure 3-17 One of the steel constructions for support of the stern put into place (photo: Björn Hedin)

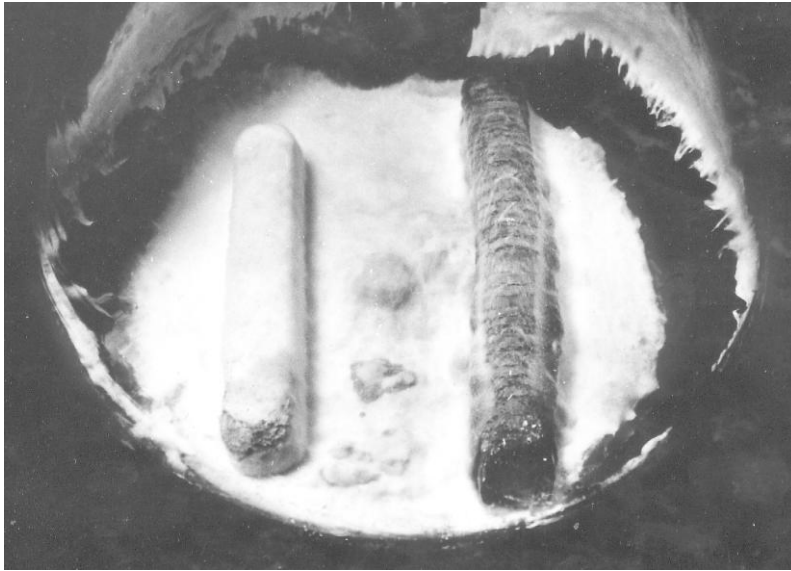
Figure 4-1 Attack by *Lenzites quercina* on untreated recent oak to the left and untreated Vasa oak to the right (photo: The Royal College of Forestry)

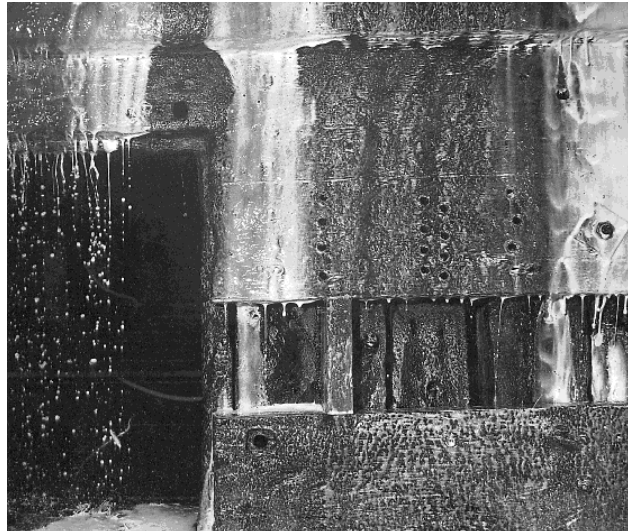
Figure 4-21 Foam on the surface of the hull produced by the spraying of the preservation liquid (photo: Göran Sallstedt)

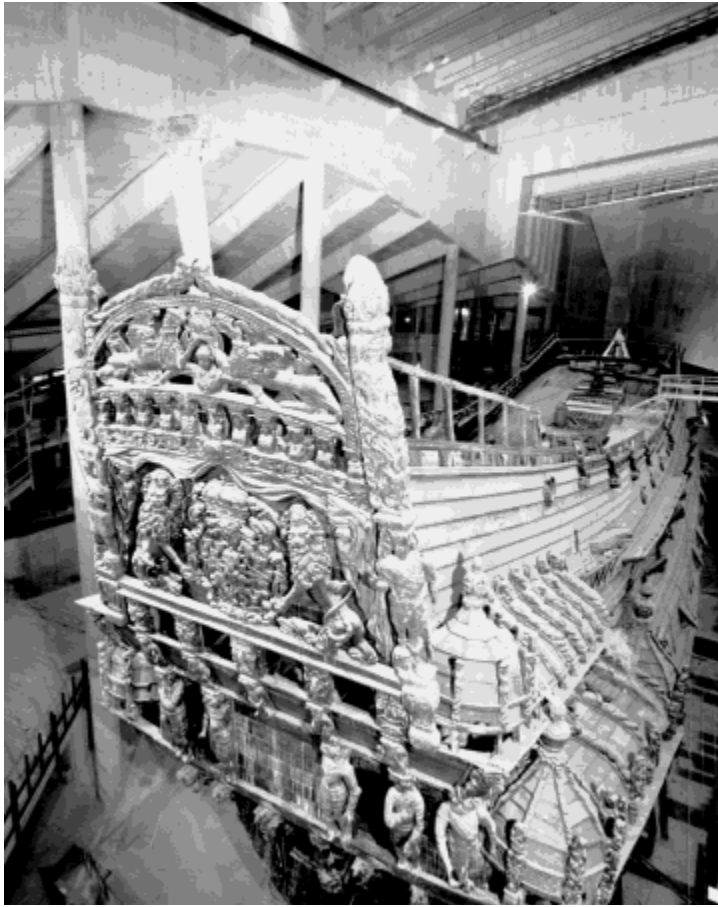
Figure 4-24 Vasa covered in dust produced by construction work (photo: Gunnel Ilonen)
