# The Sinking Town:

## The Causes and Effects of Settling Around Linnéstaden

**Degree of Bachelor of Science  
with a major in Earth Sciences  
15 hec**

**Department of Earth Sciences  
University of Gothenburg  
2019 B-1075**

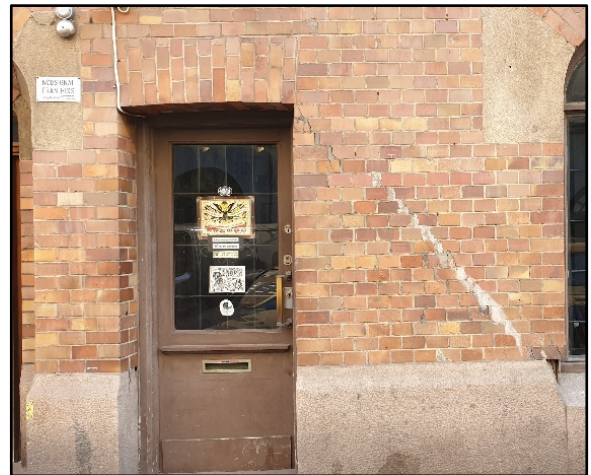
For the buildings made of bricks the sliding was a common observation and was noted 92 times. That means about 20% of all observed buildings had bricks falling apart at some rate. The bricks in the picture breaks with a similar pattern of about 45 degrees and was seen repeatedly (see fig 3.3, 3.7 and 3.9).

**Figure 3. 2.** This figure demonstrates a building with bricks sliding apart in the typical 45-degree pattern. Sveagatan 22. Code: KA0512

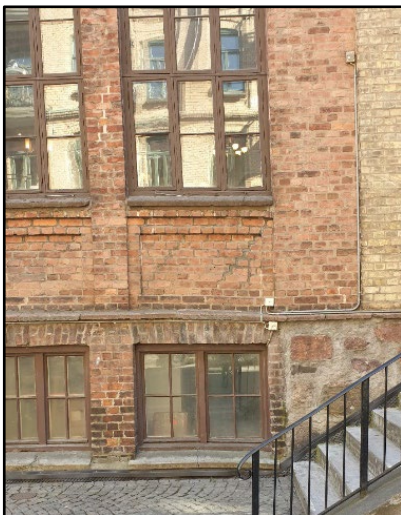
**Figure 3. 3.** Photo taken from the South East part of Hagabion. Linnégatan 21. Code: OD0101

Figure 3.3 demonstrates Hagabion which is an old building originally built as a school in mid-1870 but then rebuilt to a cinema 1983. It was built with old techniques on deep clay (25-30 m, fig 3.1) and suffers from many of the observations seen in table 1.

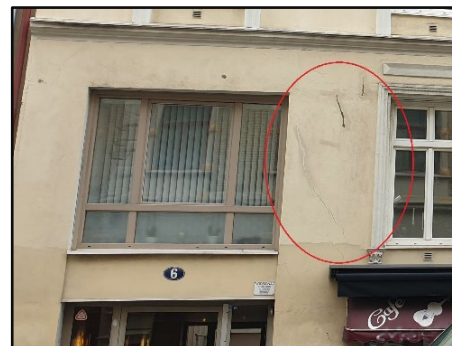
The wide distribution of the cracks led to 83 observations. Figure 3.4 shows a crack between two windows of a building that gets deformed due to the heavy load of the firewall.

**Figure 3. 4.** Examples of cracks in a plastered facade at Andra Långgatan 6, Masthugget. Code: MH0804

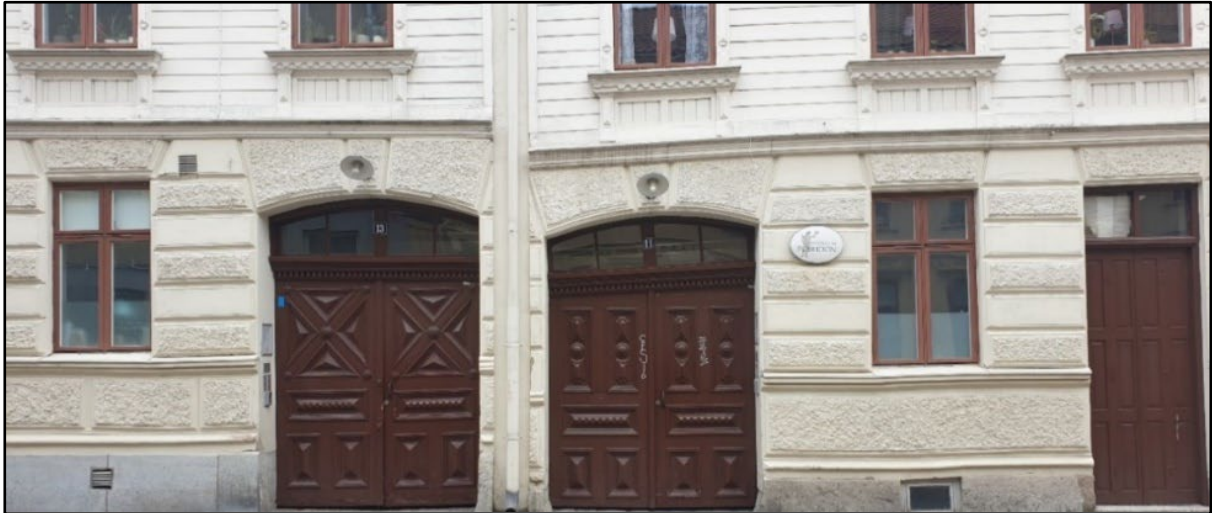
**Figure 3. 5.** Photo taken of deformed house skirting. The picture also shows an example of protracted vault. Västra Skansgatan 11, Haga. Code: HA1206e

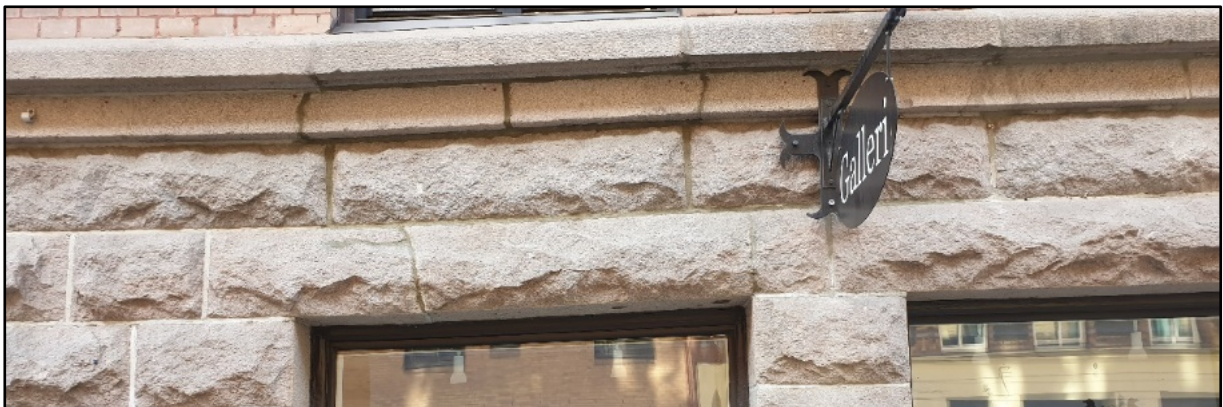
The most common observation was deformed house skirting and was noted on more than half of all the mapped buildings (see, *Table 2*). The skirting lays horizontally along the building which makes any slight deformation easy to observe. What was often seen was that the skirting started to get wavy shapes and started to break down as seen in figure 3.6.

**Figure 3. 6.** This figure shows example of crushed house skirting. Plantagegatan 9, Masthugget. Code: MH0116

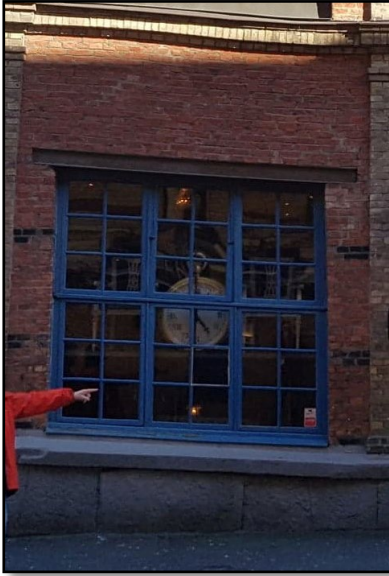
**Figure 3. 7.** Oblique window on a building in Masthugget. Nordhemsgatan 24, Masthugget. Code: MH0811a

In figure 3.7 the hand points towards one of the worst scenarios of an oblique window. This window belongs to a building located at Tredje Långgatan in Masthugget which is known for the heavy damage that the settling has brought to it over the years.

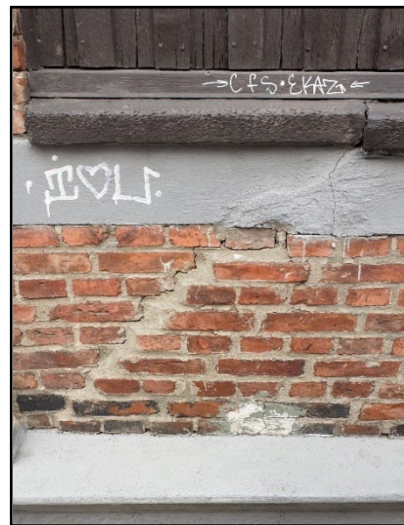
**Figure 3. 8.** On the top right a cracked and deformed windowsill is shown. Also, a pattern is seen along with the sliding bricks. Tredje Långgatan 13, Masthugget. Code: MH0811c

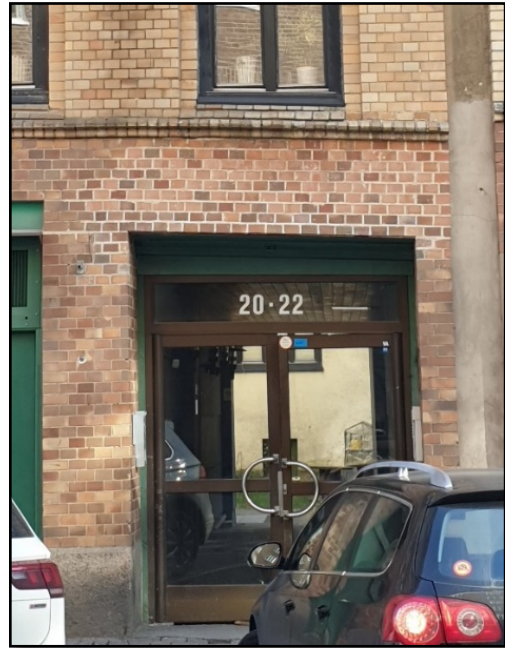
On the field about 20% of the buildings observed had protracted vaults which corresponds to 98 buildings in total. In fig 3.9 the vault is deformed in a typical way towards the firewall which also can be seen in fig 3.5 and 3.10.

**Figure 3. 9.** Example of a protracted vault in a damaged area around kommedantsägen. Sveagatan 20-22. Code: KA0513

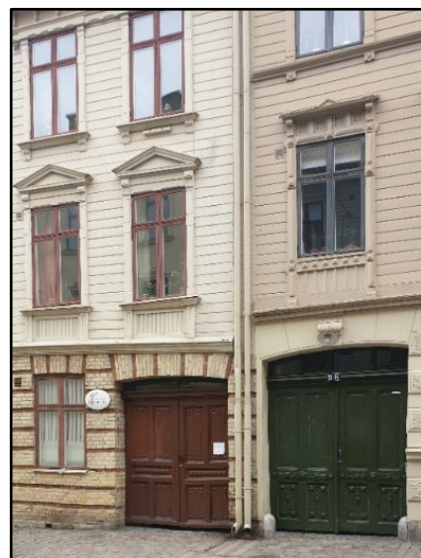
19 fire walls showed clear signs of settling. It was easily noted since the buildings that were adjacent to the fire wall showed signs of settling strongly with it (see fig 3.10 and 3.5).

**Figure 3. 10.** Evidence of a sunken fire wall by looking on how the skirting deforms. Mellangatan 9, Haga. Code: HA1211c

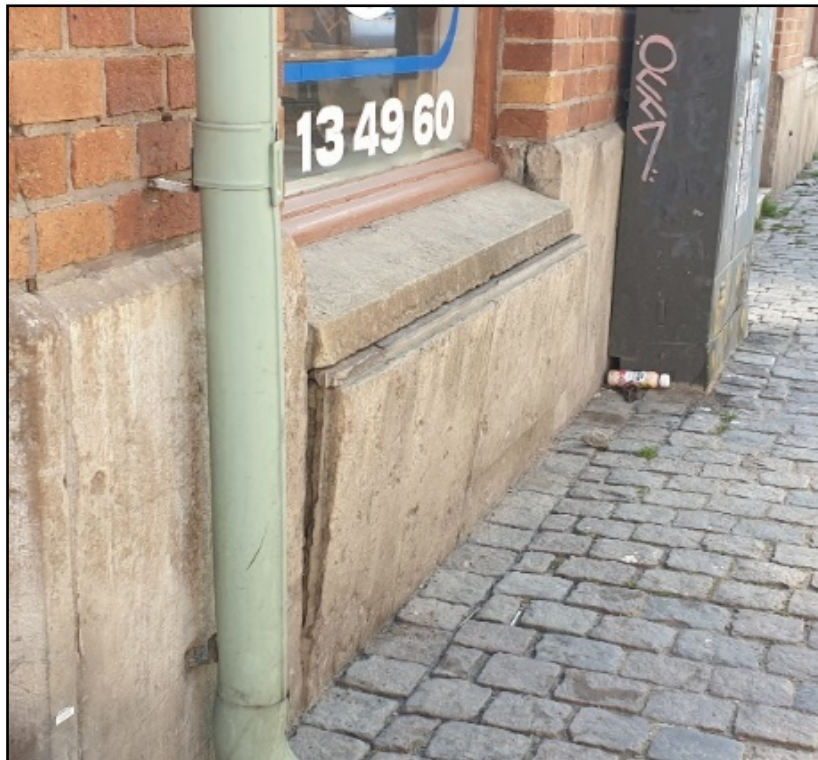
In the studied area 32 buildings showed deformation on the base stone. There were two types of base stones, one made of stone and one made of plastered façade. The latter type showed most of the observed deformations since plaster is a weaker material than stone, which in most cases were granite.

**Figure 3. 11.** Deformation of base stone found in Kommedantsängen. Majorsgatan 6. Code: KA0501

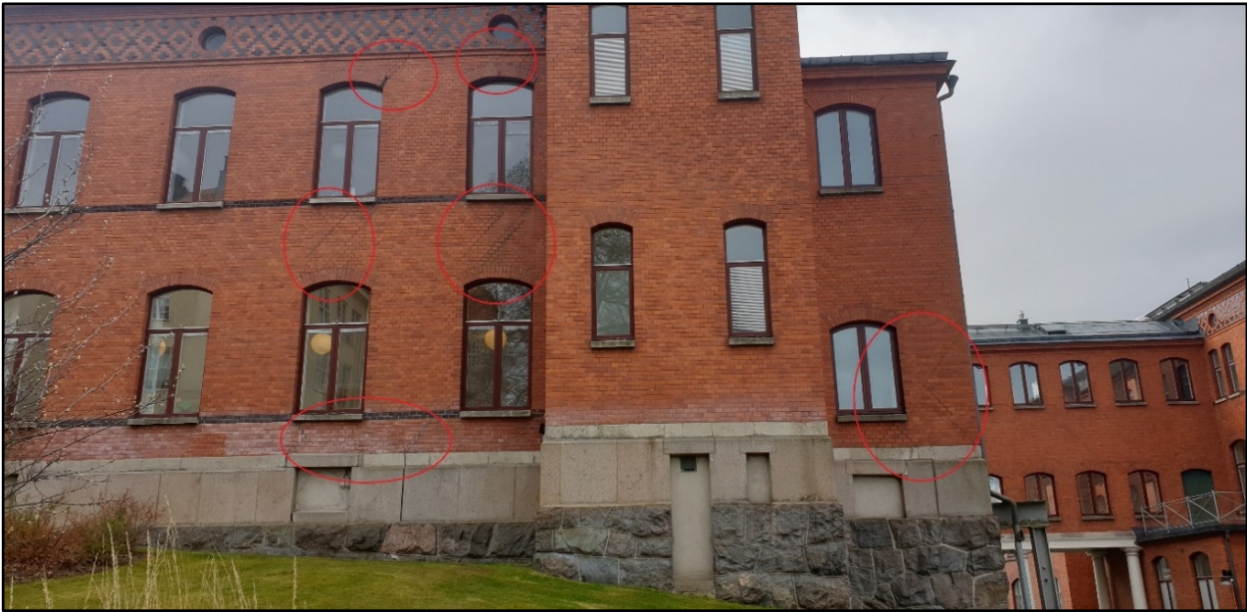
The picture taken in figure 3.13 demonstrates how the building looks like from the northeast side where the damages was clearly observed. The interpolation proves that the building stands on a heel of the bedrock and the location of the damages correlates to where the most graduated depth lies underneath. The picture has been taken quite far away so to see the observations clearer, the sliding bricks has been highlighted inside the red rings. The building also shows deformed sills and skirts, tilted windows and in figure 3.14 below we see that steel beams has been mounted in the left corner to steady up the weight.

**Figure 3. 13.** This picture was taken from the north-east side, looking south-west and is marked with a yellow dot in fig 3.12. The building varies with depth from zero meters in the south-east part (left outside the picture) to depth of 5 meters in the north-west. The red rings enclose bricks sliding apart. Konstpedimins Väg 2, Code: KV2002c

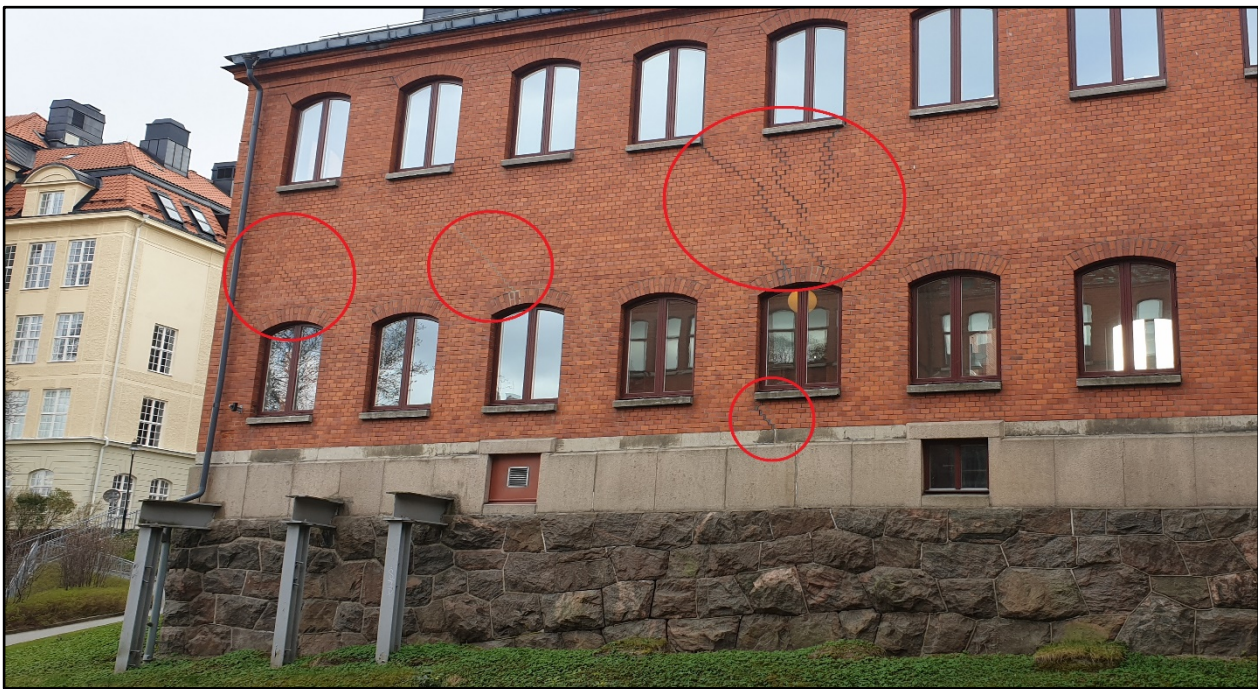
**Figure 3. 14.** Same building as in 3.13. but this time shown from the Northwest side. Konstpedimins Väg 2 Code: KV2002c

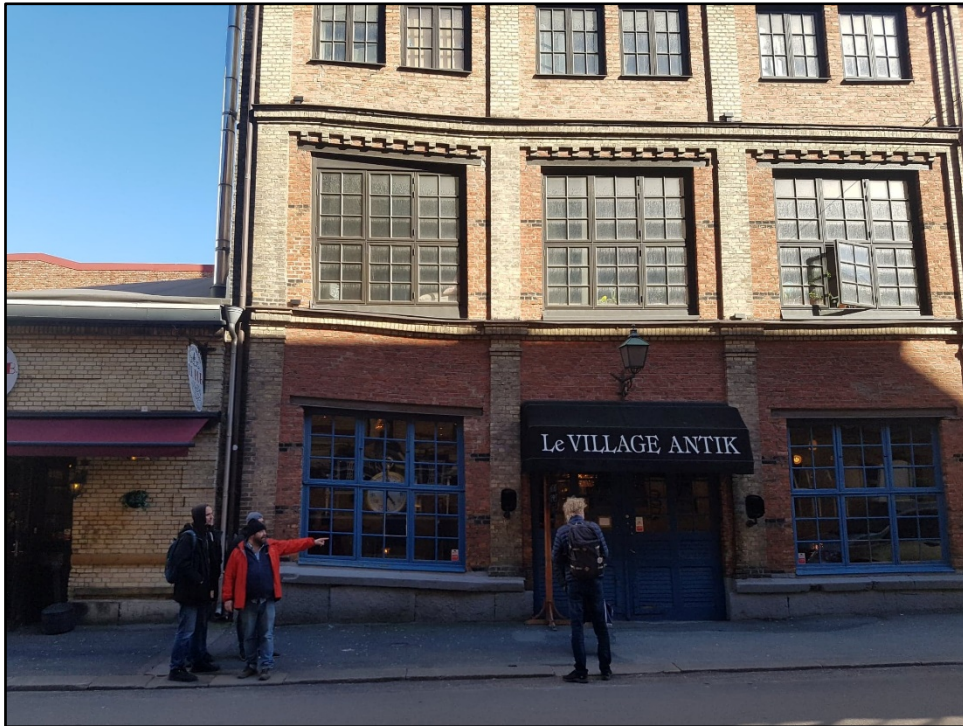
This can be a problem before the construction is finished and sometimes before starting it. Lateral displacement from piling can displace the piles that were driven down earlier making them askew before the load of the building is there. This might explain the situation of Le Village (see picture 4.1) since the bottom level is heavily settled while the upper levels are only slightly deformed. This indicates that the bottom level was deformed before the upper levels were even built.

**Figure 4. 1.** *A photo of Le Village shows severe settling in the left corner. However, on the second storey the settling is not as strong as in the ground level. Nordhemsgatan 24, Masthugget. Code: MH0811a*

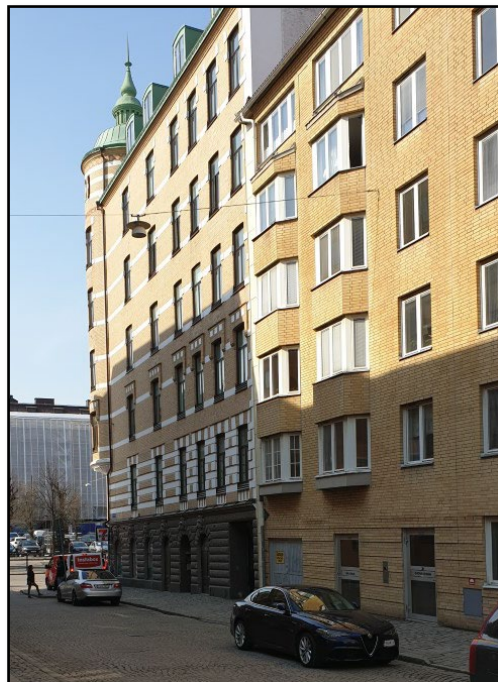
It was difficult to observe the rate of tilt on the buildings that were leaning. There were also buildings that had settled unevenly making the whole building lean towards the street as shown in fig 4.4. In this case the tilt of the building was clearly seen from the street. In some cases, however, the building seemed to have no tilt at all but when the fire wall was inspected there was evidence of it widening out towards the top, see fig 4.5.

**Figure 4.4.** *The building on the end of the streets shows clear evidence of leaning. Linnégatan 26 in Olivedal.  
Code: HA1608*

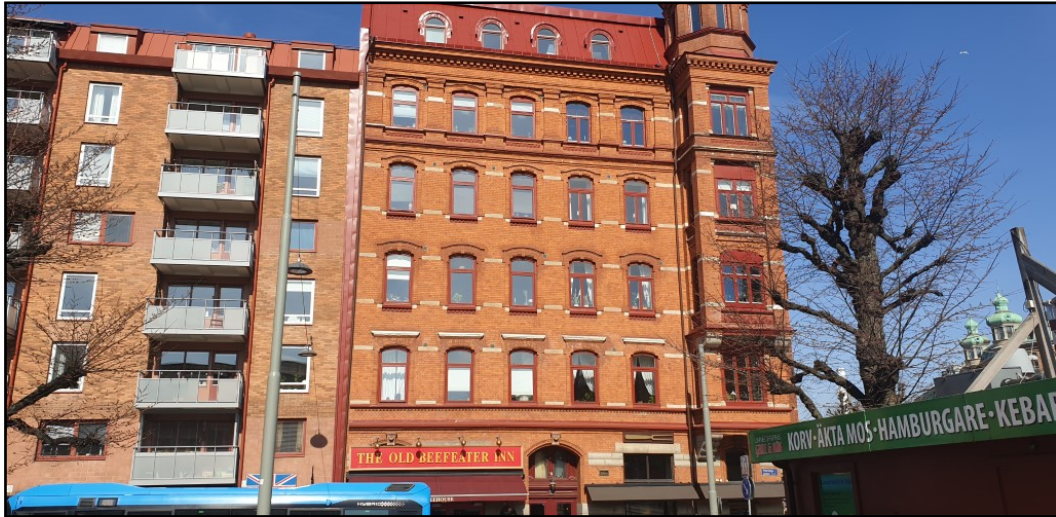
**Figure 4.5.** Seen from this angle the widened fire wall is evidence for the building leaning. Linnégatan 11 in Olivedal. Code: MH0204

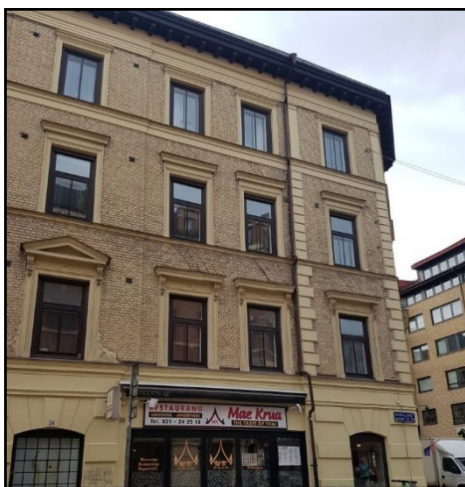
In many cases sliding bricks showed a pattern where they occurred continuously vertically (see fig. 4.6). We believe that sliding bricks is an indication of the “breaking point” of a building meaning that one side of the sliding bricks pattern is settling faster while the other side has less or no settling.

As shown in picture 4.6 below, the left side has no sliding bricks while the right side has a vertical pattern of it. This was, as mentioned, a repeated pattern but an important notation is that this theoretical “breaking point” was not as clear in all building. As seen in figure 4.7 there is no such clear pattern of the sliding bricks. It might however indicate that there are several “breaking points” where the building settles unevenly in several places. Both pictures are taken on the same street, Andra Långgatan between Järntorget and Masthugget.

**Figure 4.6.** Sliding bricks can be seen from centre to right side but not on the left side. Andra långgatan 24, Code: MH0701b

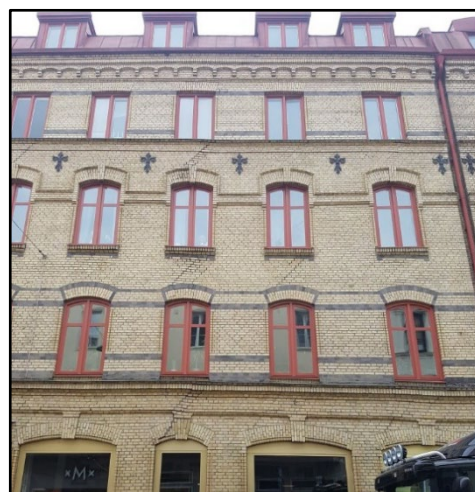
**Figure 4. 7.** Sliding bricks can be seen without any clear pattern. Andra Långgatan 4a, Code: MH0807
