# Interpretations of old wood

Figuring mid-twelfth century  
church architecture in west Sweden

KRISTINA LINSCOTT

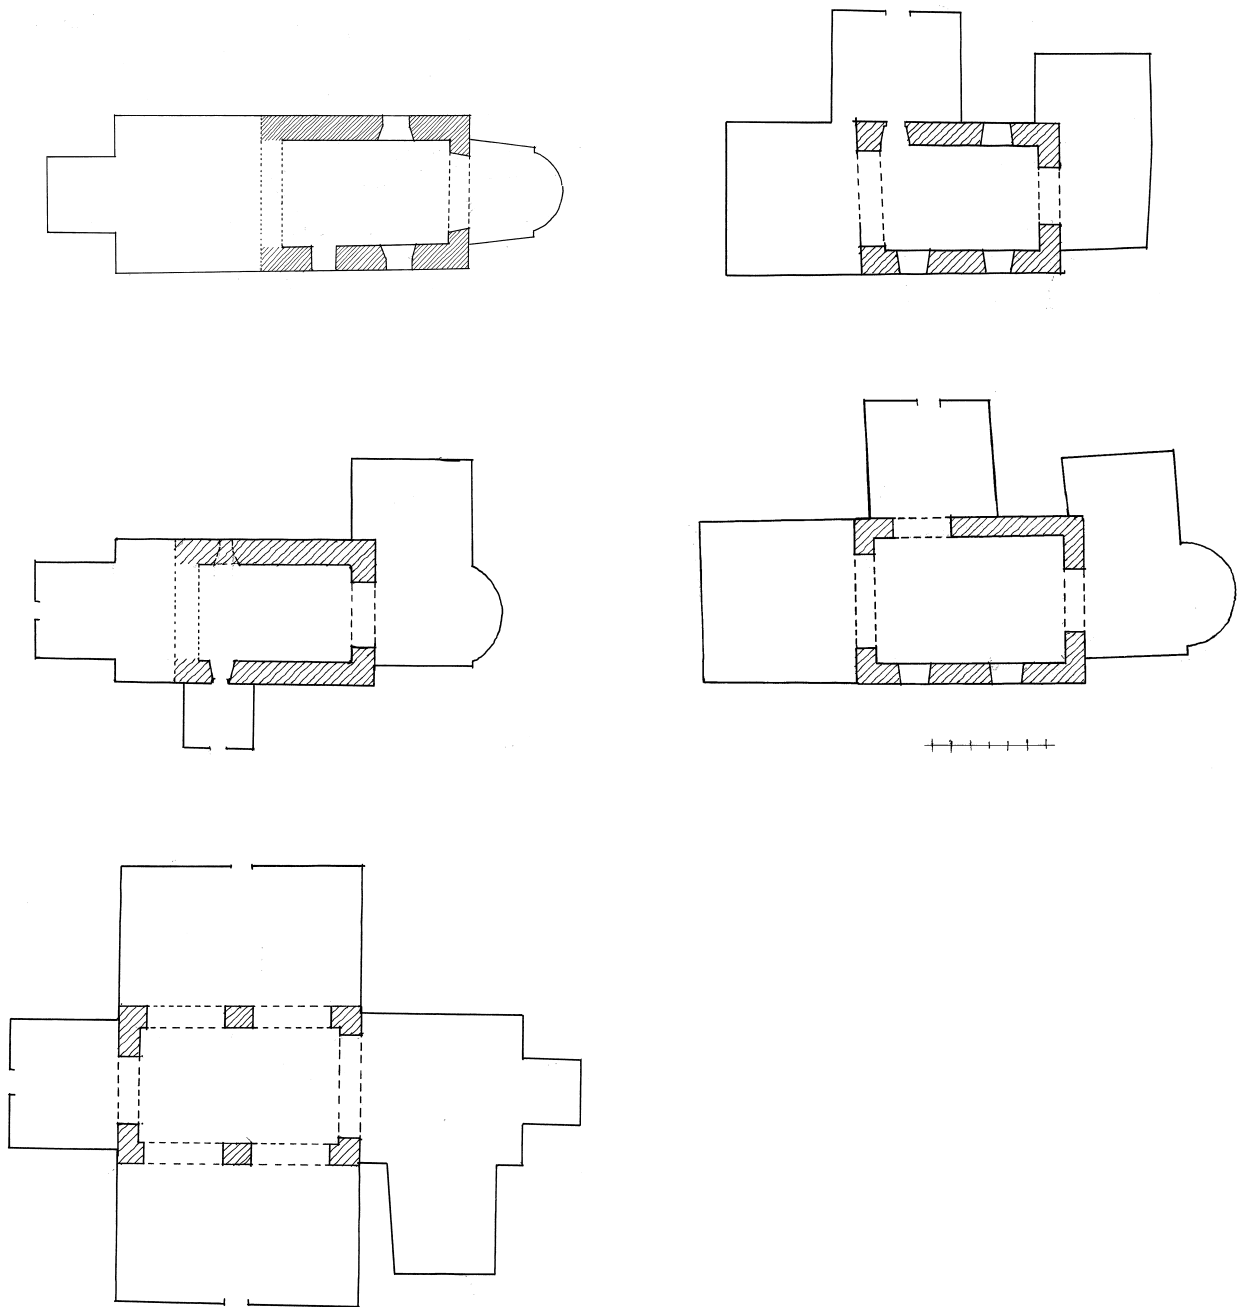
**Fig 3.** The five churches plans. North is up in all drawings. The naves are denoted. **Above left** Forsby, **above right** Marka. **Below left** Gamla Eriksberg, **below right** Gökhem. **Underneath** Forshem. The naves are in all cases added on to, with subsequent structures.

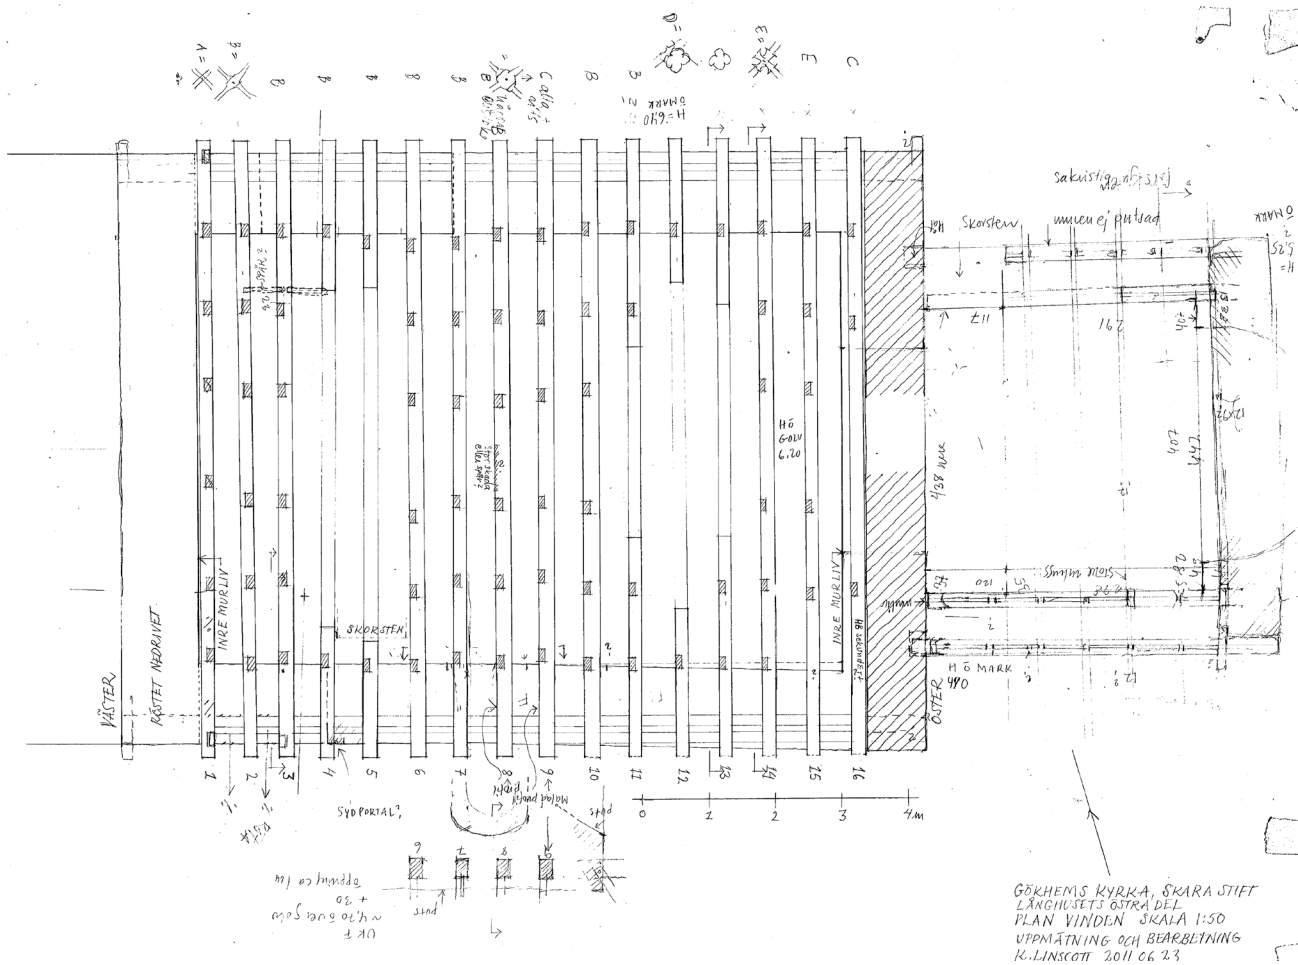
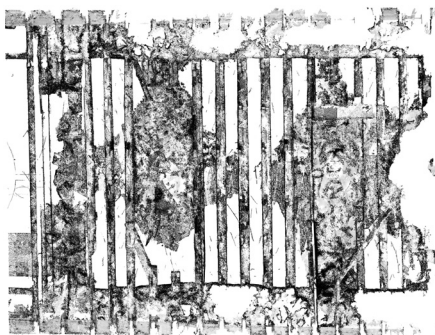
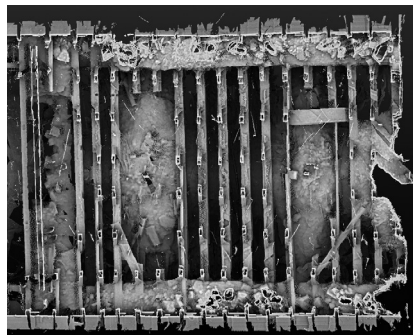
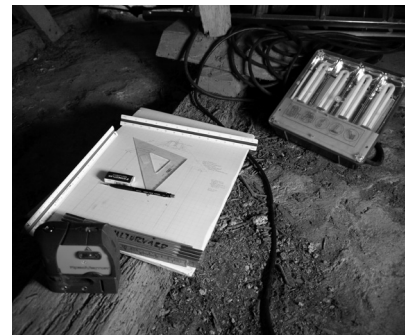
**Fig. 5.** Above, the plan over the attic in Gökhem as drawn by hand 2011–2013. Below left, the plan over the attic in Gökhem in a raw point-cloud, only dust in the air removed. Below middle, the plan in a cleaner version. Spetz 2014, 2017. Below right, the tools I used for the investigations in the attics, measuring and drawing by hand. Photo 2012.

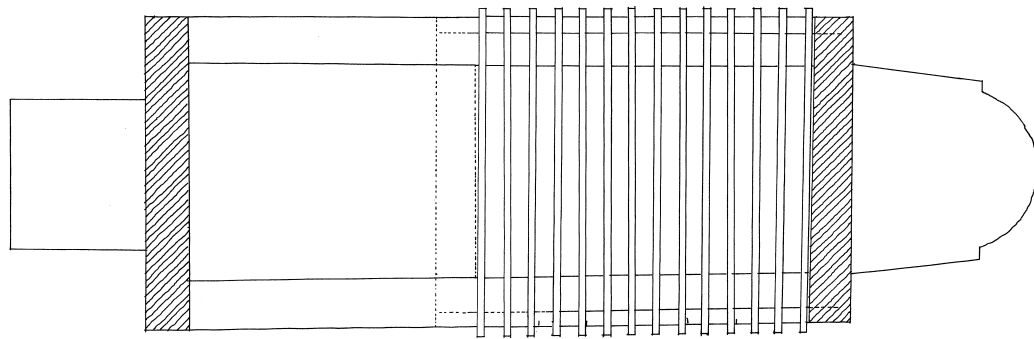
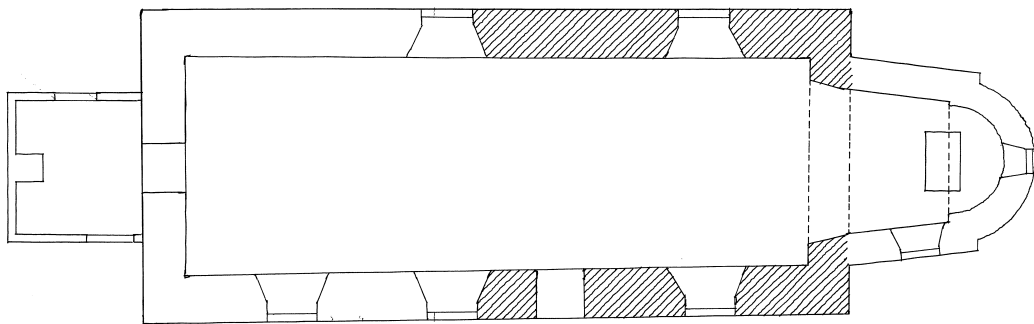
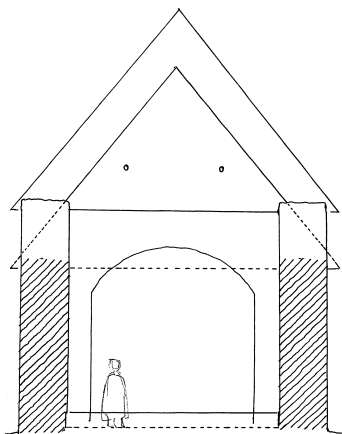
**Fig. 2.1.** **Above**, the plan of the attic over the nave in Forsby shows, the wall crests and the east roof structure with wall plates and trusses. **Below**, the plan shows the present sacristy, nave and chancel in Forsby. The original east part of the nave is highlighted. **Underneath**, the cross section [towards east] shows a seam from a lower gable crest.

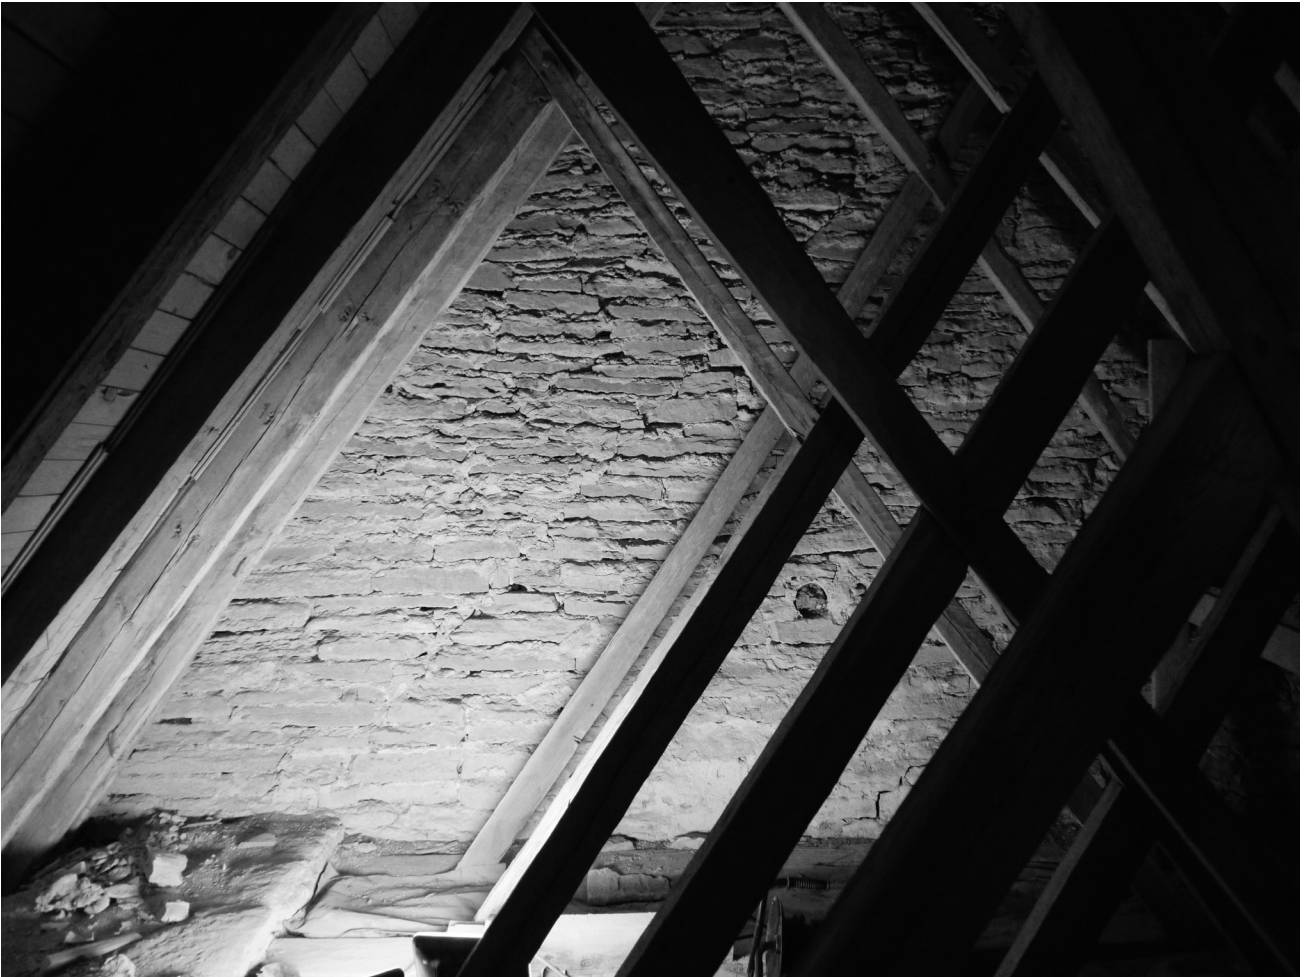
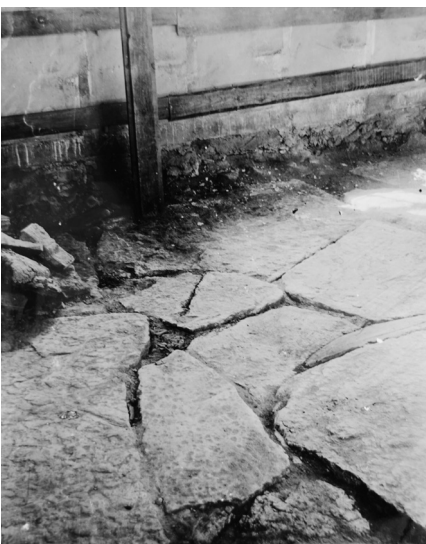
**Fig. 2.3.** **Above**, a view of the east gable in the nave in Forsby from the attic. The seam from a lower gable structure is visible. The mortar in the lower part contains small black particles of coal and is different from the mortar in the subsequent masonry on top. This may be connected to the remains of a limekiln filled with crushed limestone and charcoals, which was found outside the churchyard (Fornsök Forsby). The hole in the lower gable, which is likely from scaffolding, still contain small pieces of wood, and a sample has been identified as the species poplar wood (Seim et al 2015:42). Photo 2015. **Left**, a previous stone floor in the nave in Forsby, close to the north wall, which Norberg interpreted as original. Photo Norberg 1933, ATA.

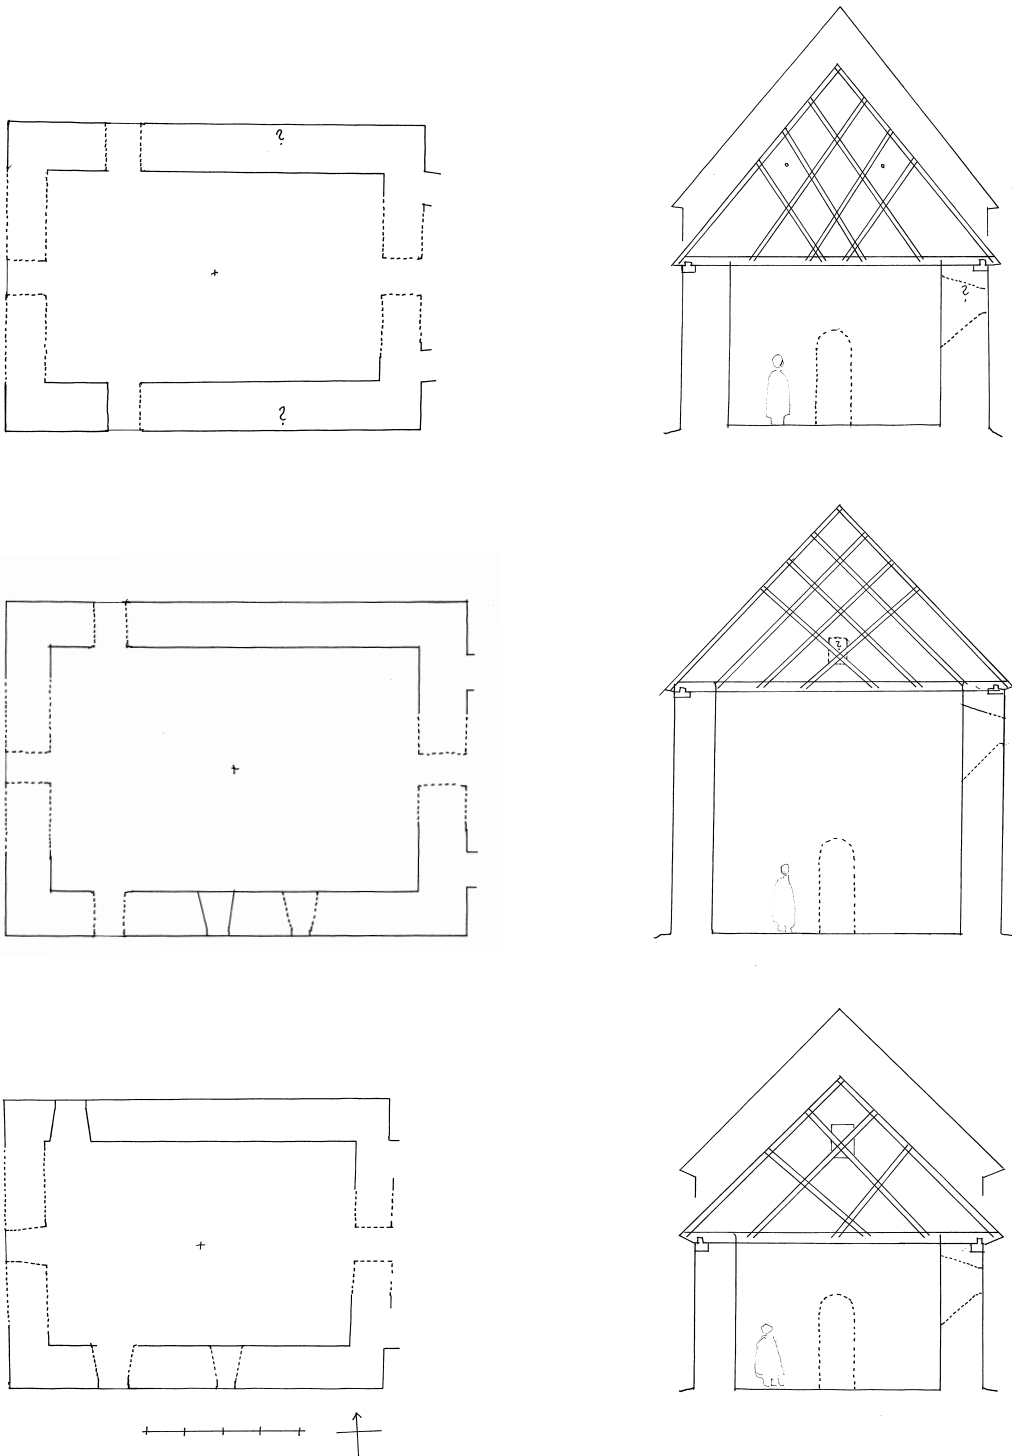
**Fig. 2.4.** Plans and cross-sections show the mid-twelfth century naves with interpreted heights and 'not impossible' doors, **above** Forsby, **below** Gökhem, and **underneath** Marka.

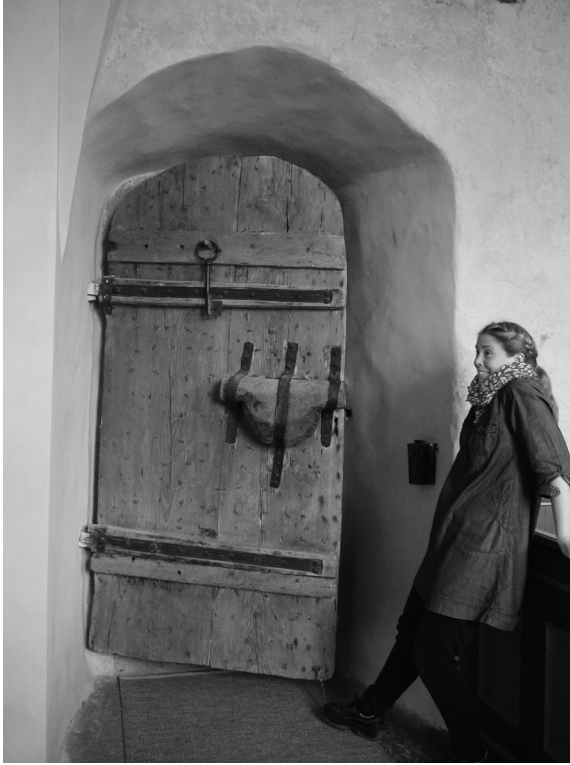
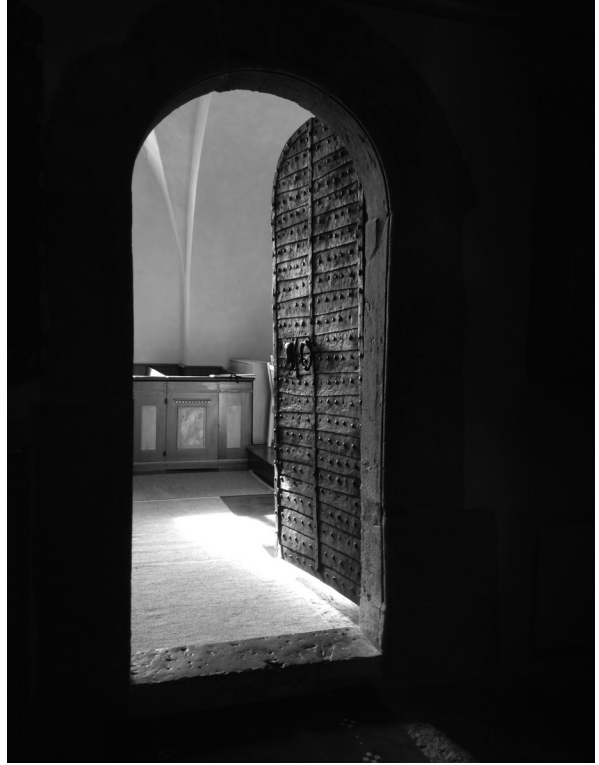
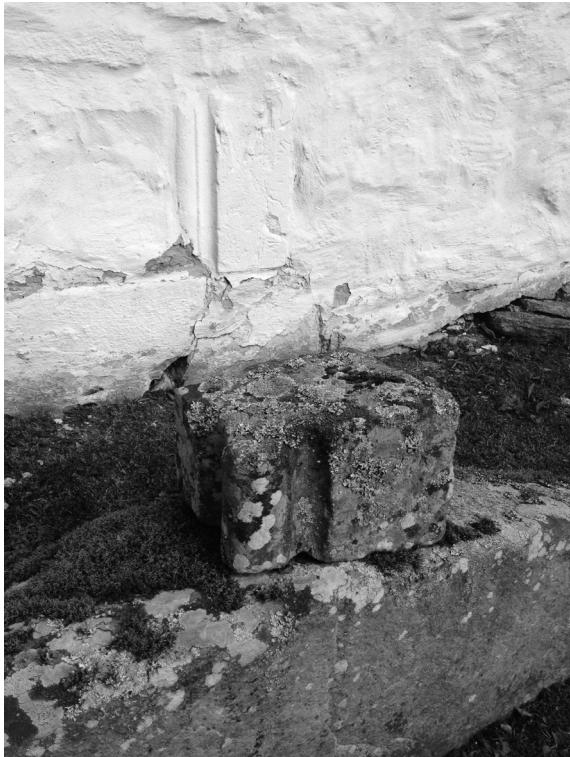
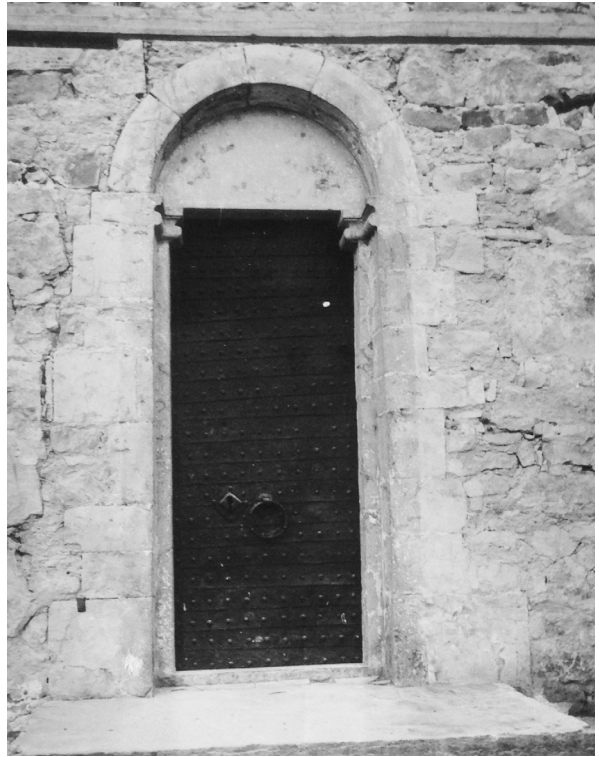
**Fig. 2.5.** Portals with ironclad wooden doors in Marka and Gökhem churches. **Above left,** the north entrance to the nave in Marka, from the inside. This has a robust wooden lock. The wooden boards are well preserved and could probably be dated with dendrochronology in the future. Photo 2015. **Above right,** is the same door viewed from the ironclad outside, i.e. now from the present porch. Photo 2015. **Below left,** the trace from a south entrance in Gökhem. Photo 2015. **Below right,** is the ironclad door with stone portal in the present north entrance in Gökhem. The photo was taken when the plaster was removed in 1967. Photo Beerståhl, ATA.

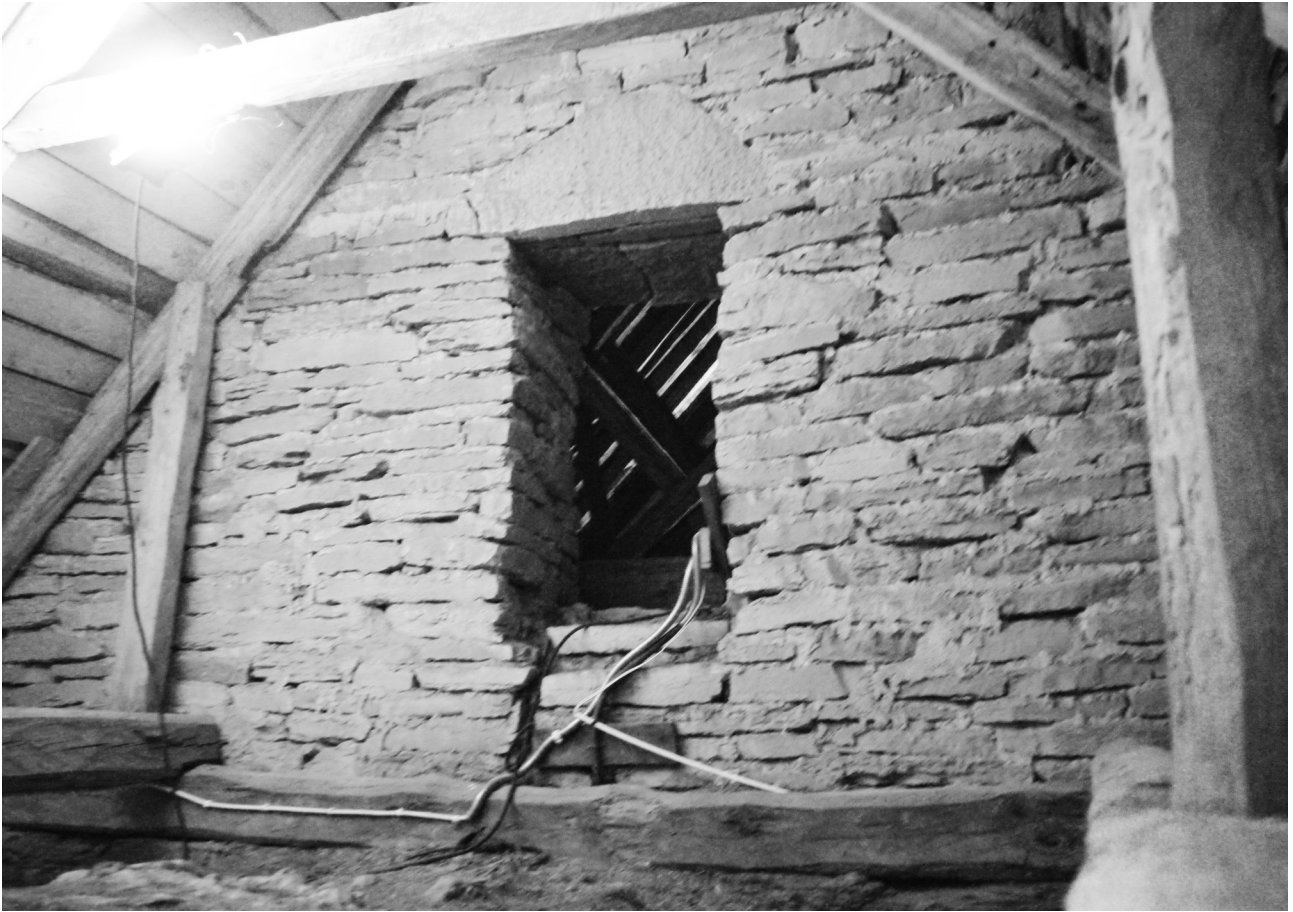
**Fig. 2.6.** **Above**, Marka church, opening in the gable top towards east, which most likely was outside in the mid-twelfth century. Photo 2015. **Below left**, Gökhem church, the top of the west of two windows remains visible from the attic. It is located right under the tiebeams. Photo 2015. **Below right**, the inside of the south wall over the vaults. The picture was taken from the space between on top of the vaults and underneath the tiebeams. The plaster is most likely not original. It was probably put up after a ceiling of boards was nailed into the undersides of the tiebeams, and before the vaults were raised. Photo 2015.

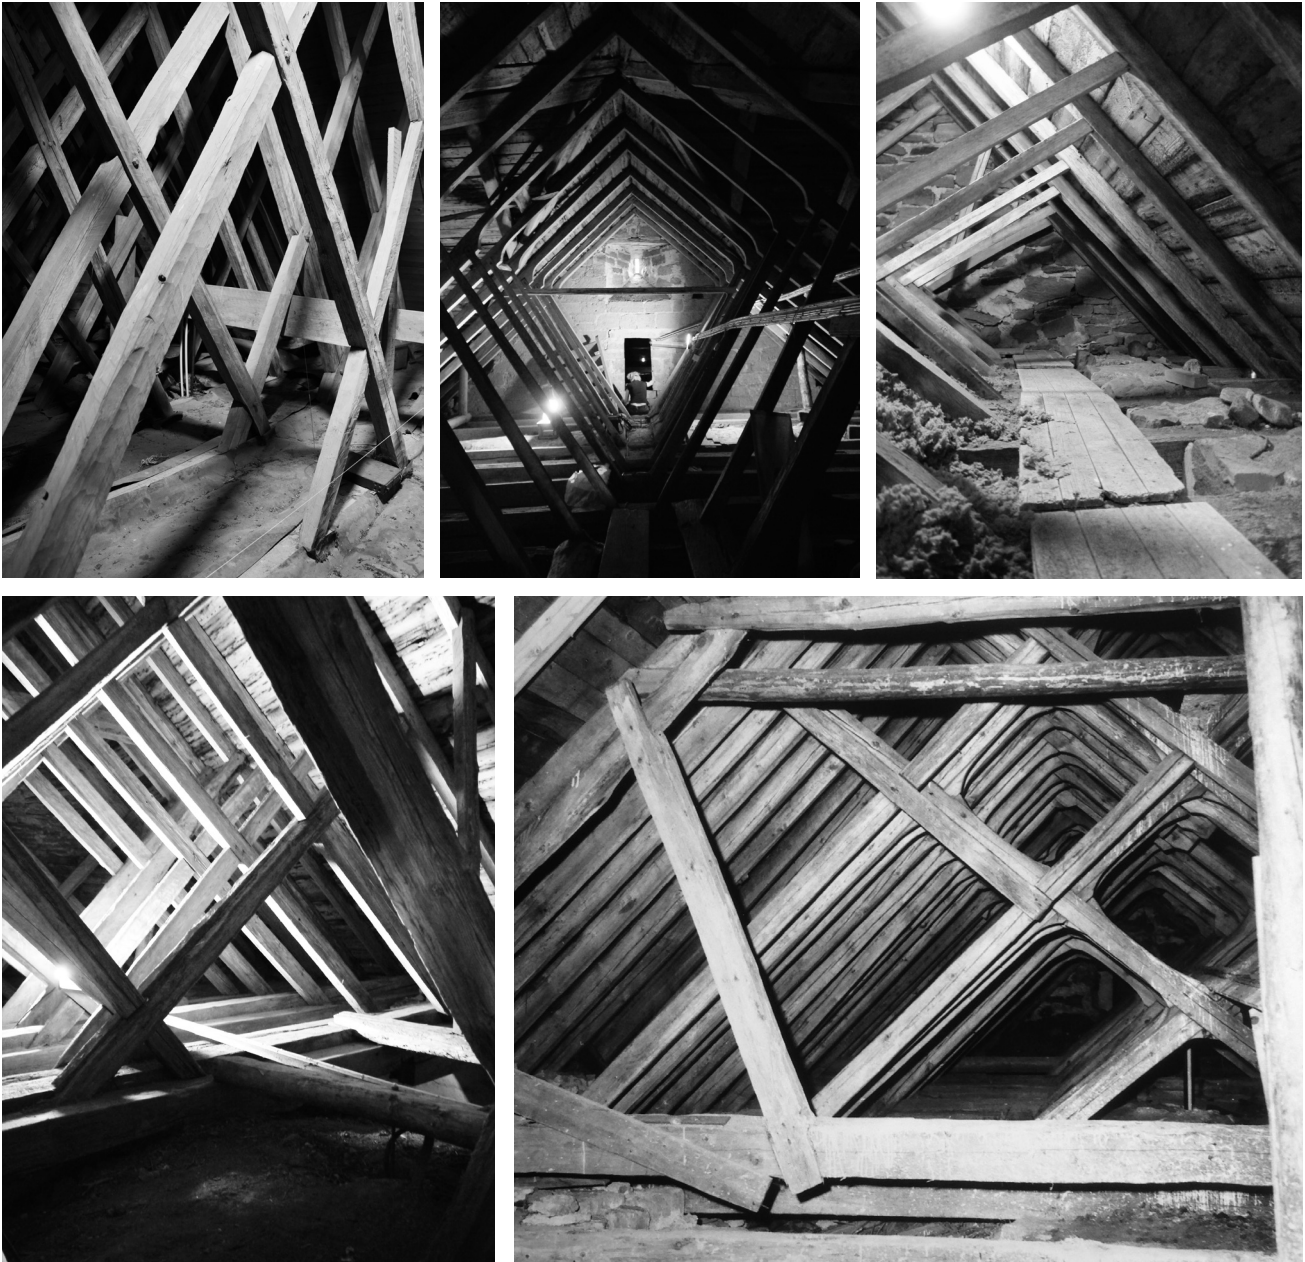
**Fig. 3.1.** The five attics. **Above left**, Forsby. Photo 2011 Eriksson. **Above middle**, Forshem. Photo 2013. **Above right**, Gamla Eriksberg. Photo 2013. **Below left**, Marka Photo 2013. **Below right**, Gökhem. Photo 1967 Klasson, ATA.

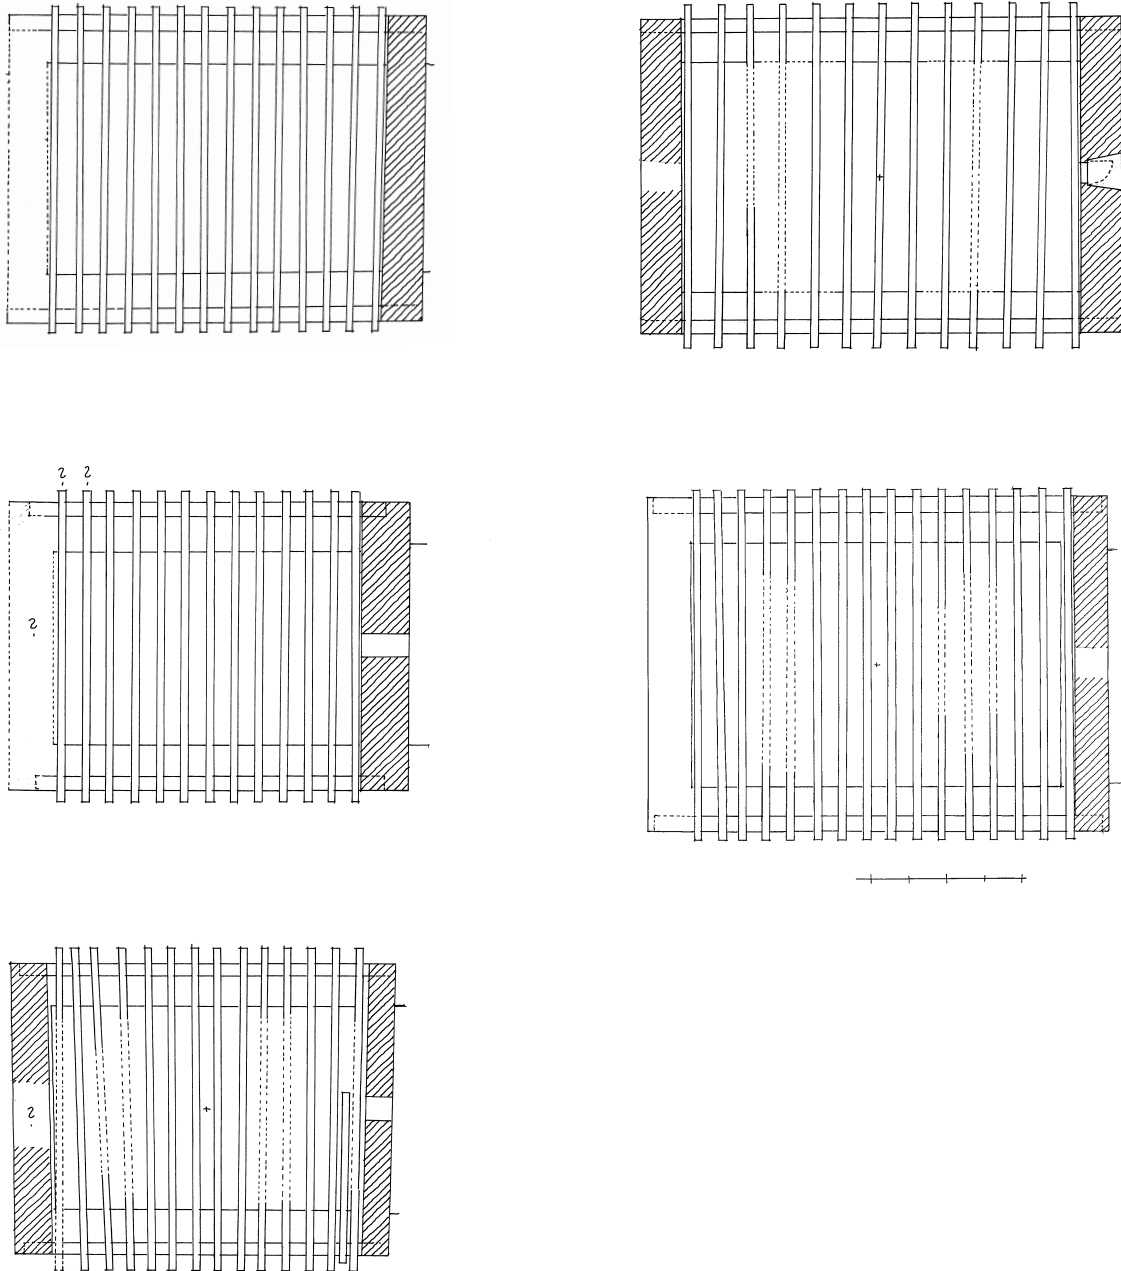
**Fig. 3.2.** Plans of the five attics with tiebeams, wall plates and wall crests. **Above left** Forsby, and **above right** Forshem. **Below left** Gamla Eriksberg, and **below right** Gökhem. **Underneath** Marka. North is up in all plans.

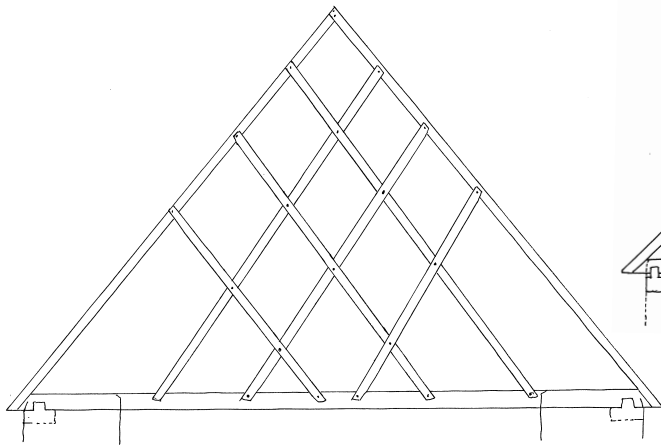
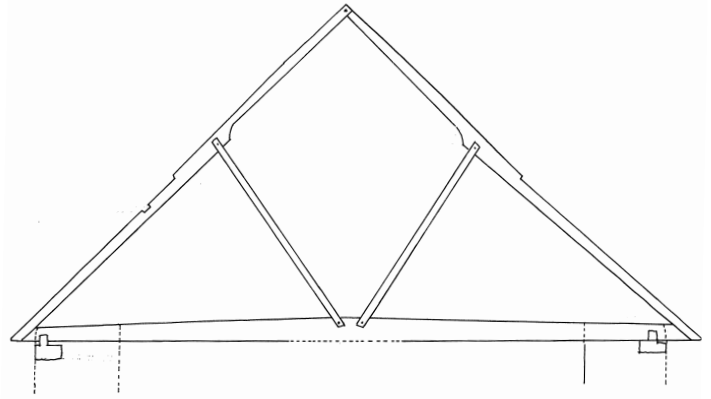
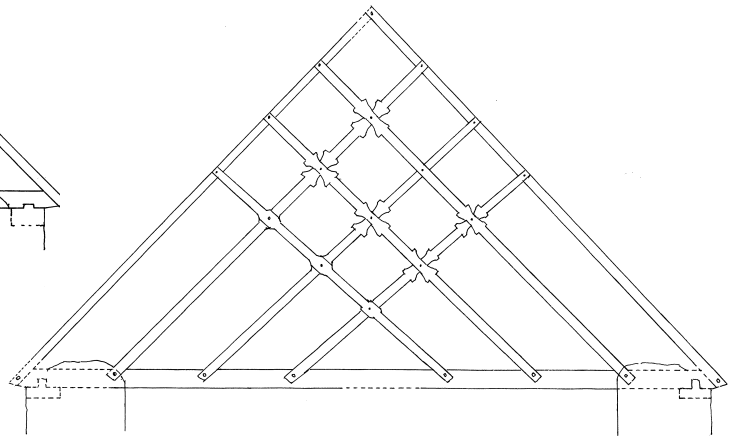
**Fig. 3.3.** Examples of the five truss types, cross-sections. **Above left** Forsby, and **above right** Forshem. **Below left** Gamla Eriksberg, and **below right** Gökhem. **Underneath** Marka.

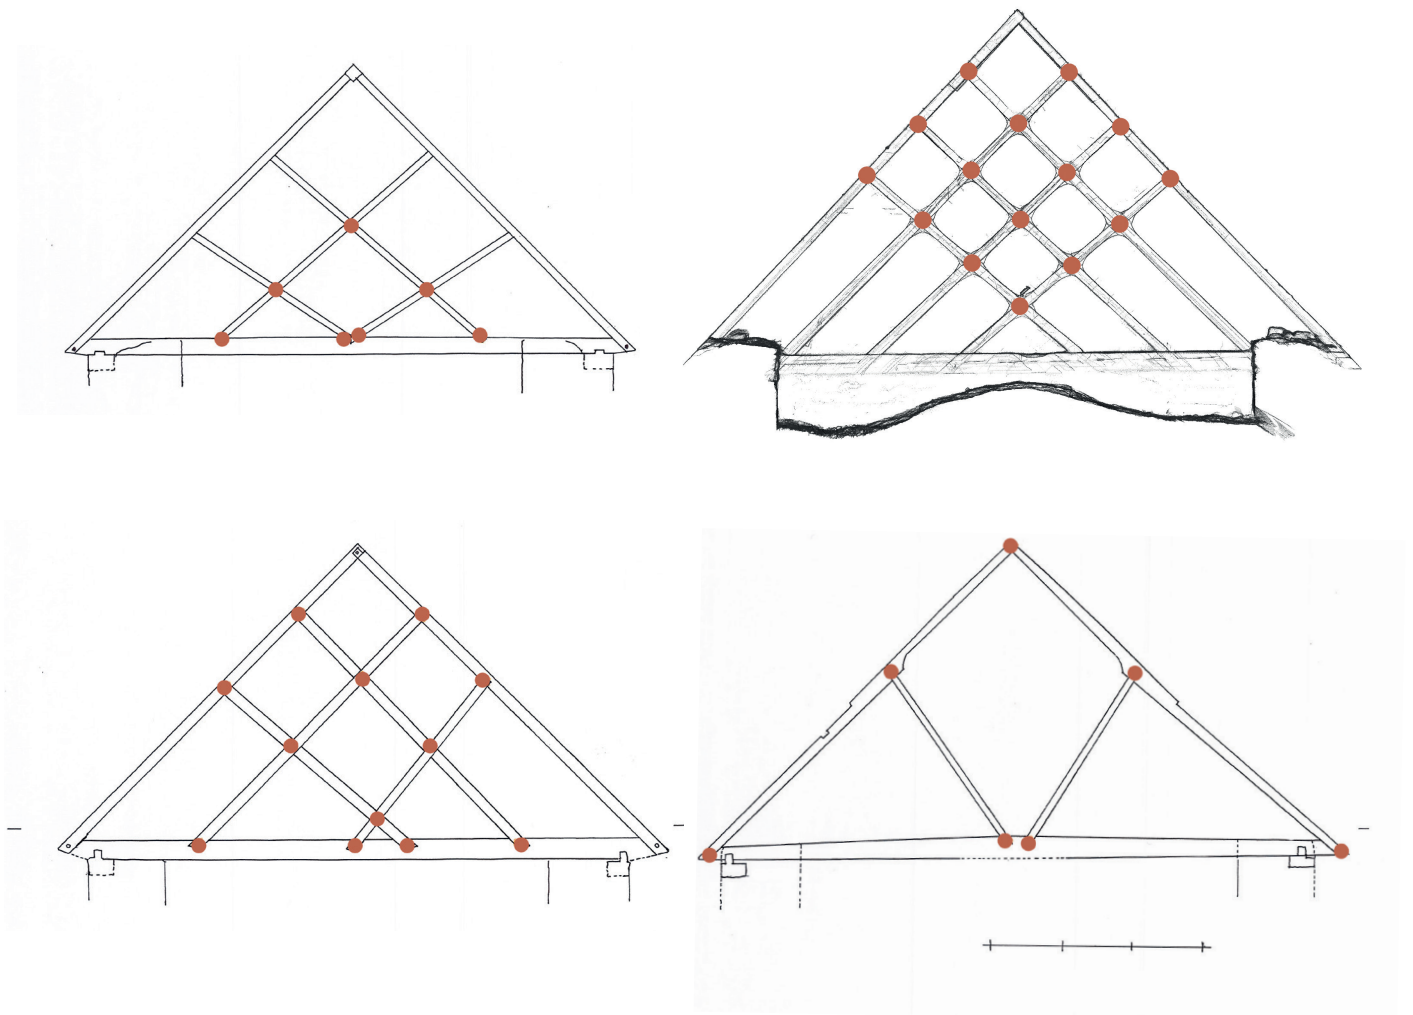
**Fig. 3.6.** View of examples of trusses with fan-shaped crossing struts, and iron nails marked with red dots. Views from the front sides. **Above left** Gamla Eriksberg, and **above right** Gökhem. **Below left** Marka, and **below right** Forshem. Forsby has only wooden dowels.

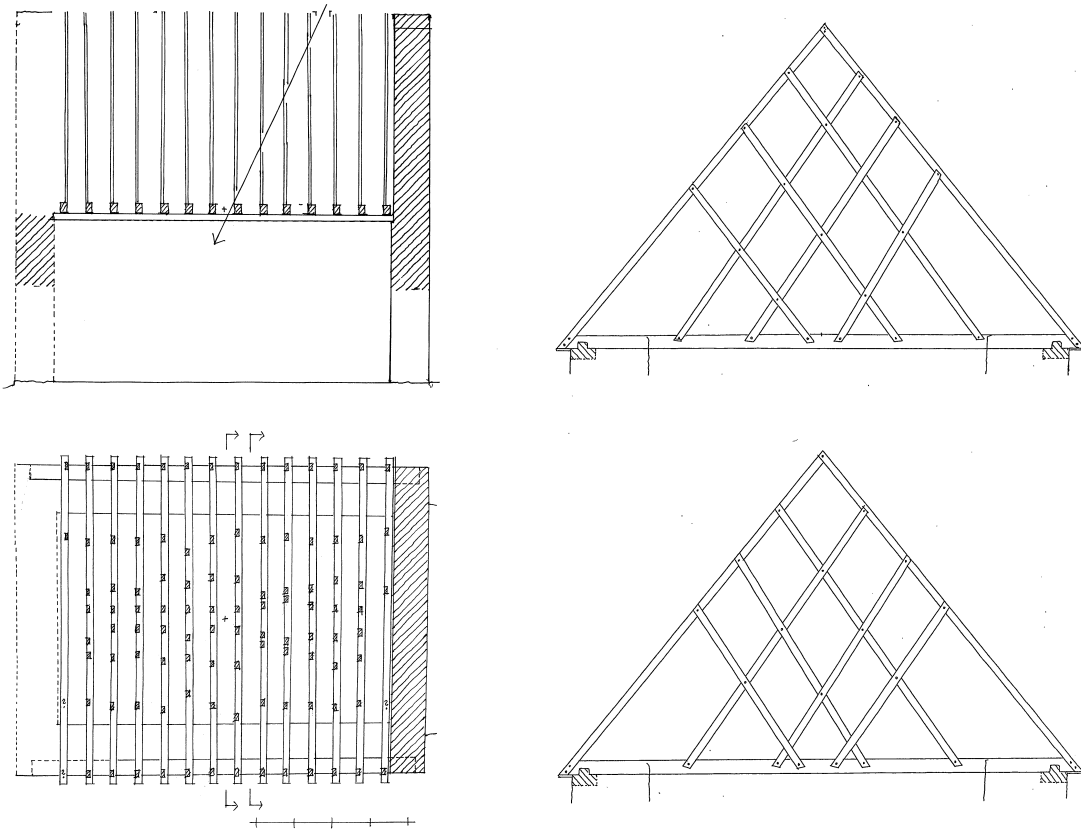
**Fig 3.7.** Above left longitudinal section in Forsby, the view from south shows the tunnel at an angle. Below left plan over the roof in Forsby the cut is taken just over the tiebeams, and includes how the struts land on the top of the tiebeam. Right above and right below views of two of the shifted trusses in Forsby, which form the tunnel at an angle.

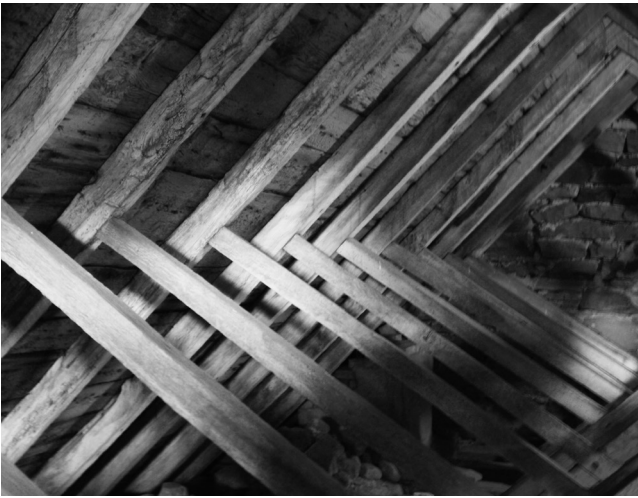
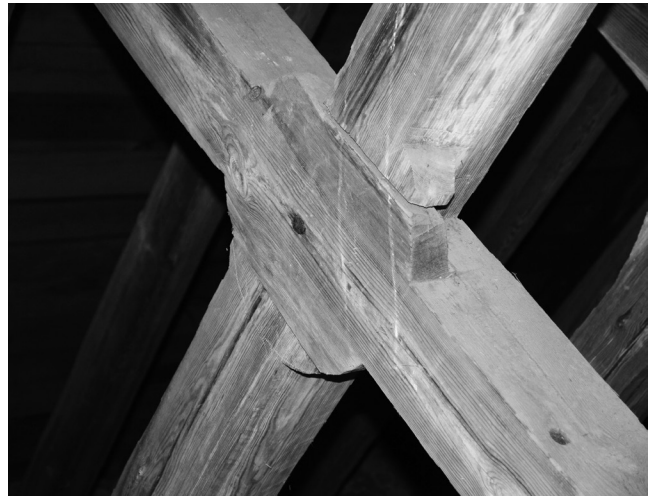
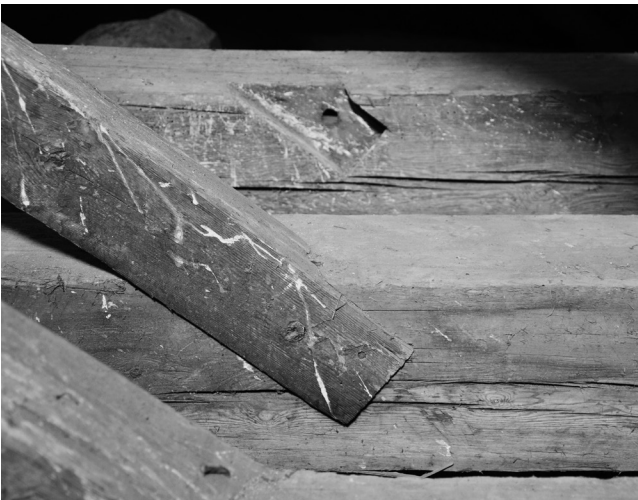
**Fig. 3.8.** Above left, plan over the attic in Gökhem. Above right, plan over the attic in Marka. The ‘cut’ is just over the tiebeams, which shows how the struts land on the tiebeam, as they are ‘billowing’ over the roof. Below left, the joinery in Gamla Eriksberg is different from the other four roofs as the carpenters solved the joining of rafter/strut by just putting the struts into small grooves in the rafters’ bottom sides. Below right, example joinery in Gökhem. The carpenters scribed the discs’ radius into the wood; it forms a perfect circle even though the discs edges are uneven. Photo 2015. Underneath left, joinery in Gökhem and underneath right, surfaces in three different struts belonging to the same truss [3] in Gökhem. Based on a recording by Stornes 2011.

In all but a few trusses in Gökhem, the carpenters placed and joined the three struts that goes from the bottom at the tiebeam to the southern rafter first, followed by the three others

on top. In Marka, they followed the same procedure, using only four struts in total. The carpenters in Forsby placed their six struts differently. They first put the longest truss towards north in place, then the longest towards south across, on top. Thereafter the two middle sized struts, and last the two shortest. Like braiding with stiff thread. However, there are a number of variations on this theme in the fourteen trusses in Forsby. In Gamla Eriksberg, they placed their four struts one at a time, as in Forsby. However, the two shortest struts do in fact not cross each other. They just meet at the middle of the tiebeam.

The carpenters joined the different parts in each truss, mainly, with straight, halved lap joints. They fastened the rafters and struts to the tiebeams in notches, which they made in one side of the thick beams. This way they created front- and backsides in the trusses. They were generally more careful to make the intersections tight and flat in the front sides and at the tiebeam. If they made mistakes, they fixed them, in the front sides carefully (Willebrand 2012:33). In most cases, they made straight lap joints at the intersections strut/rafter and strut/strut. In Gökhem, they made the grooves for struts across the whole width of the rafter, in all trusses. In Forsby, they made the intersections in varying ways. The differences occur even within the same individual truss. In Eriksberg, the carpenters solved the joining of rafter/strut in a completely different way, as they just put the struts into small recesses in the rafters' bottom sides. However, they made the intersection between struts and tiebeams as in Gökhem and Forsby.

- p. 99 Fig. 3.8. Plans over the attics in Gökhem and Marka with the 'cut' just over the tiebeams. Examples of the joinery in Gamla Eriksberg and Gökhem, and drawing with examples of different surfaces in three struts in the same truss.

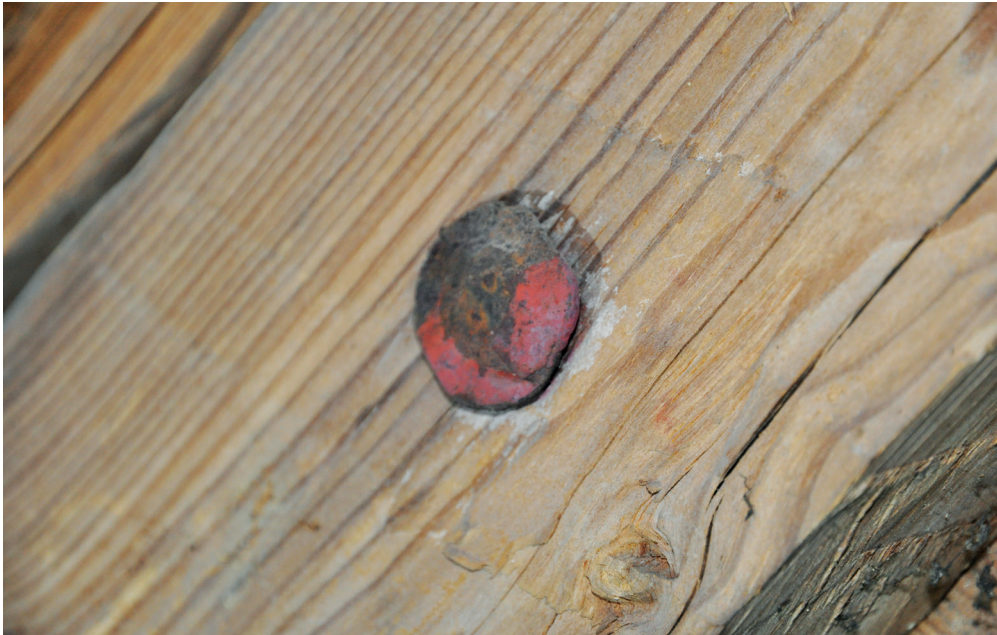
**Fig. 3.9.** In Mosjö church in Närke, red paint remains on an iron nail. Remains of white paint occur in many places in this roof, and in some cases traces of black (Eriksson & Borg 2014:76f, 81). The roof over the nave in Mosjö church has been dated with dendrochronology to 1214 (ibid). Photo Eriksson 2014.

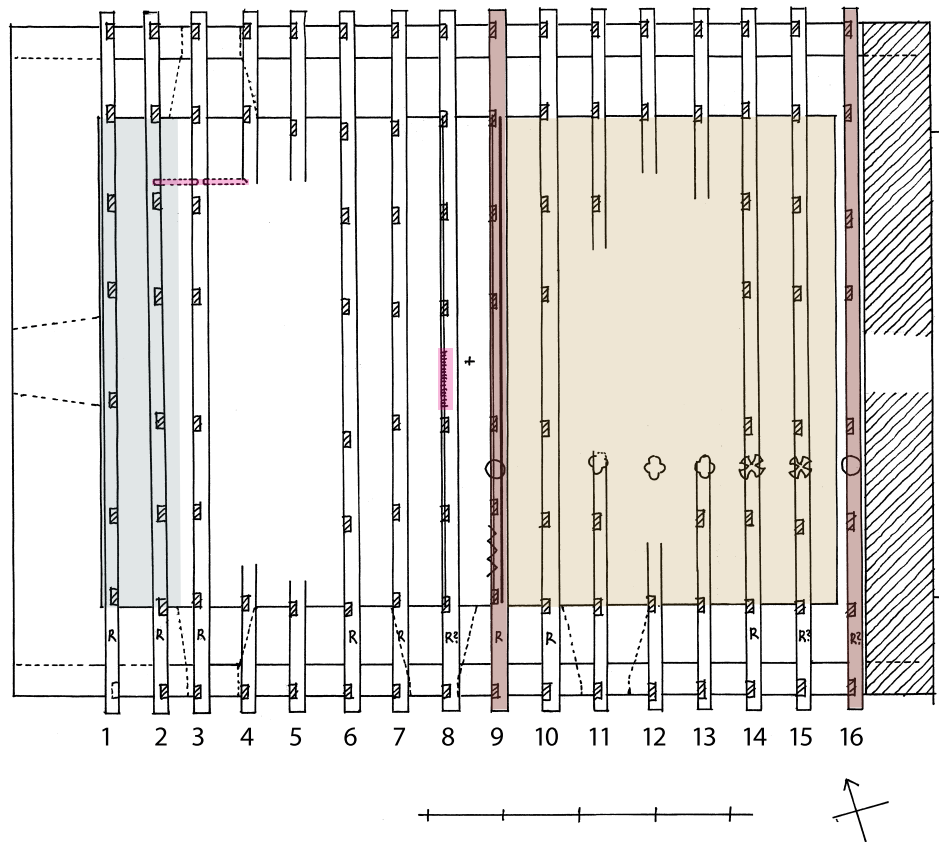
**Fig. 3.10.** Plan of the roof in Gökhem. The builders in Gökhem placed the two trusses that face east, number 1 and 2, over the most western part of the nave, by the west wall. The other fourteen trusses, which face west, were spaced over the rest of the room. Trusses, which include circular discs, are number 9 and 16, quatrefoils are number [11?], 12 and 13, crosses occur in number 14 and 15. The traces in the north-west corner suggest that something happened below, which is in the northwest corner of the nave next to the entrance in the north wall. Perhaps bells were hanging here.

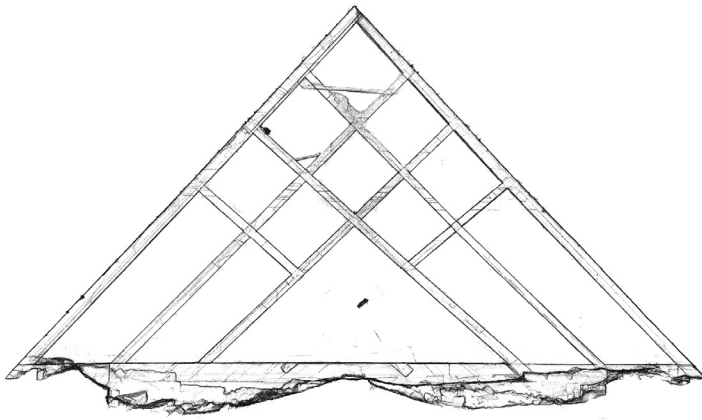
**Fig. 3.11.** **Left** 3D laser scan of the west truss [1]. Spetz 2014. **Right** trace from something hanging in the tiebeams [2, 3 and 4]. Photo Eriksson 2012.

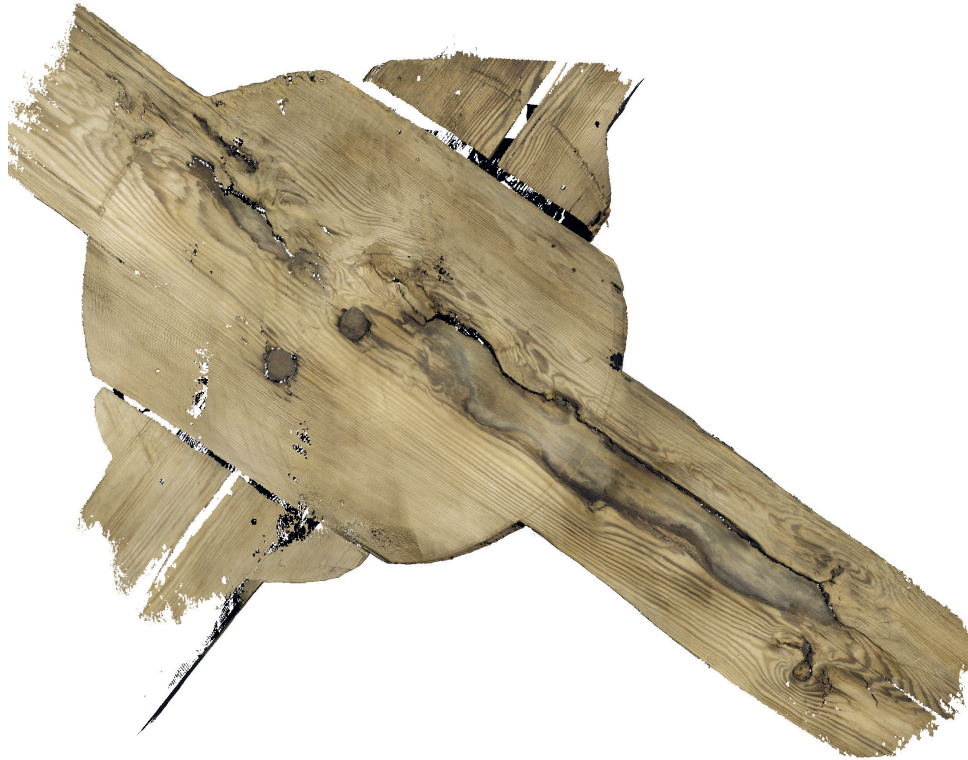
**Fig. 3.13.** **Above**, 3D scan of the scarred strut, placed towards the south wall and the window. This is the only truss were the carpenters chose to use timber which had been scarred like this, likely by lightning. They chose to expose the scar by placing it at the [west] front side. Further, it was placed in the very middle of the room, and it was well lit by the window. I interpret that this placement was intentional. Spetz 2014. **Below left**, the carved thin beaded curve. Photo Eriksson 2012. **Below right**, the black line under the tiebeam [truss 9], which marks the middle of the room. Photo Eriksson 2012.
