# Interpretations of old wood

Figuring mid-twelfth century  
church architecture in west Sweden

KRISTINA LINSCOTT

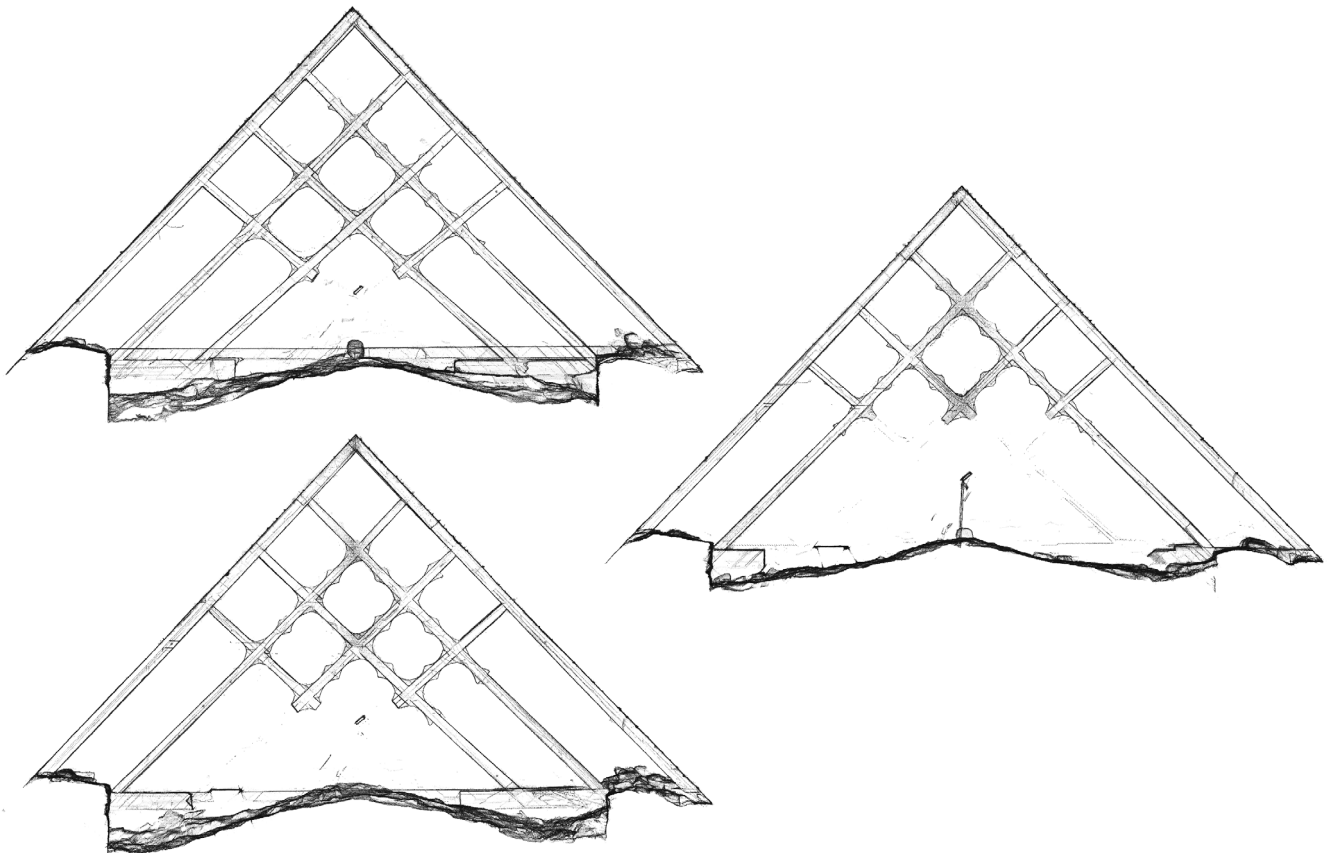
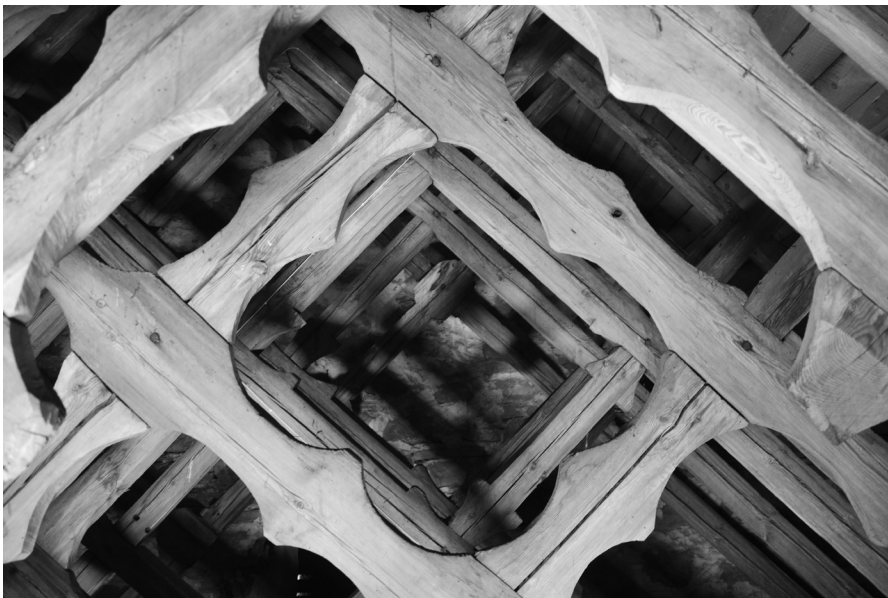
**Fig. 3.14.** Above, the 3D laser scans show the three trusses [11, 12, 13]. The different quatrefoils vary and they are uneven. The shapes do not include all lobes, and those parts that were included are not precise nor symmetrical. In addition, the carpenters made extra segments in some struts, more than needed to form the four quatrefoils. This is not due to mistakes or later damage, it is how the carpenters completed and finished the trusses in 1140–1141. Spetz 2014. **Left**, the same trusses seen from west. Photo Eriksson 2012.

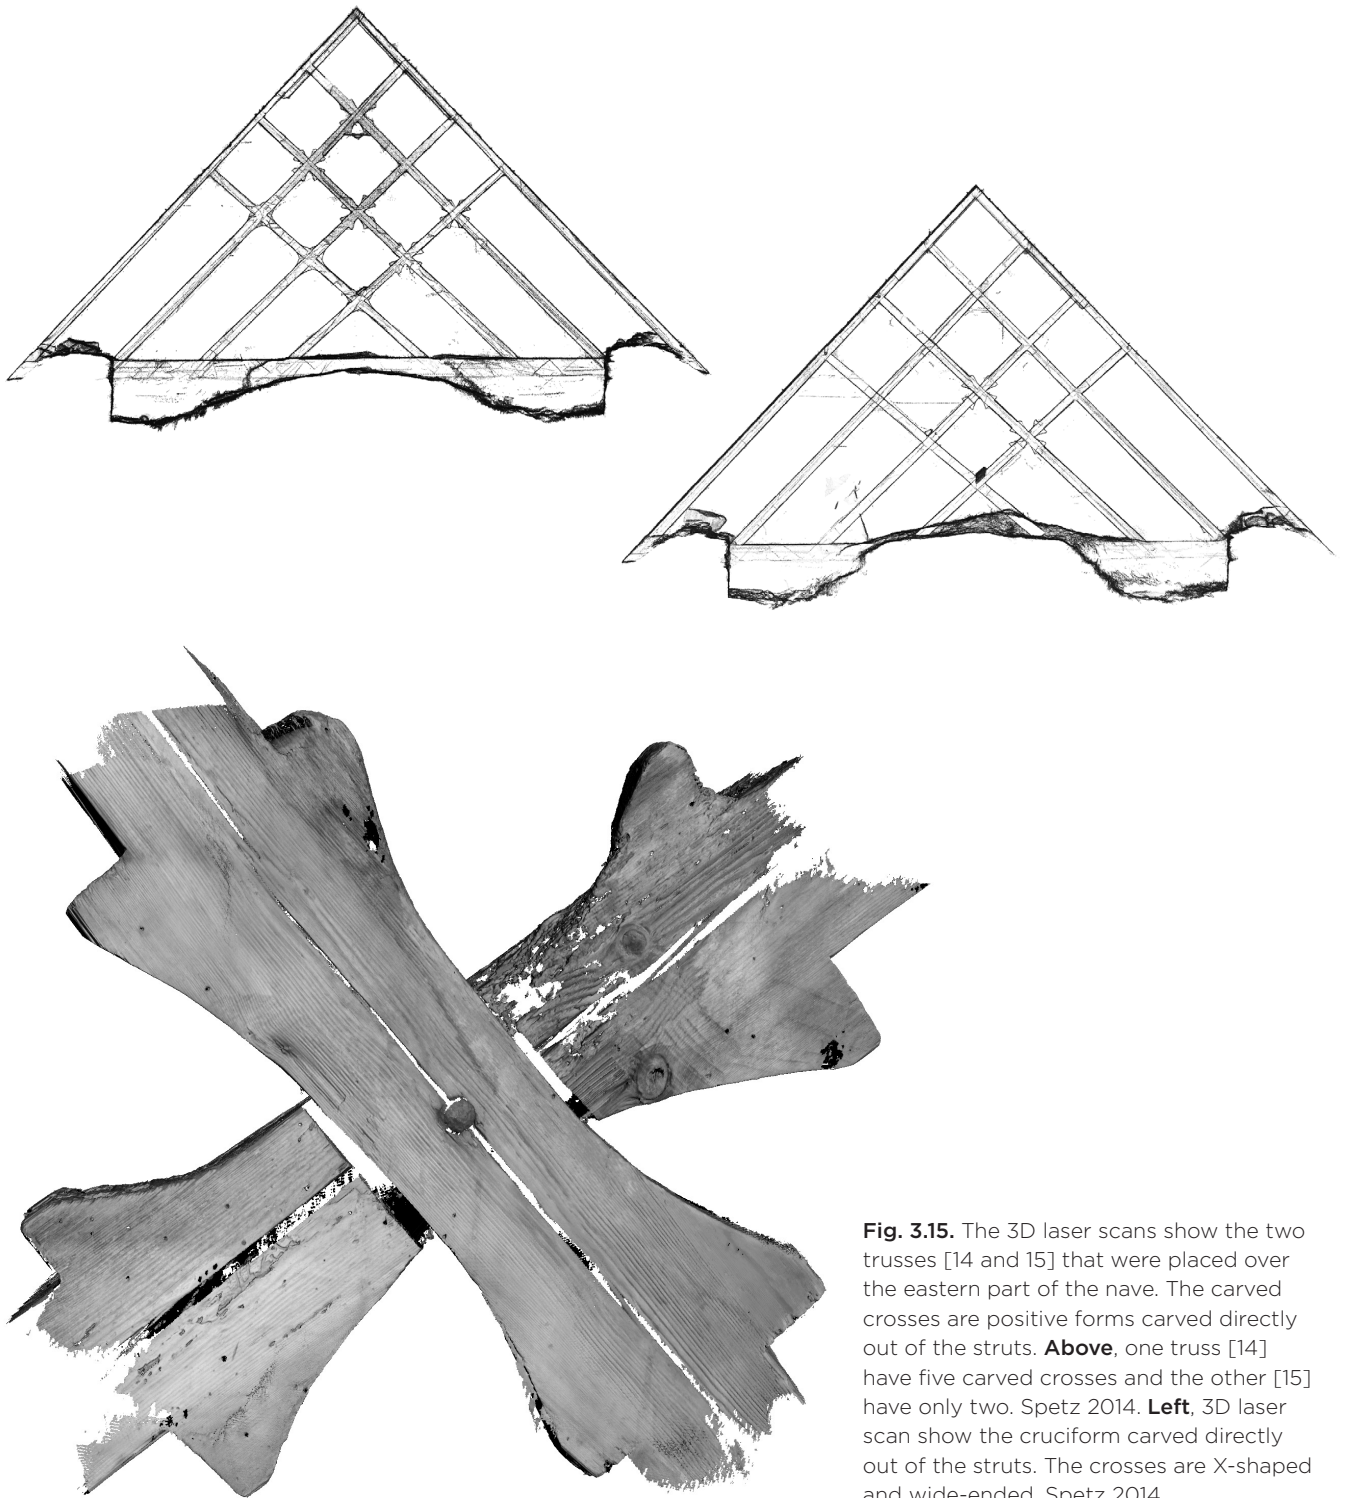
**Fig. 3.15.** The 3D laser scans show the two trusses [14 and 15] that were placed over the eastern part of the nave. The carved crosses are positive forms carved directly out of the struts. **Above**, one truss [14] have five carved crosses and the other [15] have only two. Spetz 2014. **Left**, 3D laser scan show the cruciform carved directly out of the struts. The crosses are X-shaped and wide-ended. Spetz 2014.

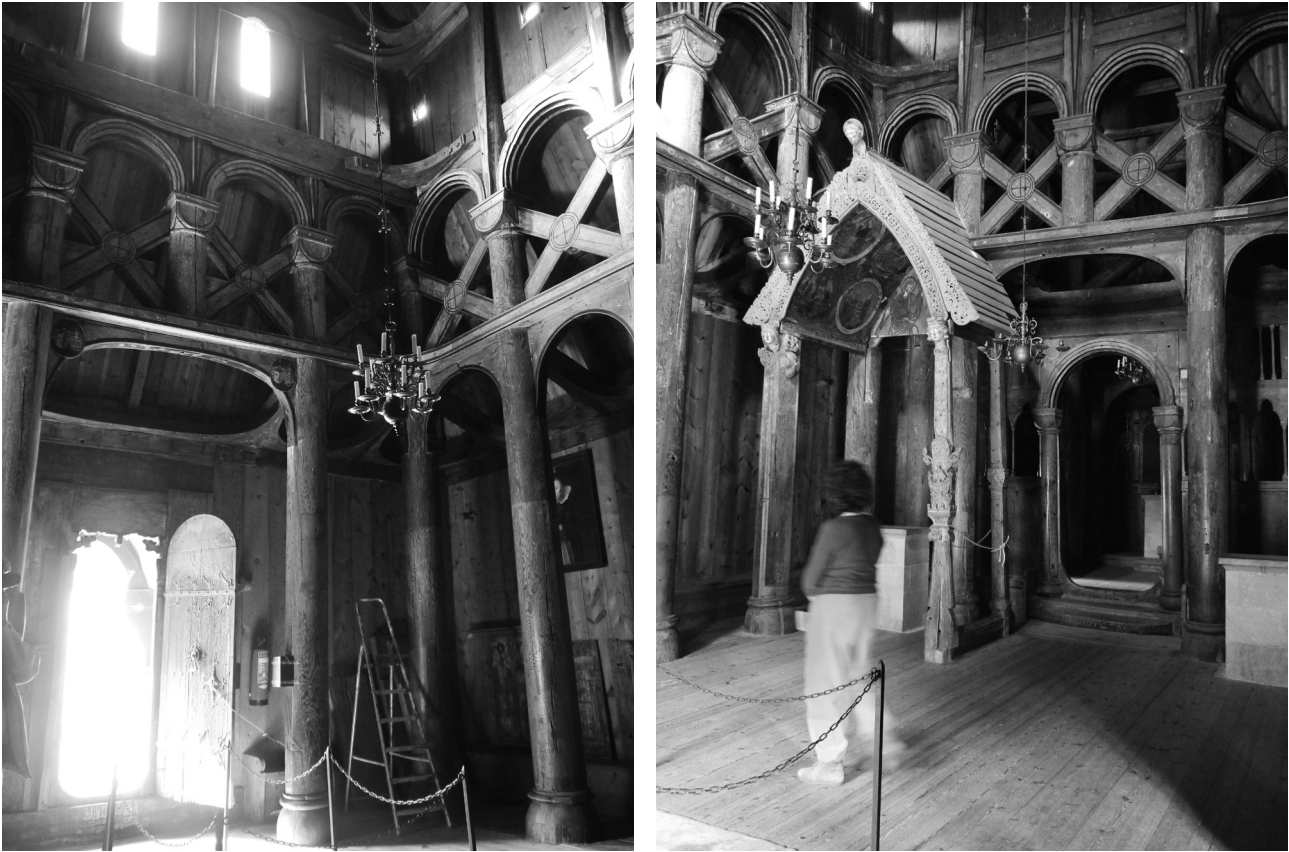
**Fig. 3.16.** St. Andreas crosses in Hopperstad stave church form a grid-frame around the elevated middle room space. Photo 2016.

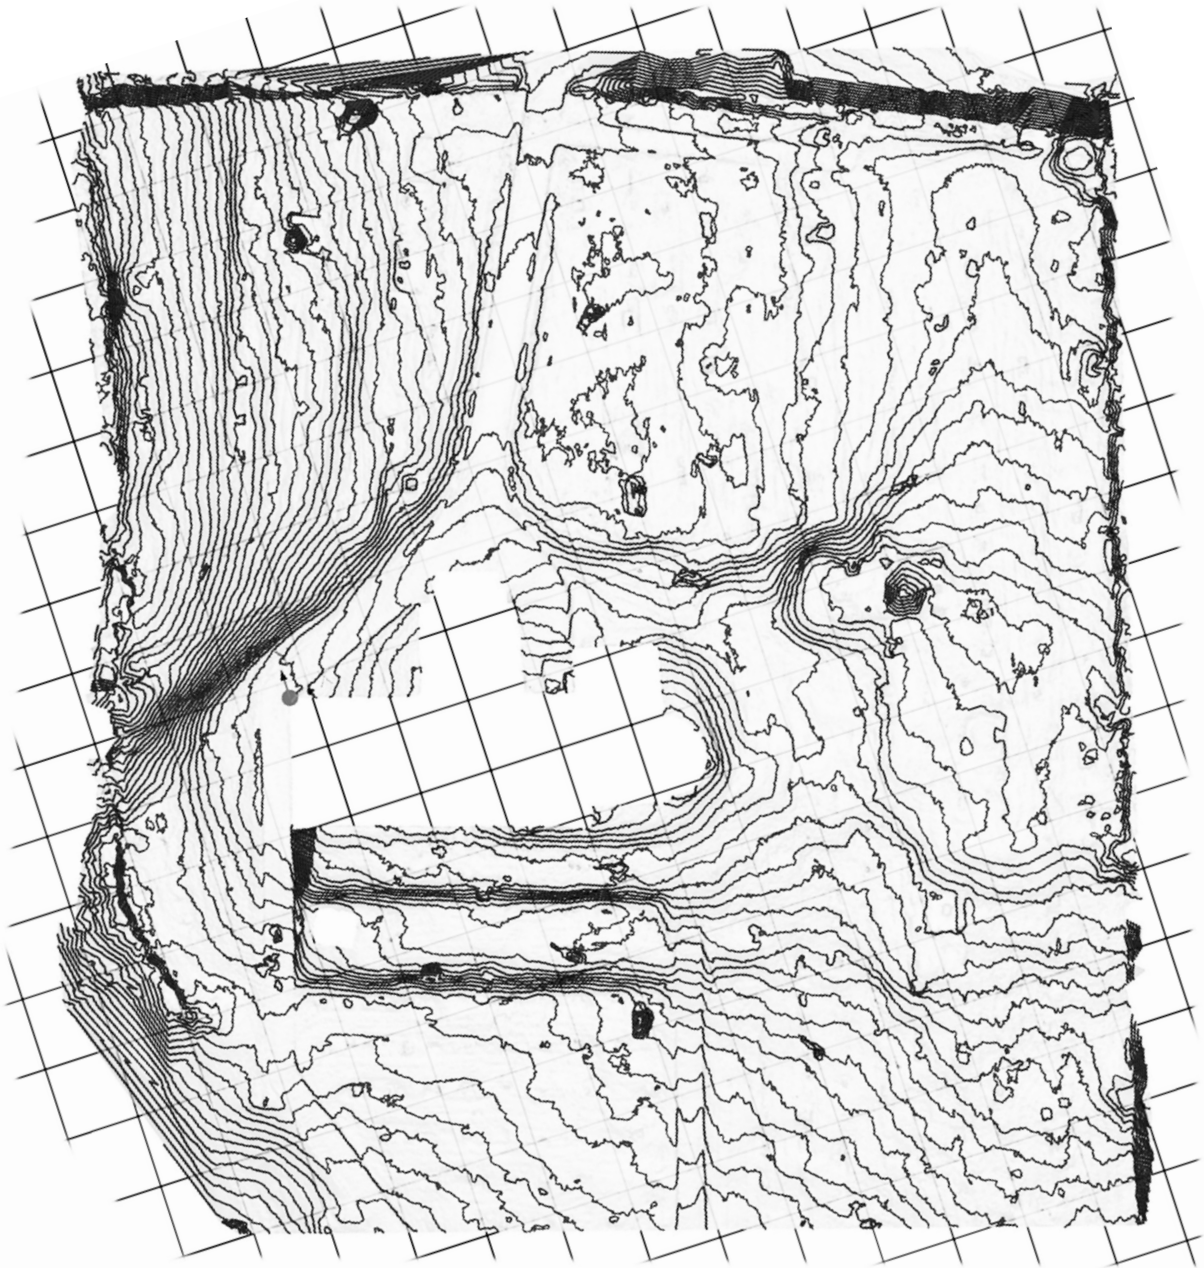
**Fig. 4.5.** A site plan of Gökhem church. The lines are at 0.2 m equidistant, the grid shows the capital directions. Spetz 2017.

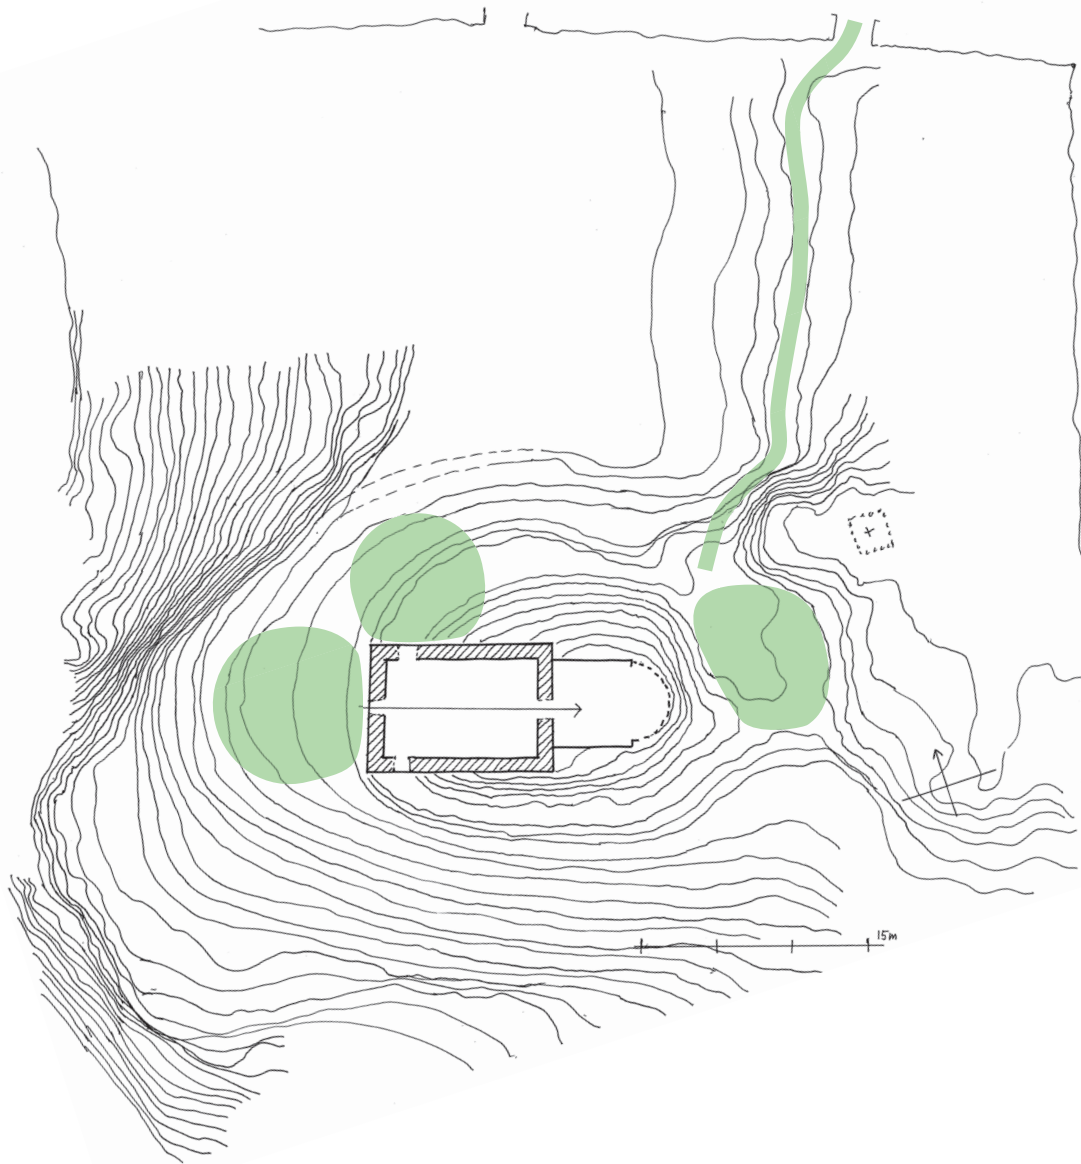
**Fig. 4.6.** Site plan that analyses the theme 'peninsula', with the original nave and chancel. Three flat areas, 'places', 1) east of the chancel, 2) by the north entrance, and finally 3) west of the original nave are identified. The south route is narrow, close to the slope. The north route is more convenient. Drawing based on the scan by Spetz 2017.

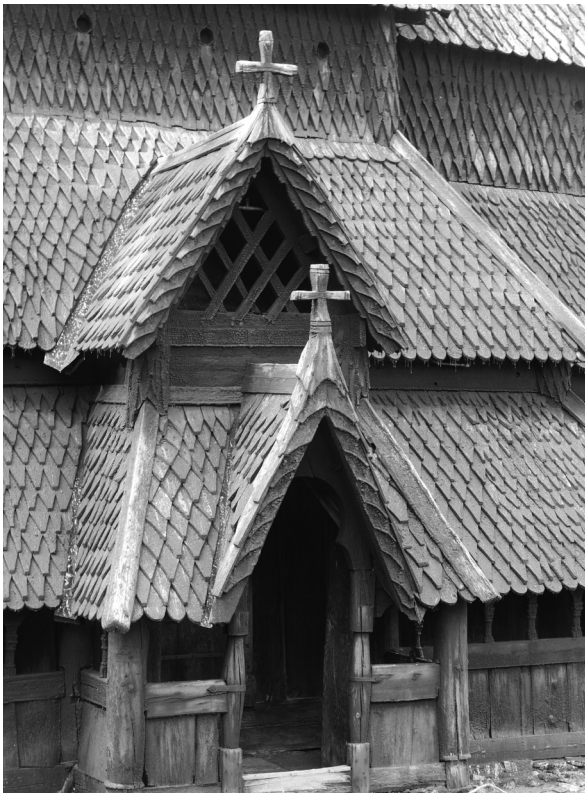
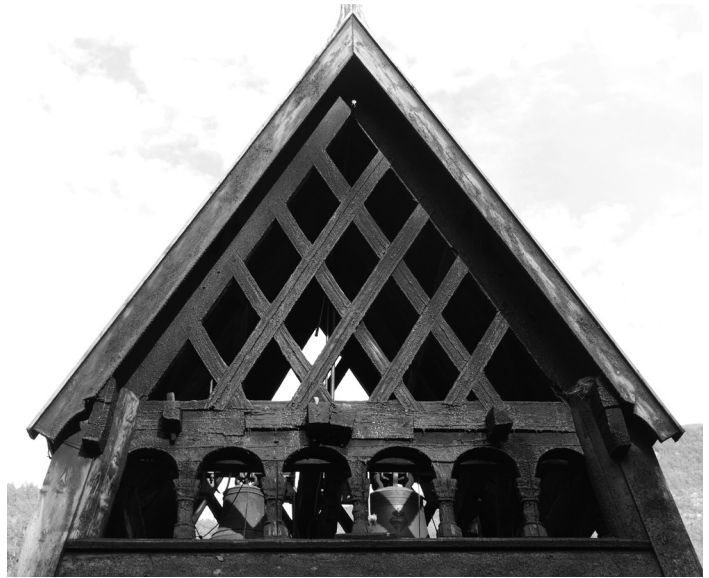
**Fig. 4.7.** **Left**, the entrance to the gallery in Borgund, and **right**, the bell tower in Borgund. Both have 'lattice' grids. The bell tower in Borgund is the only freestanding tower with stave construction in Norway (Anker 2005:151). The bell tower in Lomen stave church, also have lattice, see picture in Hauglid (1990:59). Photo 2016.

New examinations of stave churches in Norway provides a context for the interpretations of the entrance situation. The purpose in this part is to deepen the understandings by connecting the trusses in Västergötland to a small number of similar, though much smaller ‘lattice tie-beam trusses’, which were placed over entrances. Traveling about 600 km north-west takes the thesis exploration to the four stave churches; Flesberg, Nore, Uvdal and Borgund, in Norway. The idea from the chapter on roofs [3], that lattice tiebeam trusses may have been an important part of the articulation of entrances, both comes from, and leads to questions and investigations in stave churches in Norway. Now, early medieval churches in Norway do not have roofs with common-tiebeam lattice trusses (cf. Storsletten 2002b). Yet, during a visit to Borgund stave church in 2015, I noticed that the three entrances to the gallery have archways [*skruu*] (Christie 1993:47), which are formed like lattice tiebeam trusses. They are indeed quite similar to the ones in Forsby and Gökhem. They have a tiebeam and rafters forming a triangle, braced by six crossing straight struts, set in a fan like shape. Only, they are miniatures. Like the rest of the exterior in Borgund, they are covered with black tar.

- p. 131 Fig. 4.6. Site plan that analyses the theme 'peninsula' with nodes and pathways.
- p. 133 Fig. 4.7. The entrance to the gallery in Borgund, and the bell tower in Borgund with 'lattice' grids.

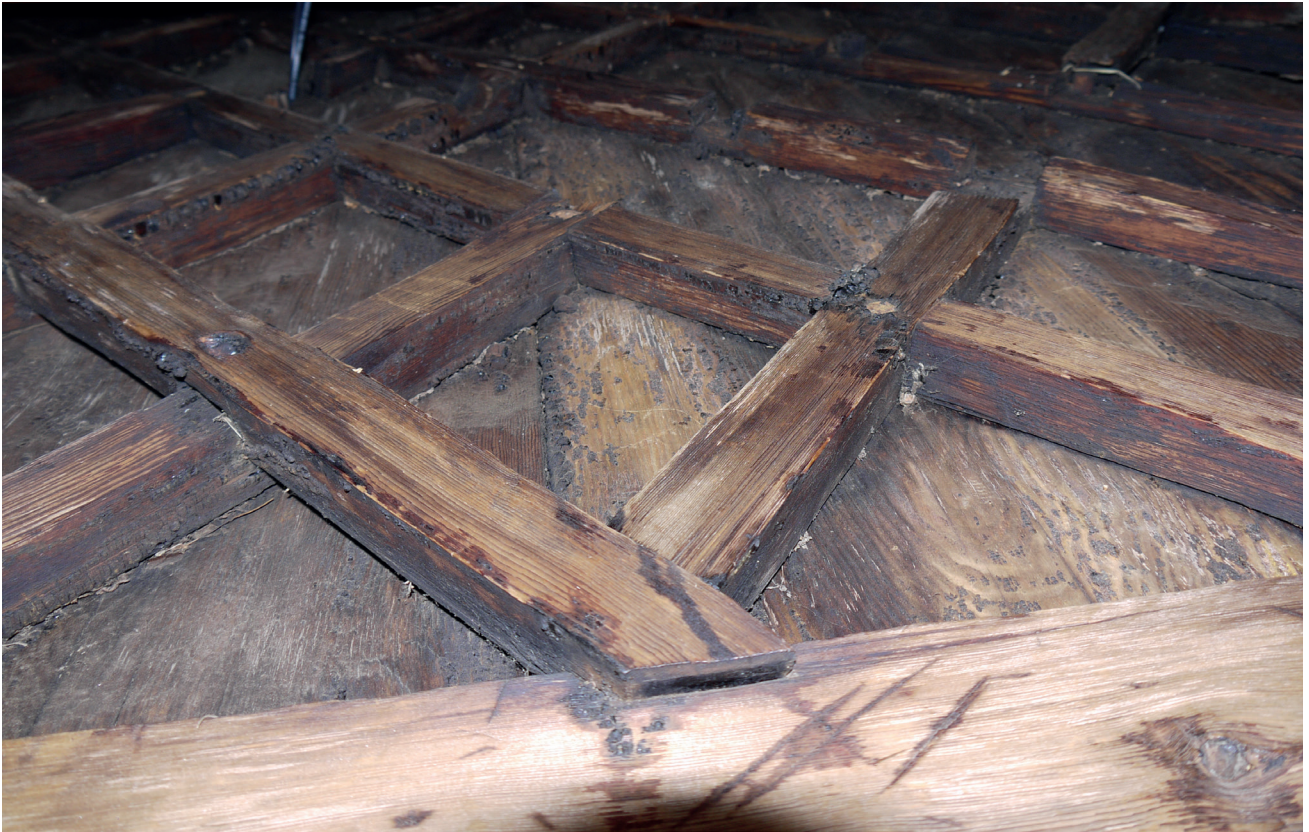
**Fig. 4.8.** **Above**, the most likely original miniature lattice truss in Nore stave church, which is located over the west portal however, hidden by the subsequent ceiling in the present porch. **Below left**, portal carvings without subsequent paint, that are also located over the ceiling, and not visible from the porch. **Below right**, the top of the portal carvings that are visible in the porch. Photo 2016.

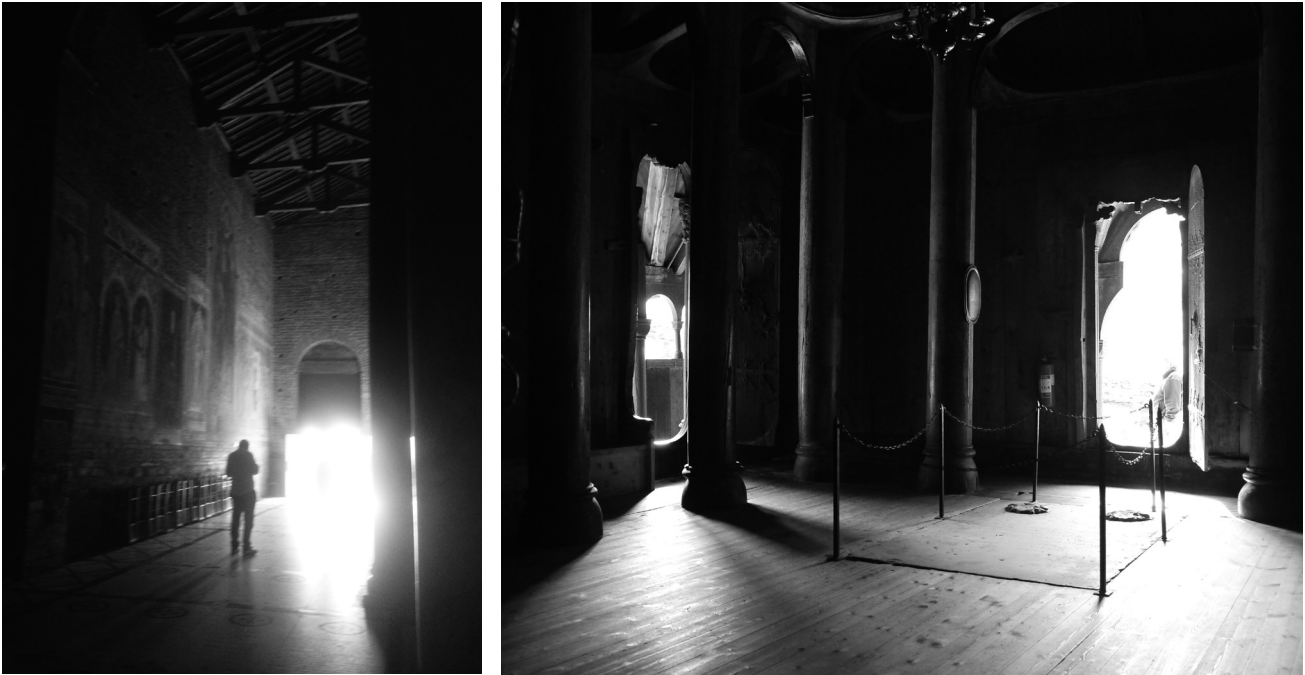
**Fig. 4.9.** **Left**, looking from the nave back towards the west entrance in the eleventh-twelfth nave in the church San Miniato al Monte in Florence, photo 2015. **Right**, west entrance zone in Hopperstad stave church. Photo 2016. The examples gives an idea of the contrasting light in the west entrance-zone.

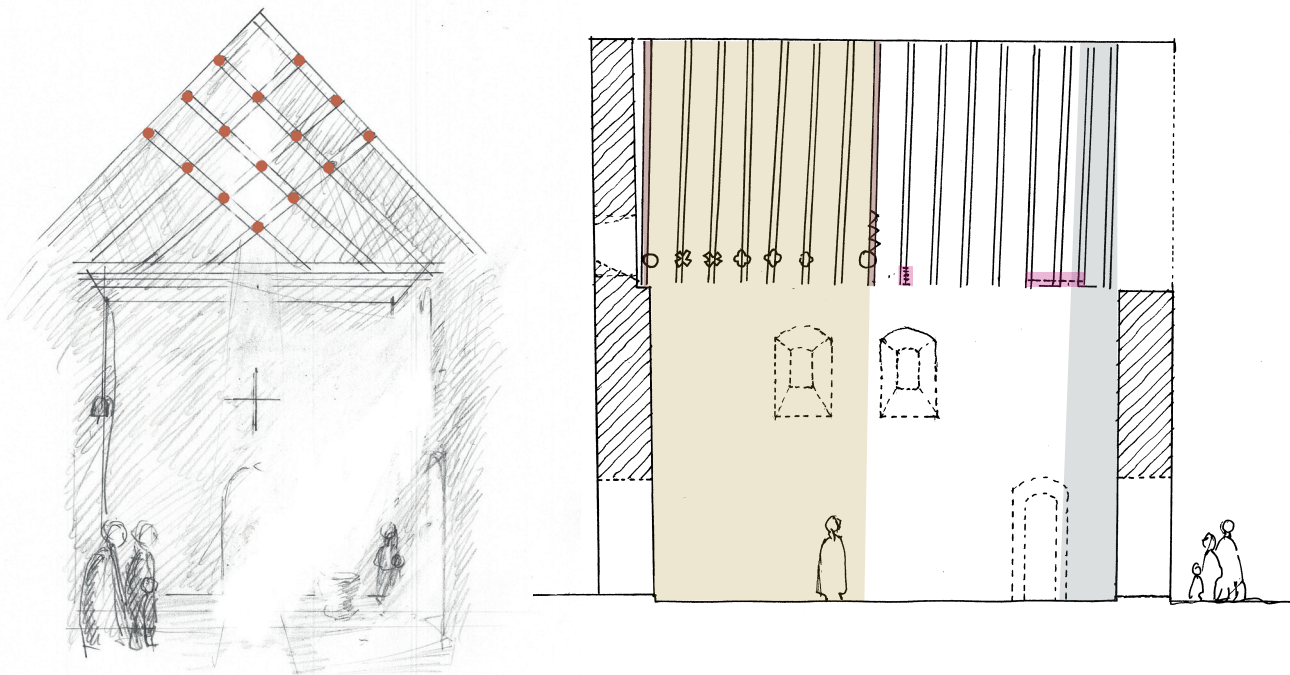
**Fig. 4.10.** **Left** the room viewed from west. The vivid roof was viewed from below. The eyes are drawn towards the light diagonally across the room, in the southeast and high up. **Right** the beam with the black line marks the middle. Sketch and longitudinal section based on scan 2017.

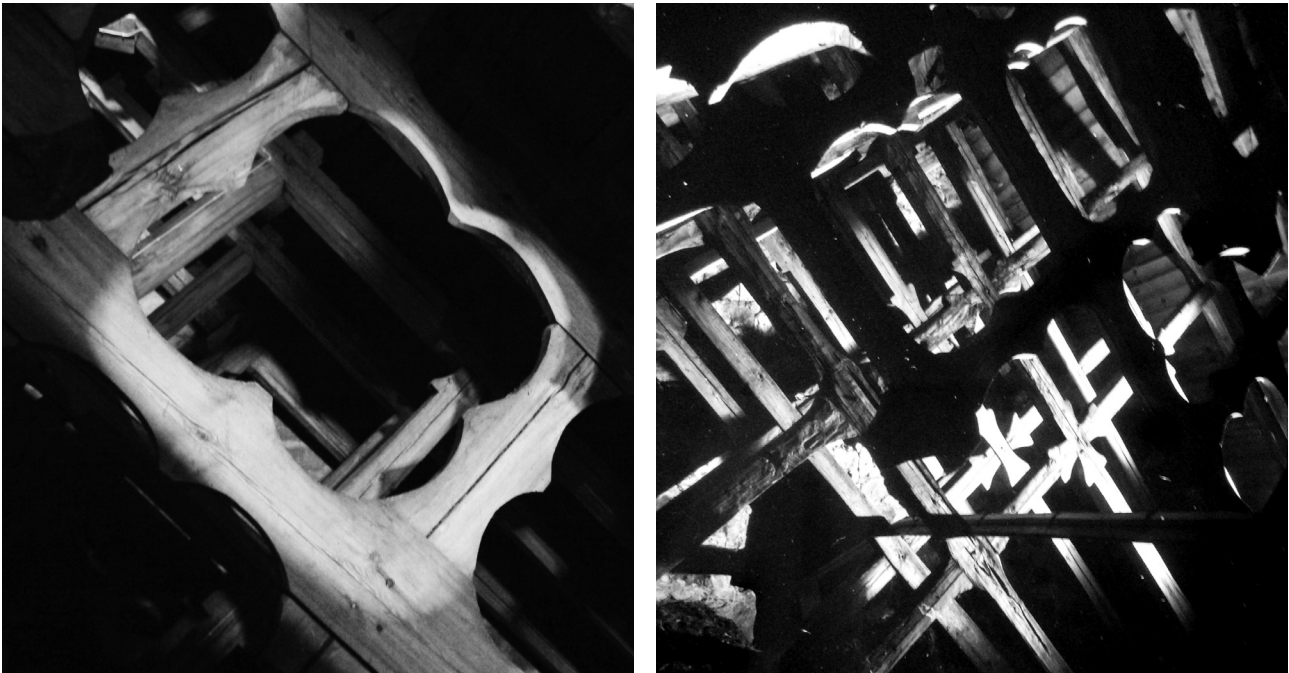
**Fig. 4.11.** **Left**, trusses with quatrefoil in Gökhem. Photo 2012. **Right**, trusses with cruciform in Gökhem. Photo Klasson 1967 ATA.

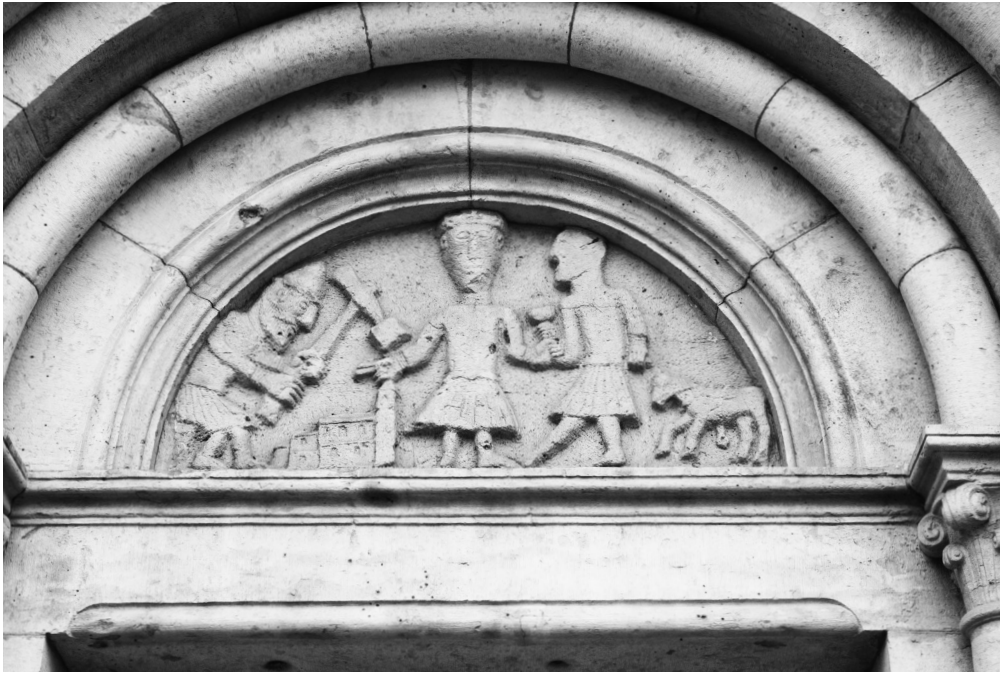
**Fig. 4.12.** The stone relief placed over the west entrance in Forshem church. The church seems to be a small 'model' of a church building, which is placed at the feet of a stonemason at work. Photo 2015.

In this part, I build on literature to highlight two well-known early images of churches in Sweden. These are reliefs carved in stone, one is over a portal in the church Forshem in Västergötland [Fig. 4.12.], and another on a baptizing font from Tingstad, in Östergötland.

The stone relief placed over the west entrance in Forshem church is, most likely, dated by the roof over the nave to the mid-twelfth century. The church pictured in the stone seem to be a small 'model' of a church building, which is placed at the feet of a stonemason at work (Svanberg 2011:30). Svanberg suggests that the pictured stonemason is a self-portrait

and that the model-church communicates that the stonemason was a master builder (ibid). The pictured model-church shows the exterior. It is the north facade of a two-story structure with windows and doors, set in masonry walls. The church has a west-tower, nave, chancel and apse (ibid). Svanberg points out that the model could not be a representation of the one story twelfth century church in Forshem itself (ibid), and proposes that it is a “role model for a larger Romanesque church”<sup>16</sup> (ibid).

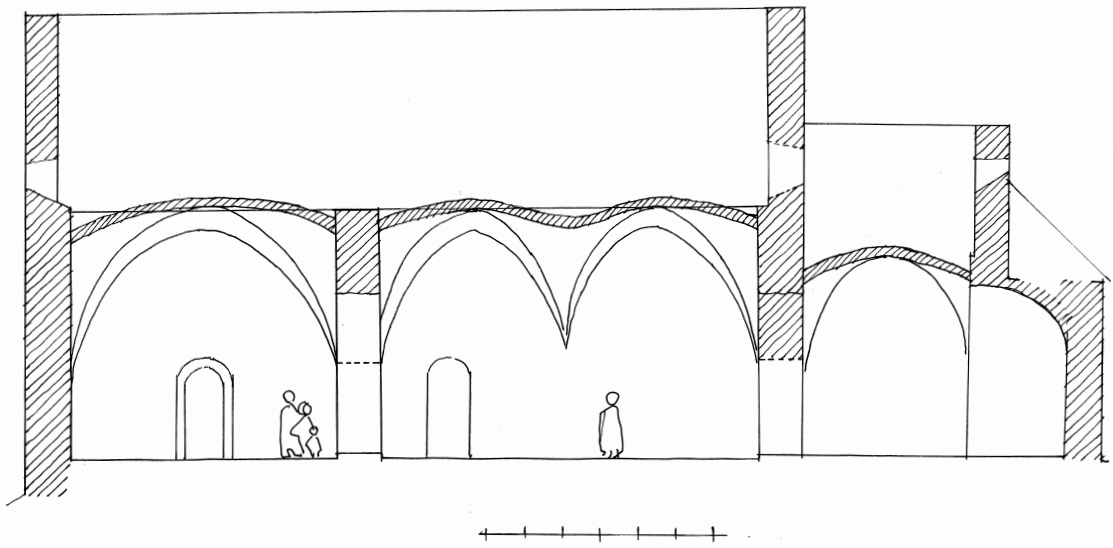
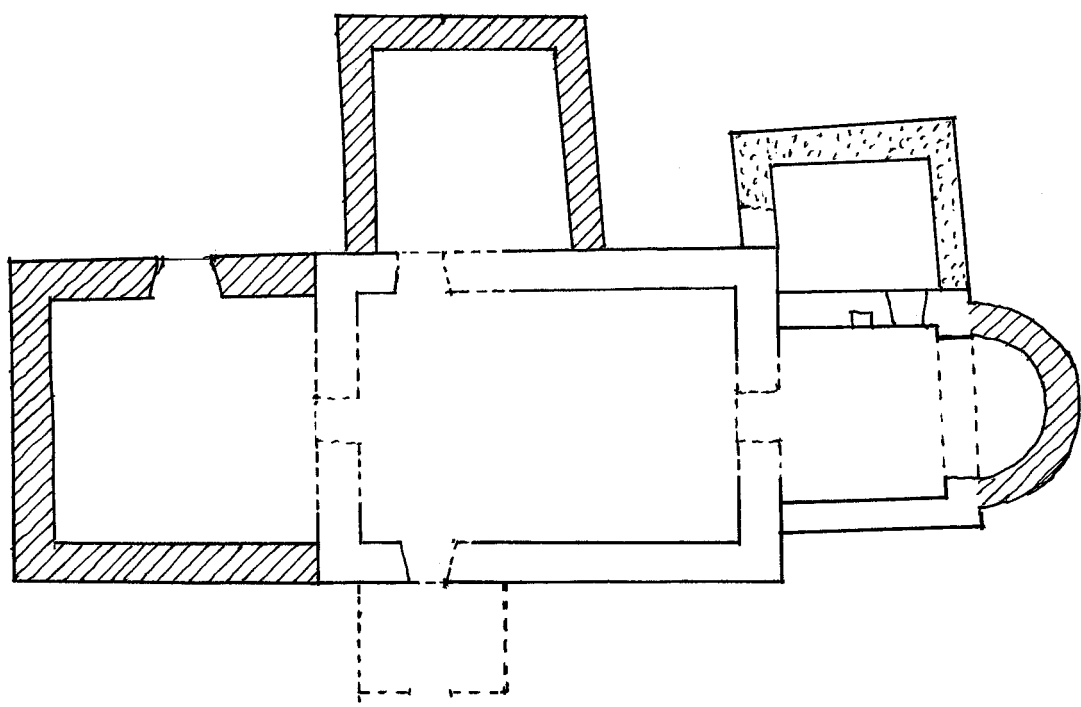
**Fig. 4.15.** Above, longitudinal section and below, plan layout with west, north and south additions in Gökhem.

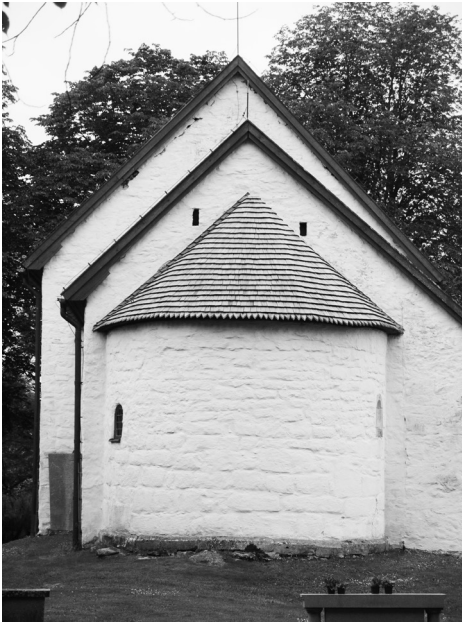
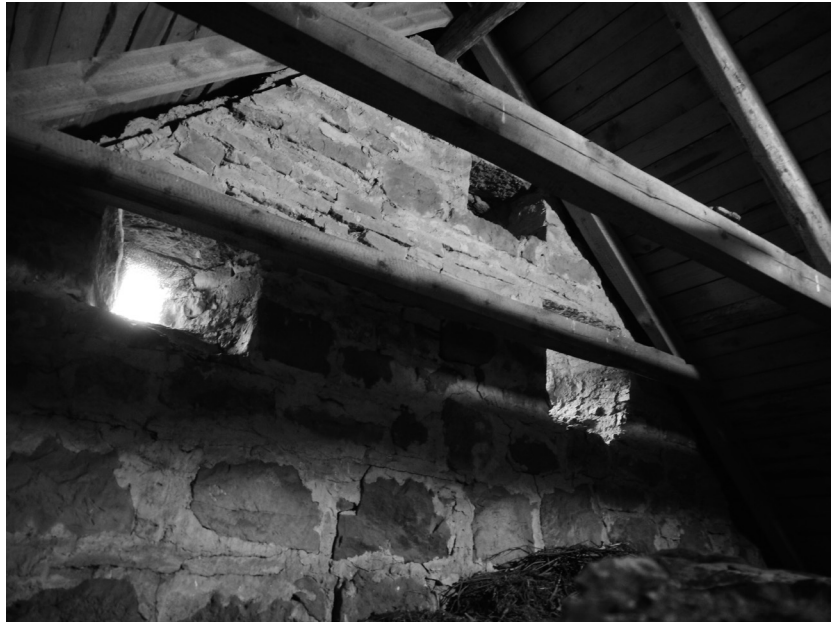
**Fig. 4.16.** Above, Gökhem east gable top in the chancel with openings. **Above left**, from outside and **right** from the inside. Photo 2014.

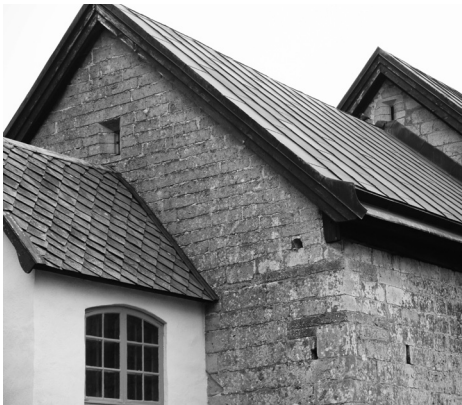
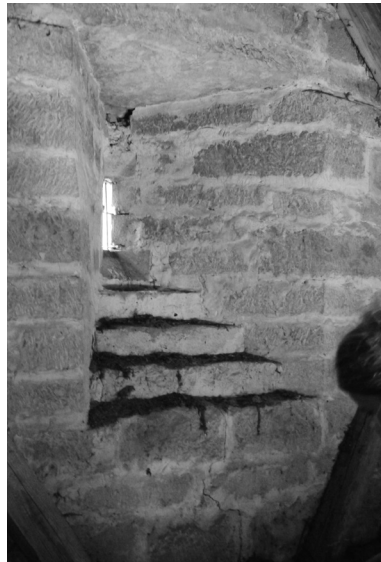
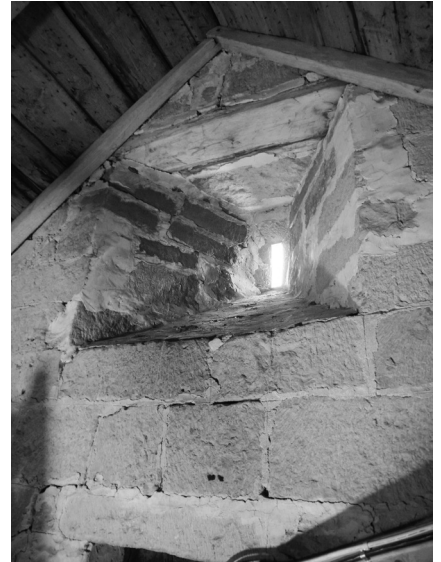
**Fig 4.17.** Below, Forshem **left**, east gables from the outside. **Middle**, east gable top in the chancel with opening. **Right**, east gable top in the nave with a subsequent opening. Photo 2014.

Two or three decades later, probably in the 1260s [after 1256] (Seim et al 2015:47), people in Forshem decided to build a completely new chancel, and they too, wanted the chancel-room to be higher than before. Both roof and masonry are preserved, almost complete. The roof was made of a mix of oak, pine and spruce. They placed two wall plates [of oak] on top of each wall. The structure has nine trusses. The two outer, by the gables, have tiebeams and two canted struts, however, the seven in between have a collar instead of a tiebeam. The joinery is similar to other early roofs. This is both a common-tiebeam roof construction and not. As in Gökhem, I interpret, the chancel has a subsequent stone vault. In the east gable of the new chancel, they made one small opening, a window with a cruciform shape, which is still open. Just below this, i.e. under the vault, is a triple lancet east window in the chancel-room. Both these windows have a Jacob's ladder at the bottom. I interpret that this roof, as in the chancel in Gökhem, was open to the room in the 1260s. The opening high up in the gable, cast like a spotlight, from high above into the room.

The new higher chancel in Forshem church had consequences for its nave, as the original opening in the nave's east gable was covered. Therefore, masons re-built the top of this gable, and created a new smaller opening at the very top. This opening is narrow and similar to the one in the chancel, though it is only straight, not cruciform. Thus, I interpret that the roof over the nave in Forshem was still open to the room when the chancel was built new in the 1260s. The opening high up in the gable, suggest that the nave-room below was lit with a beam, like a spotlight, from high above.

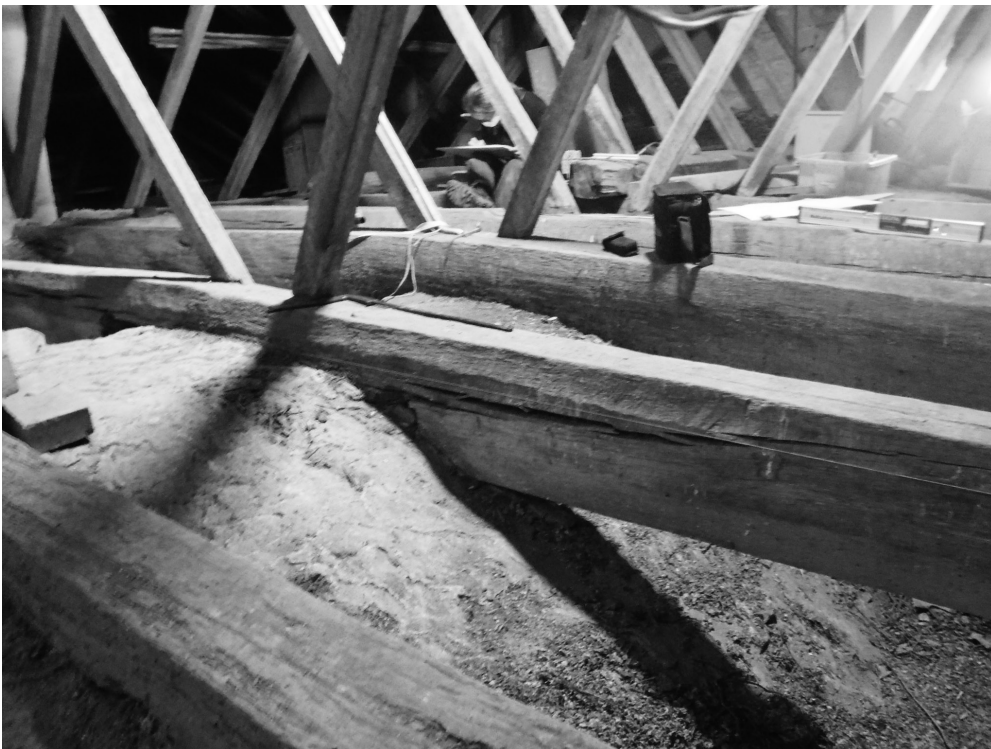
**Fig. 4.19.** Tiebeams and vaults in Forshem. Photo Eriksson 2011.
