Vernacular Buildings and Urban Social Practice

Wood and people in
early modern Swedish society

Doctoral thesis
Department of Historical Studies, University of Gothenburg,
defended on the 18th of September, 2020

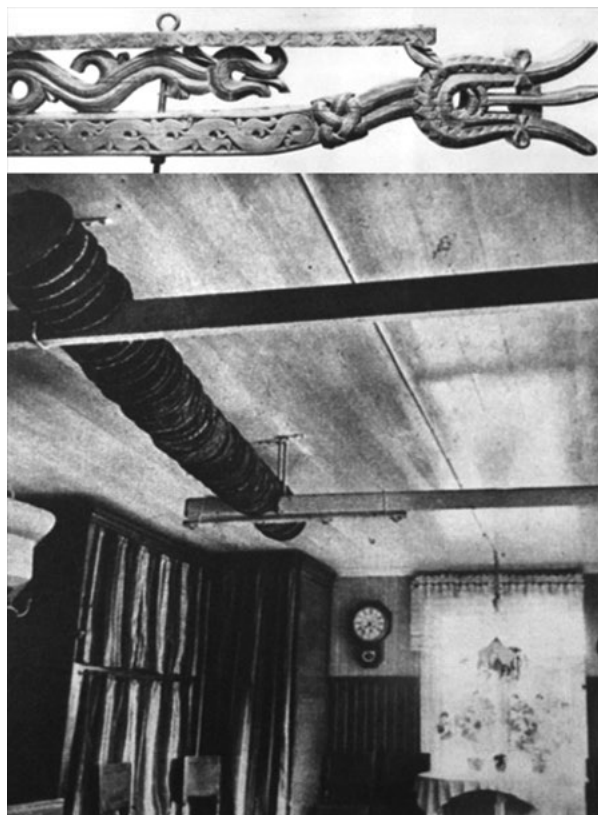
Figure 2 Example of a crown rod (*Kronstång*) as a social space divider and as a decorative object (Erixon 1938: 283–84).

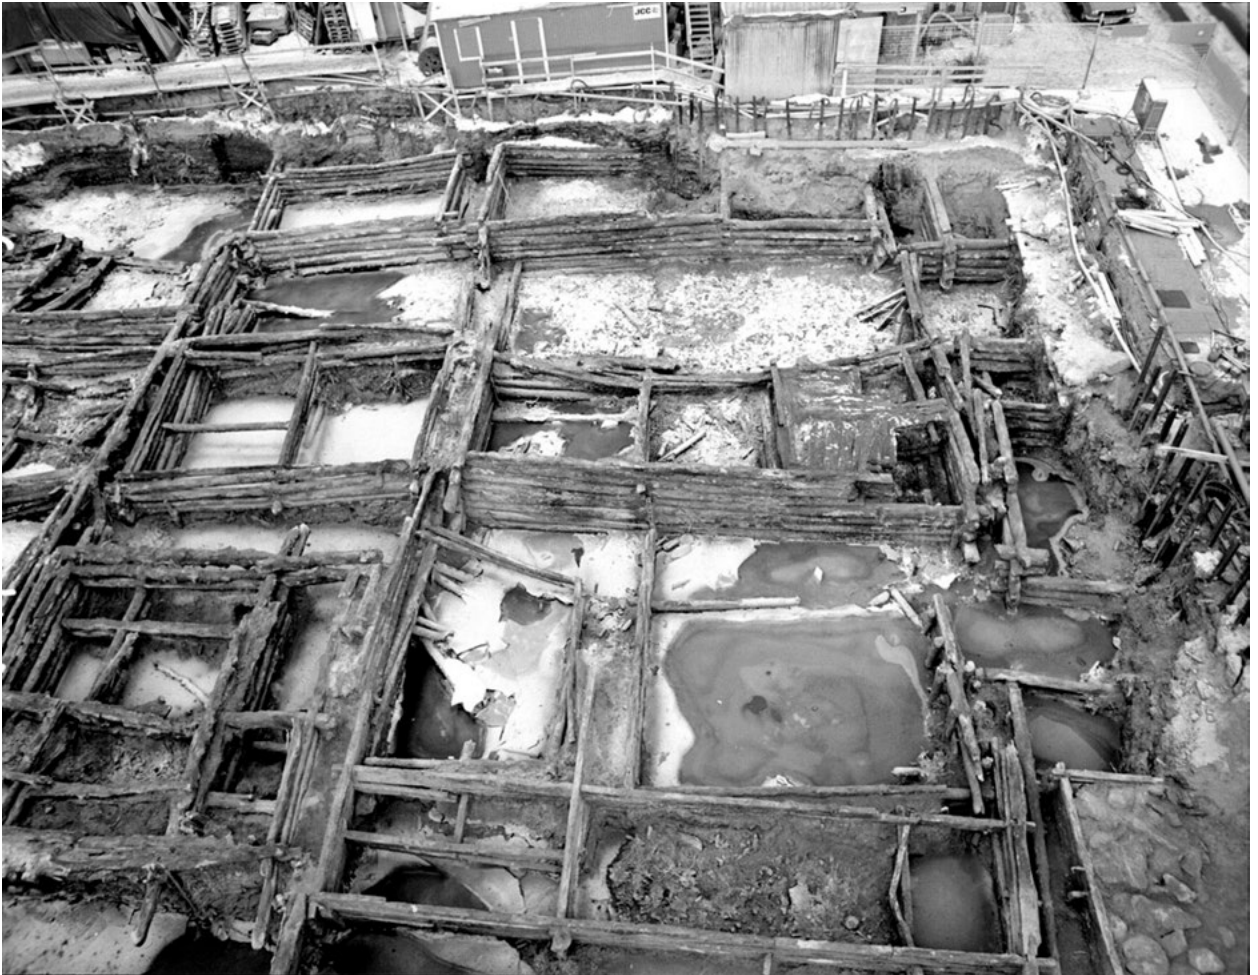
Figure 1 A system of box revetments emerged during excavations in Kv. Ansvaret 1984-1985, Jönköping

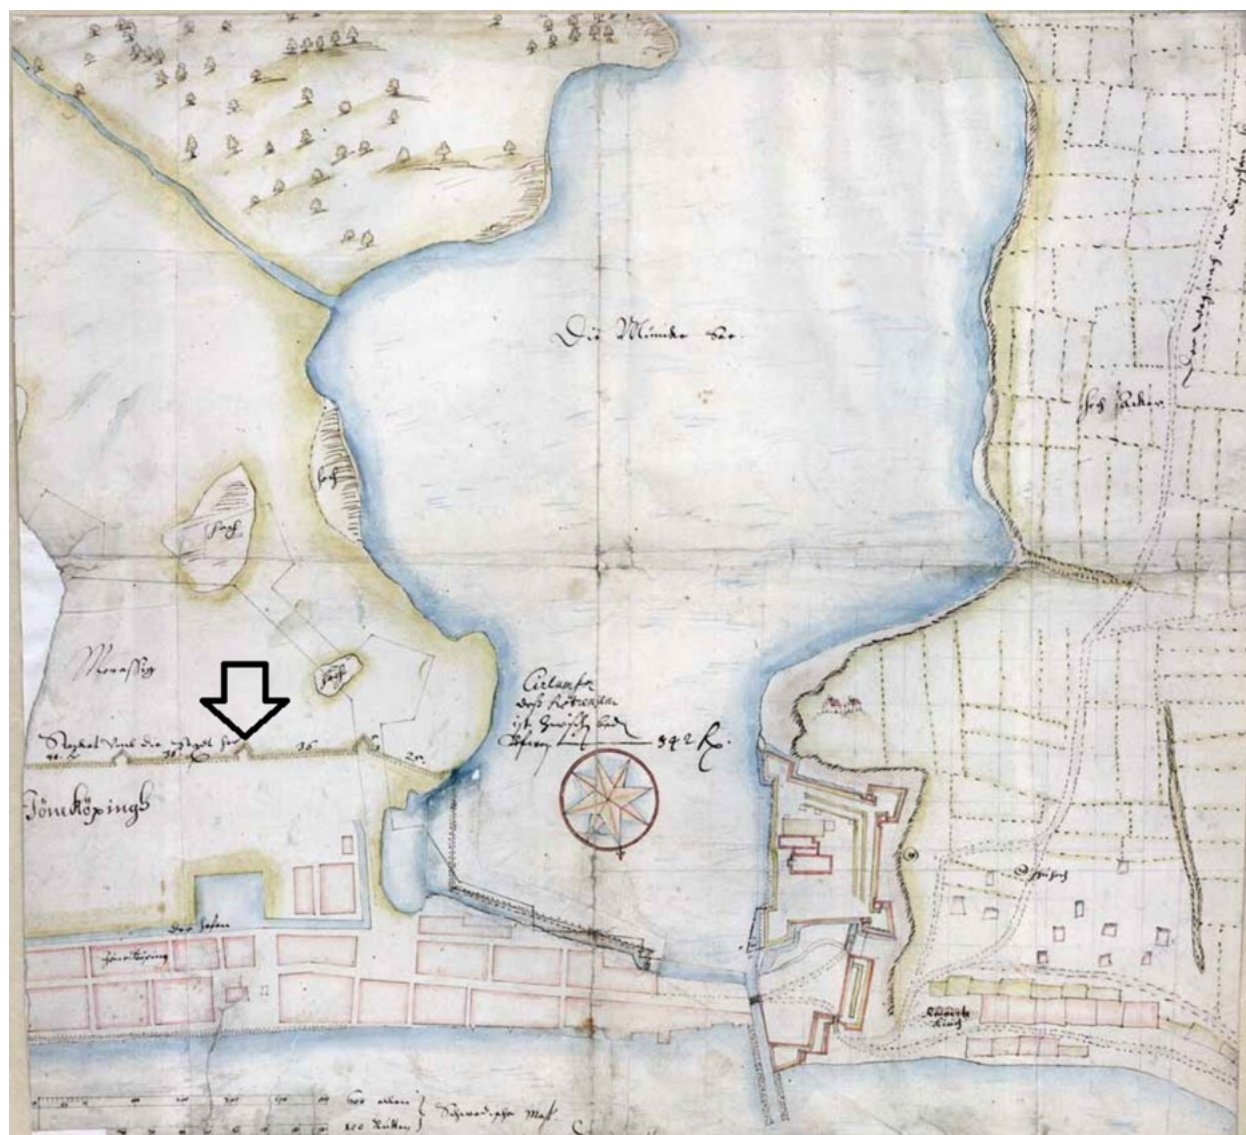
Figure 3 Toll fence with bastions on top of earth works in Jönköping 1624.

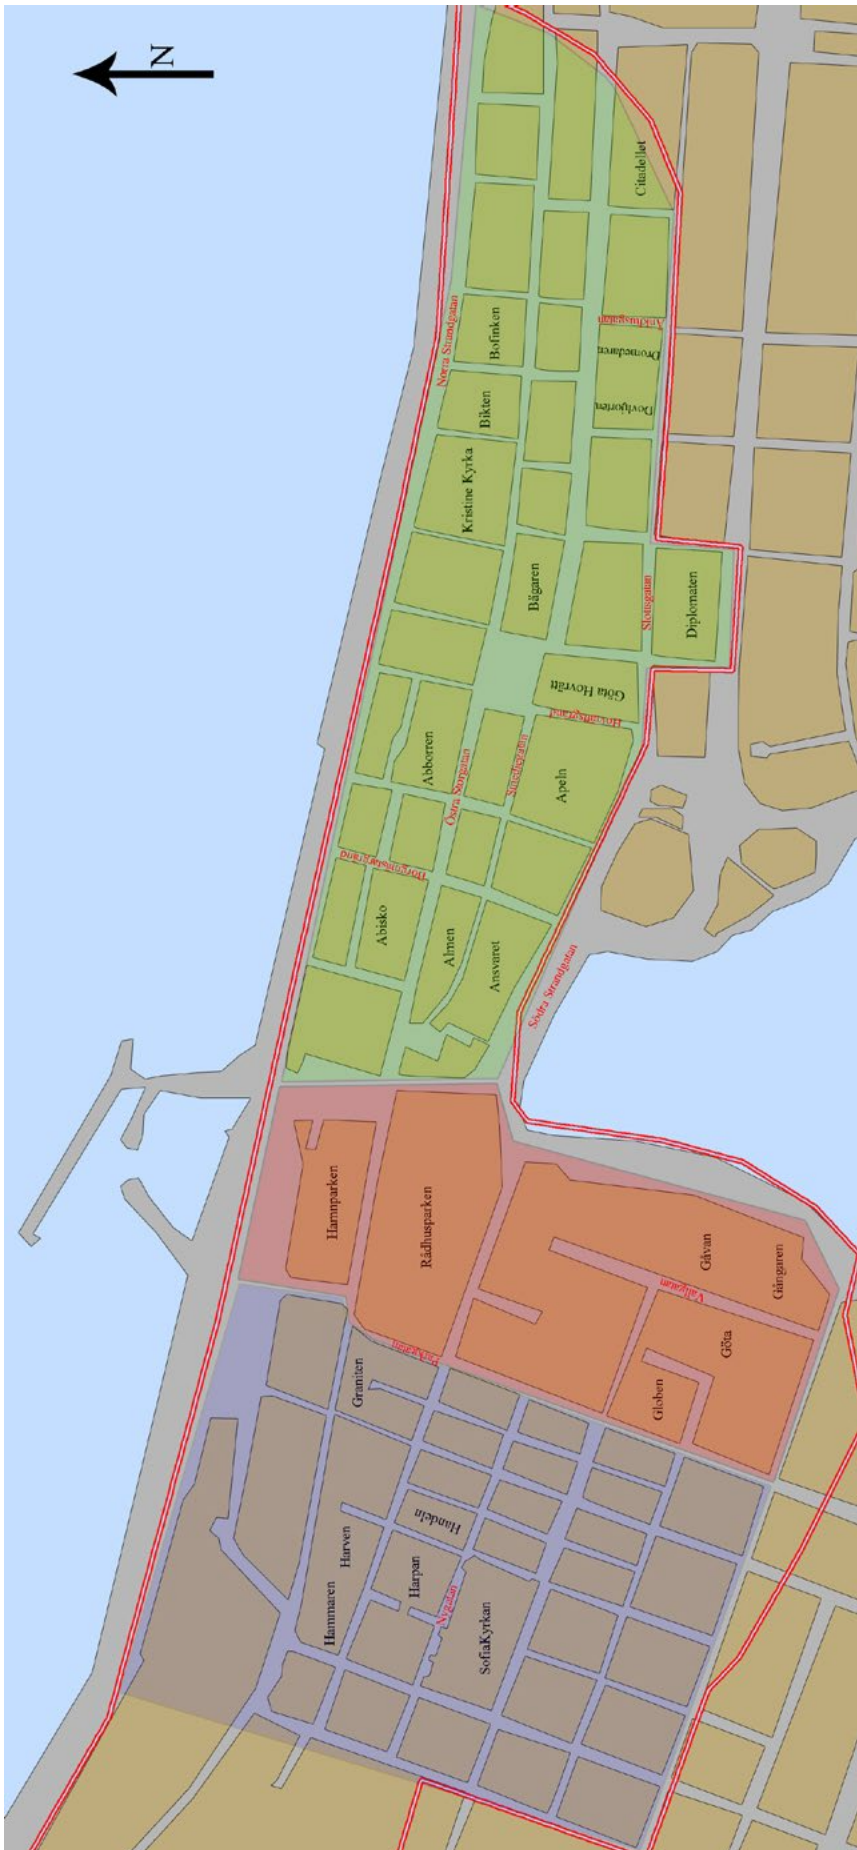
Figure 6 West and East Jönköping (Nilsen 2013: 72) by Rich Potter. The blue field is the Old town or West Jönköping, the pink field is the New town or East Jönköping, and the green field is the former fortification.

The fortified castle with a moat was geographically located between the two historic town formations, as illustrated in Figure 6.

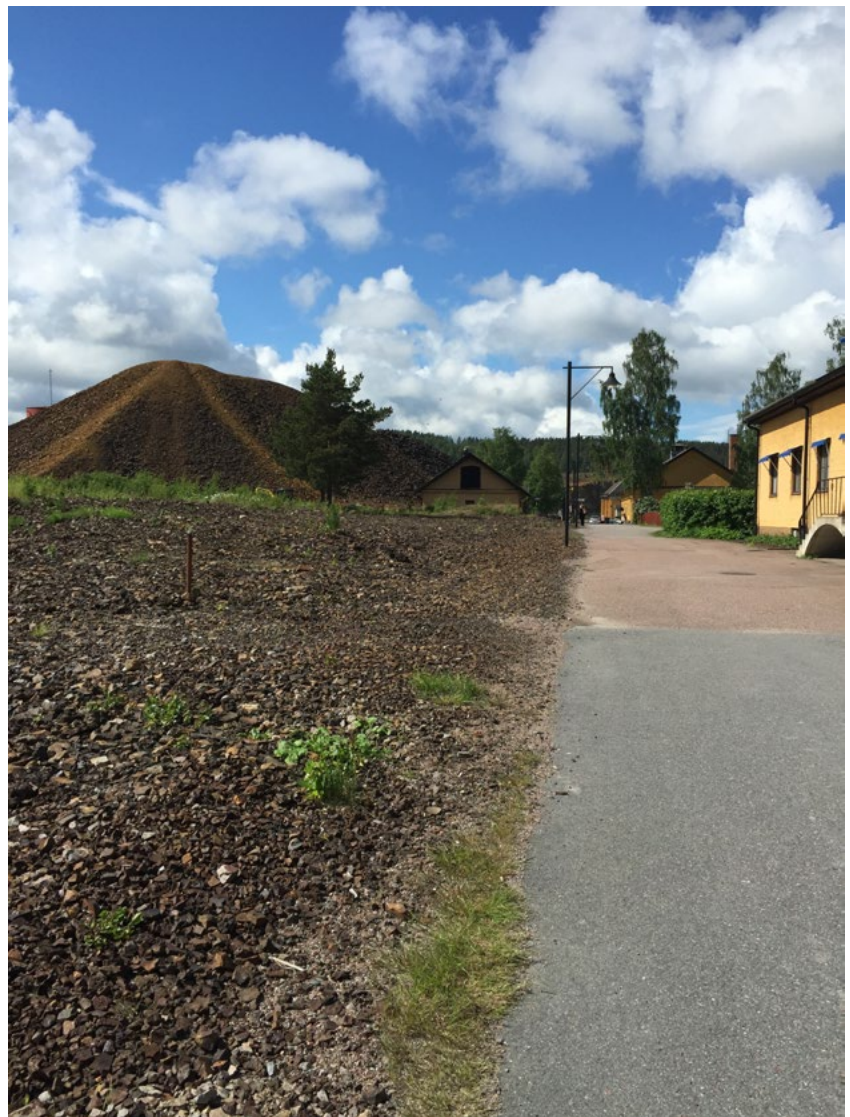
Figure 8 Slag in and around Falun was a material originating from the copper mine and used in a number of ways. Photo A. Nilsen.

surfaces. Sometimes to a depth of several metres. It was also used as a building material for houses, but it never caught on outside Falun.

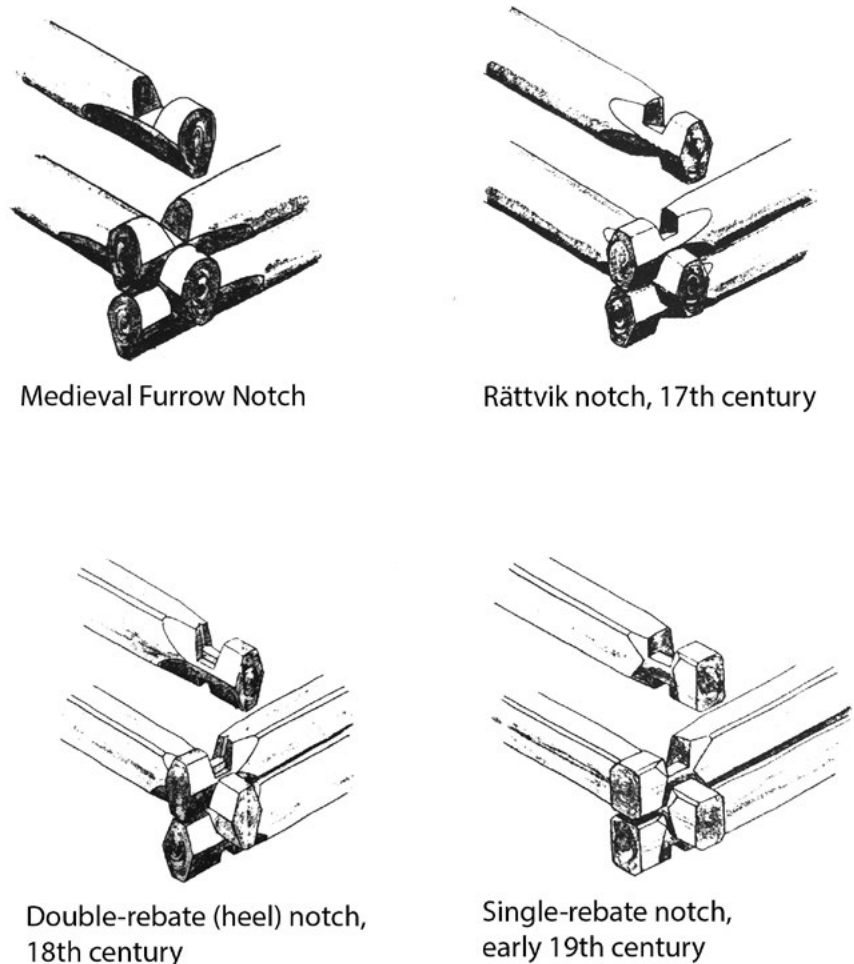
Figure 1 A sketch of corner notching methods from different centuries, with examples from the province of Dalarna related to log-timber construction. There are over a hundred different ways of shaping the corner notch with more, or less sealing properties from a viewpoint of insulation. Roland Andersson originally made the drawing, and it was part of an information board at Gammelstan in Norrboda provided by Dalarna County Administrative Board.

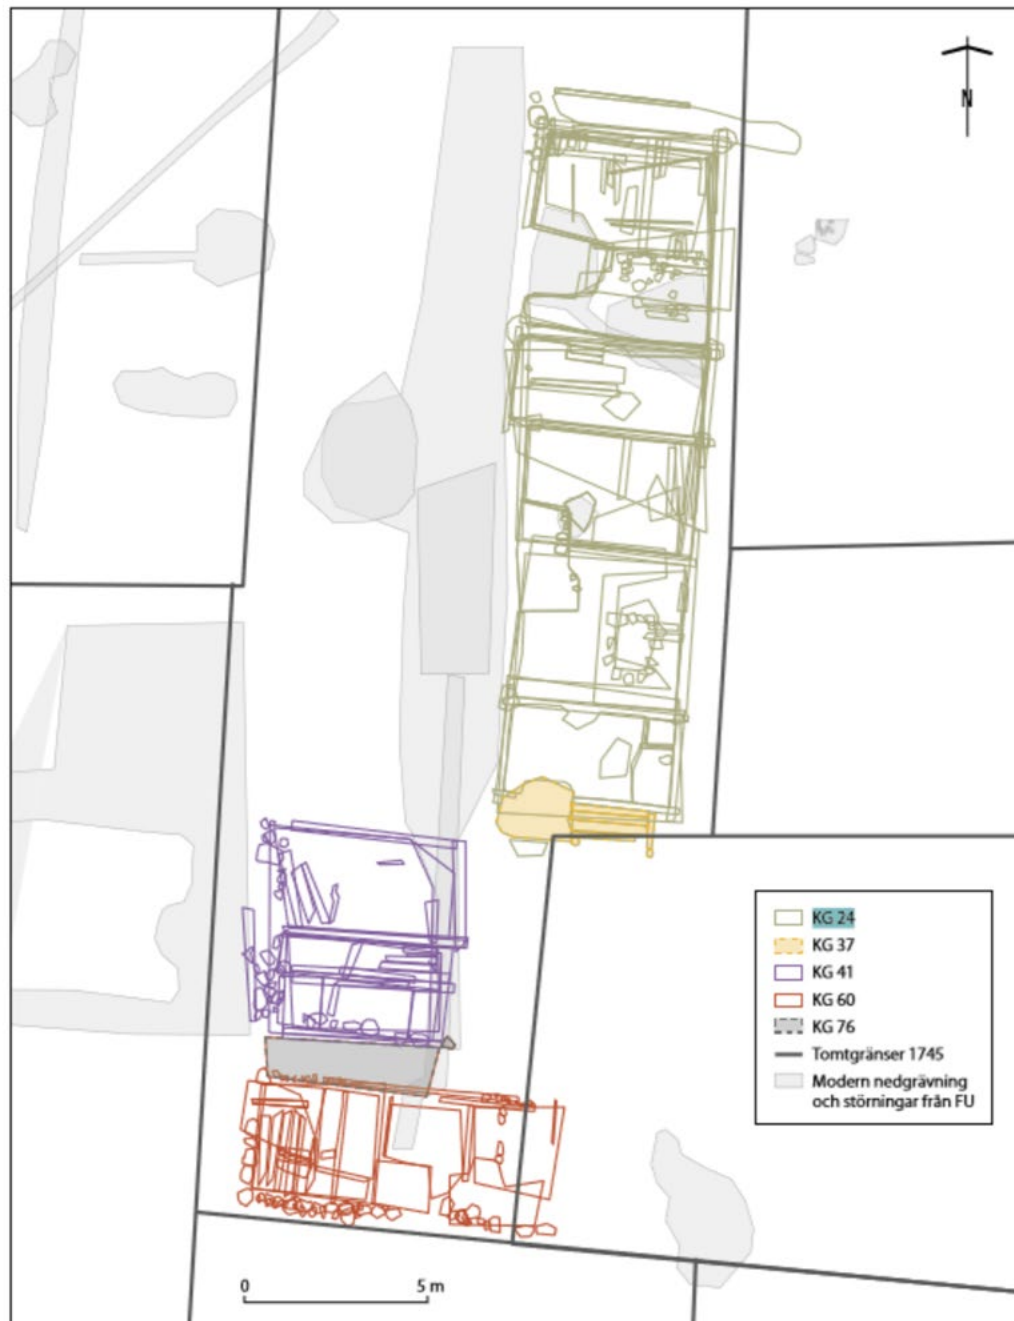
Figure 5 KG 24 in Kv. Dohjorten in Jönköping (Bramstång Plura et al. 2012:36).

This row of houses has five different units or modules; a storage room or possibly a servants’ quarters (thus a dwelling), a smithy, a kitchen, a larder and a privy.

Plan, fas 2-4. Skala 1:150.

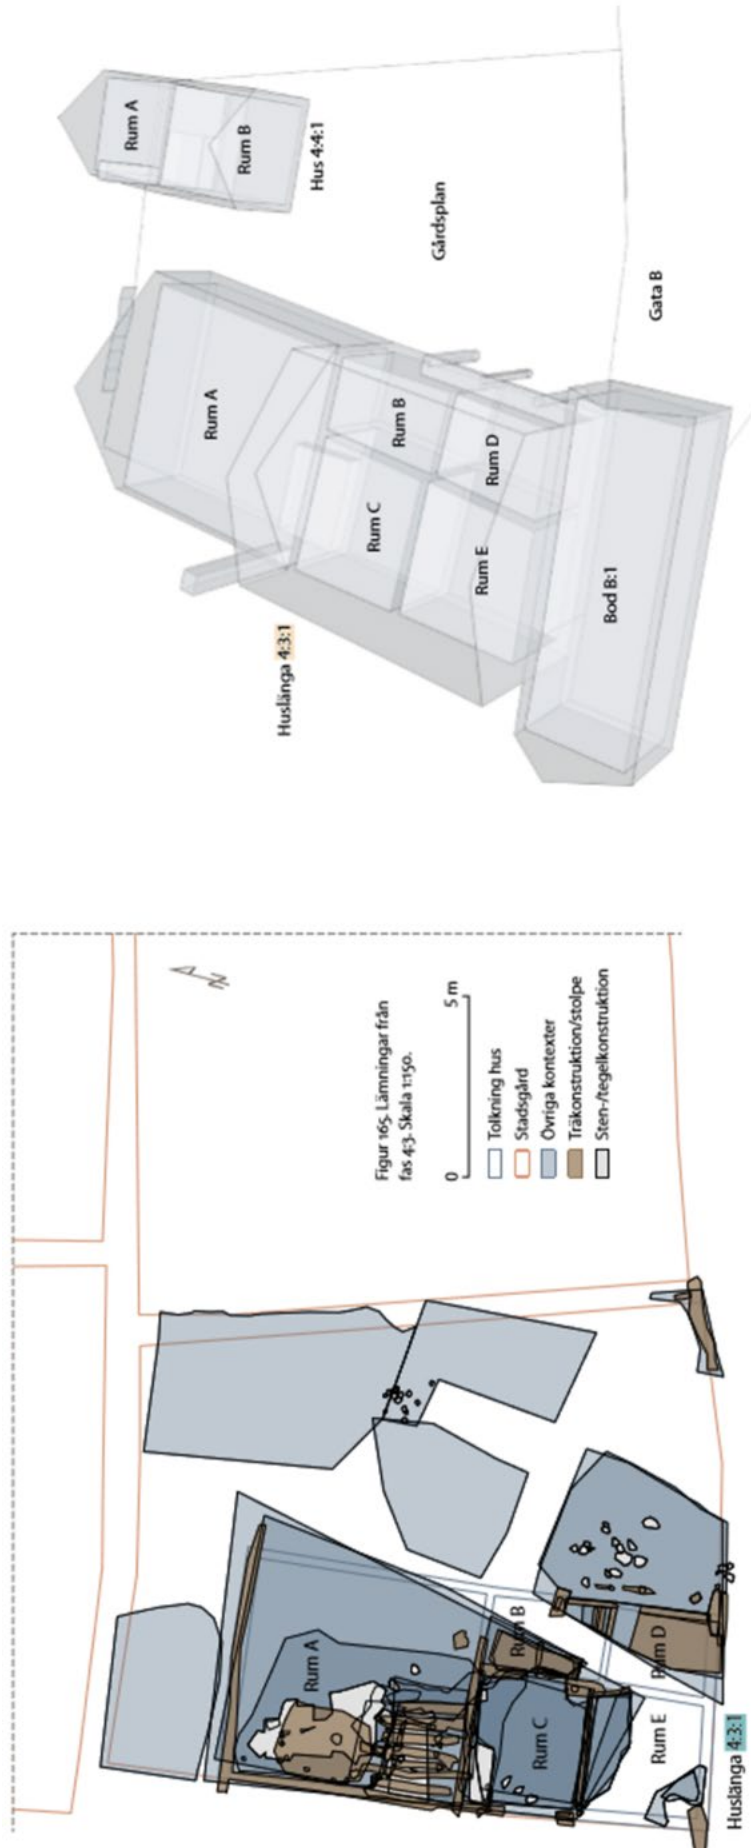
Figure 7 Layout of 4:3:1, Nya Lödöse (Öbrink and Rosén 2017: 51, 260)

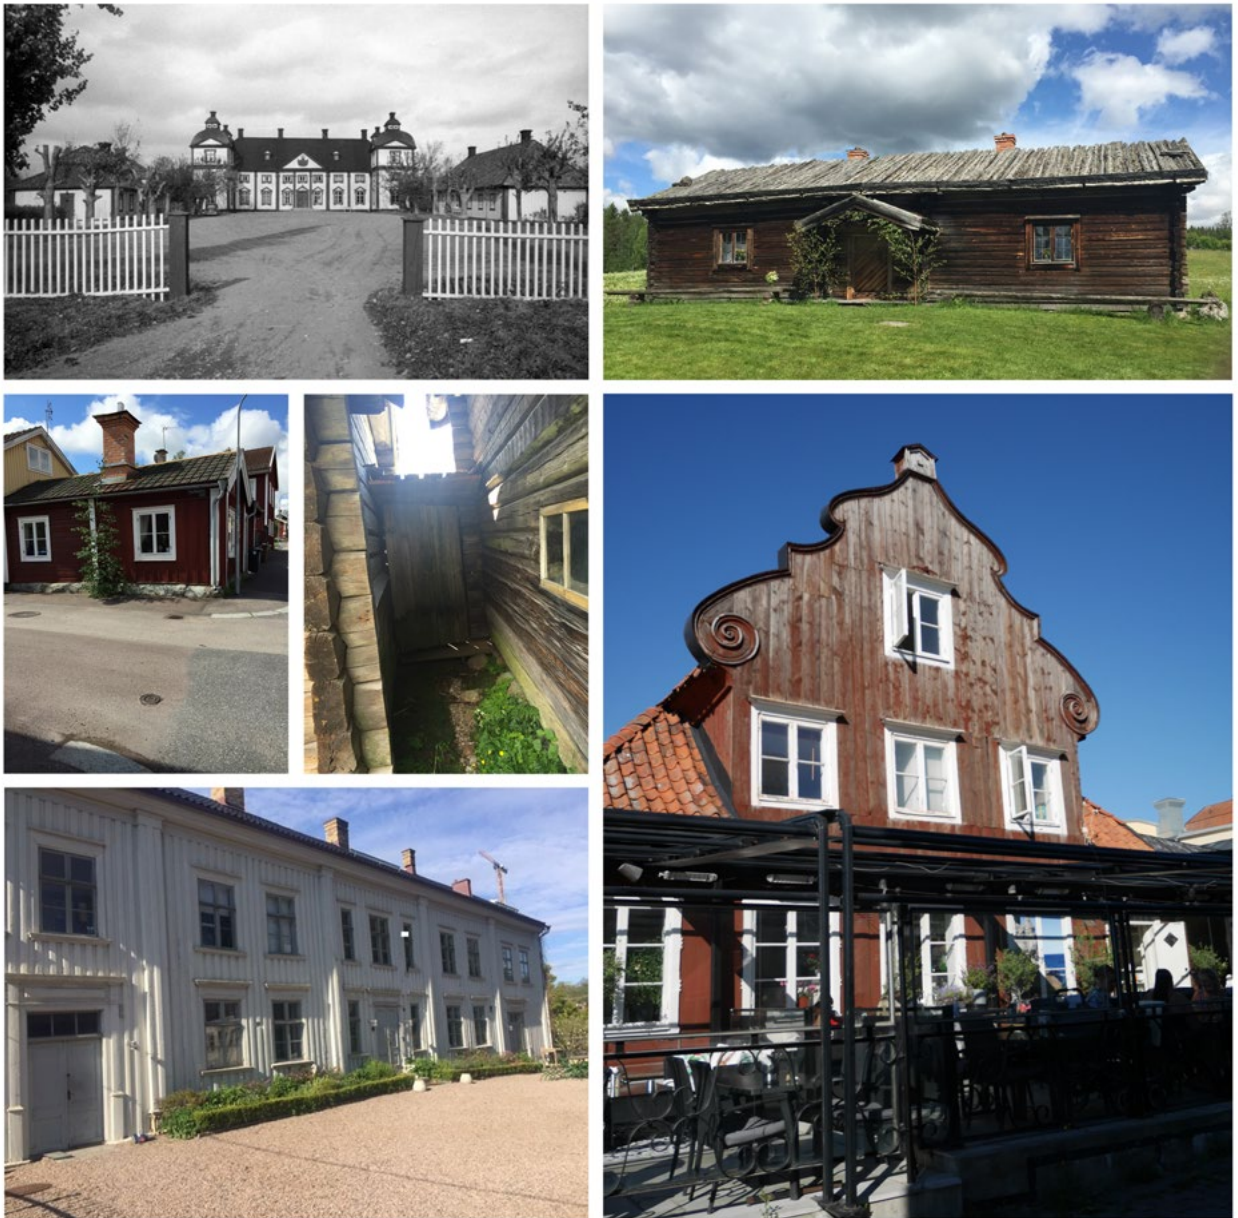
Figure 9 Examples of log timber buildings in Sweden. Gripensbergs slott was photographed by Berit Wallenberg Public domain raa.se. The rest of the buildings, photos by A. Nilsen.

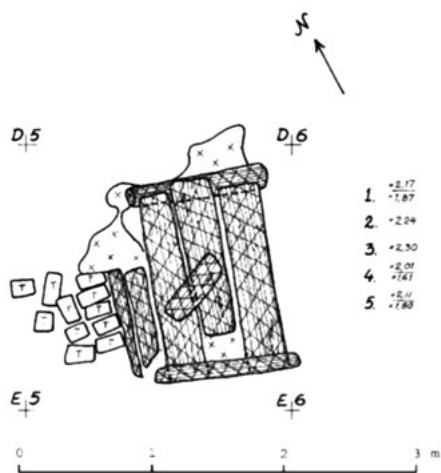
Figure 4 The layout of A20a in Mynttorget, Stockholm (Söderlund 2011: 197).

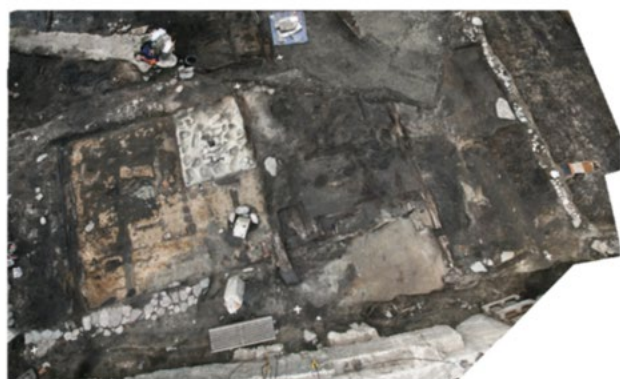
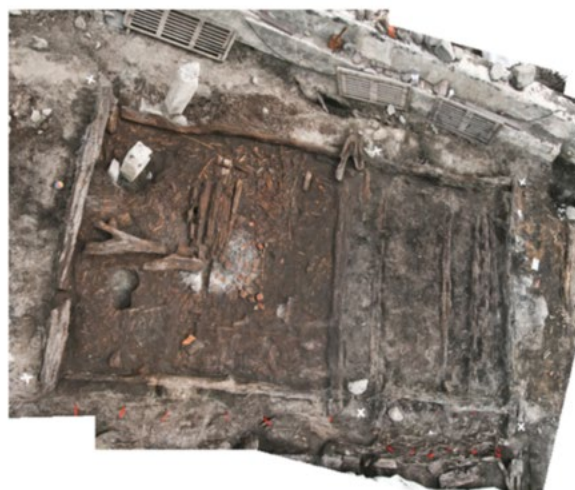
Figure 5. The orthophoto is showing the row of houses (1:2:1) with the two shops in timber-framing technique to the right. The stone threshold shows where the door was on the street front. Photo Projektet Staden Nya Lödöse 2013.

- In Nya Lödöse (1:2:1 a-g) where there was also a row of houses *Figure 5* partly constructed in timber-framing, dated to the 1480s-1540s, through stratigraphy and the finds assemblages (Rosén and Öbrink 2017: 130). There was a log timber dwelling with a layout including a porch, a small storage room, the main room (*stugan*)

as well as two additional sheds or storage rooms. There were also two shops (1:2:1 a, b) both possibly constructed using timber-framing techniques, as part of the row of houses. Shop A had a wooden floor with a layer of insulation, later changed into a clay floor. The shop was set on sill stones and might have had glass windows. Shop B had a wooden floor with an insulation layer. There was evidence of probable plastered walls. A threshold led into the shop from the street, (Rosén and Öbrink 2017: 83).

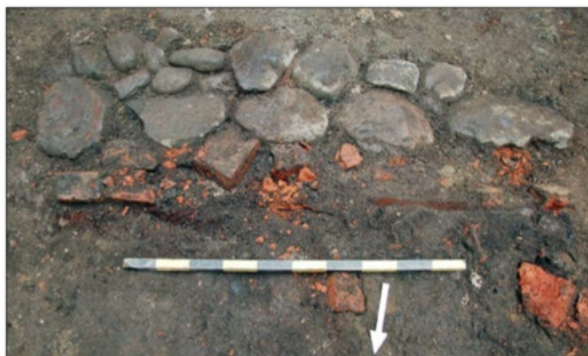
Figure 6 Kv. Mercurius in Stockholm had remains of a possibly timber-framed building (Contextual group 27). Parts of a stone sill, a collapsed wall and a clay floor. Photo taken looking south (Carlsson and Svensson 2015,162).

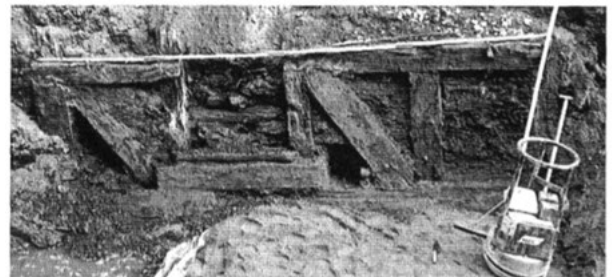
Figure 7 The timber-framed house (A73) in Kv. Argus, Stockholm. The image shows the eastern stratigraphy with the house wall in a north-south direction (Johansson 2000: 64) (Photo: Mikael Johansson (S96-0194/10).

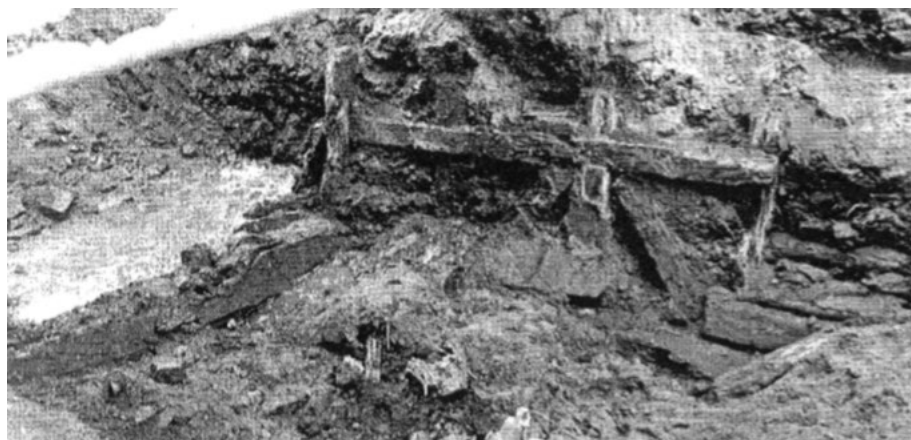
Figure 8 The timber-framed house (A73) in Kv. Argus. The wall of the house is seen in an east-west direction. Parts of a wall post are visible in the centre of the (Johansson 2000: 65) Photo: Mikael Johansson (Photo S96-0243/1).

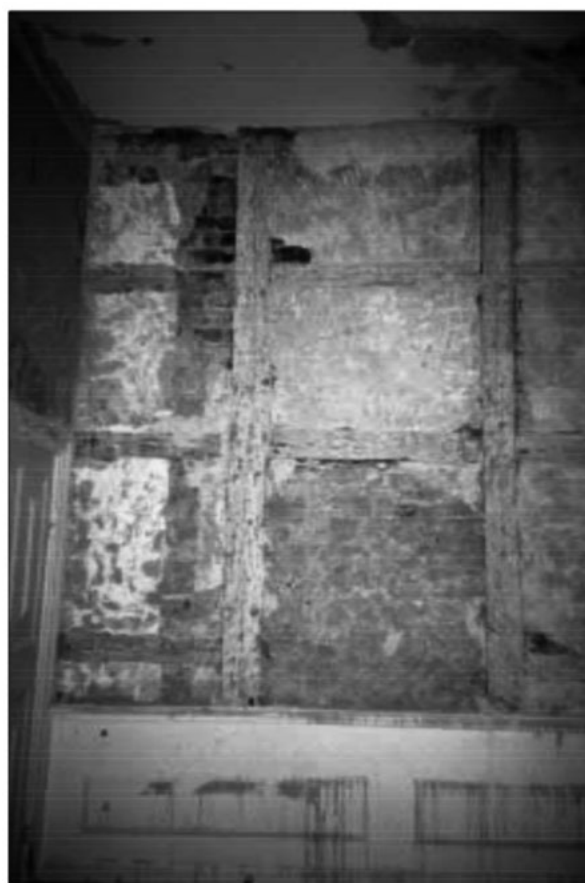
Figure 9 A timber-framed partition wall in Linköping Castle, with traces of a moved partition wall and a bricked-up door. (Modén 2003:36) Photo Eva Modén.

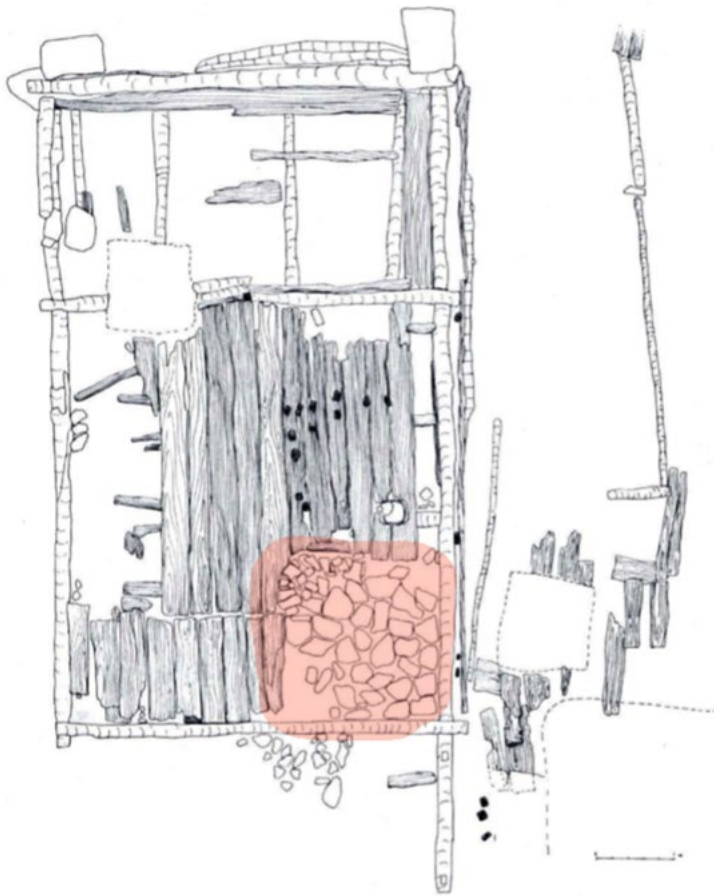
Figure 11. The traces of timber-framing in house 1, phase 2, in Kv. Gamla Teatern in Gothenburg with the corner fireplace coloured beige (Jeffrey 1984).

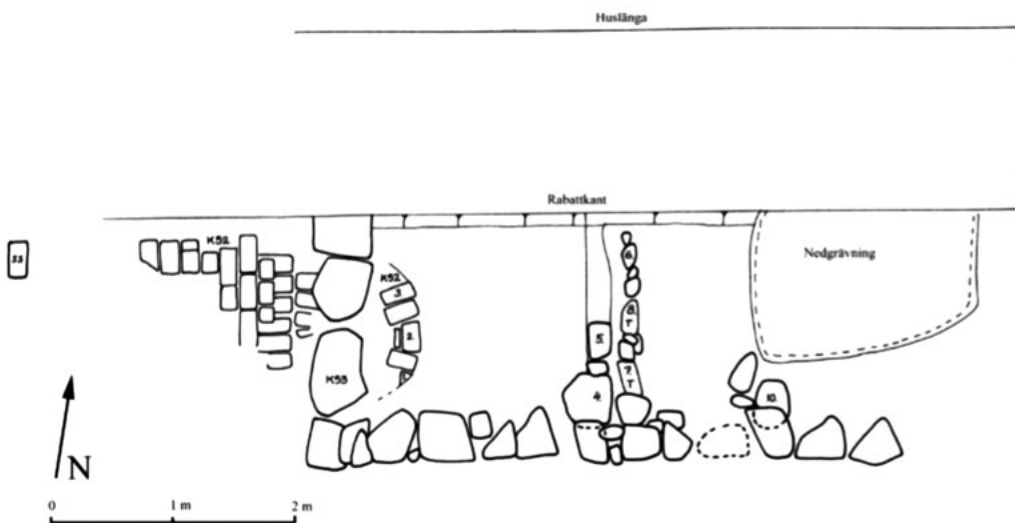
Figure 12 Kv. Västergötland 6. A plan over the sill stone foundation K 53 and the brick foundation K 52, in scale 1:40 (Fennö 2006: 19)

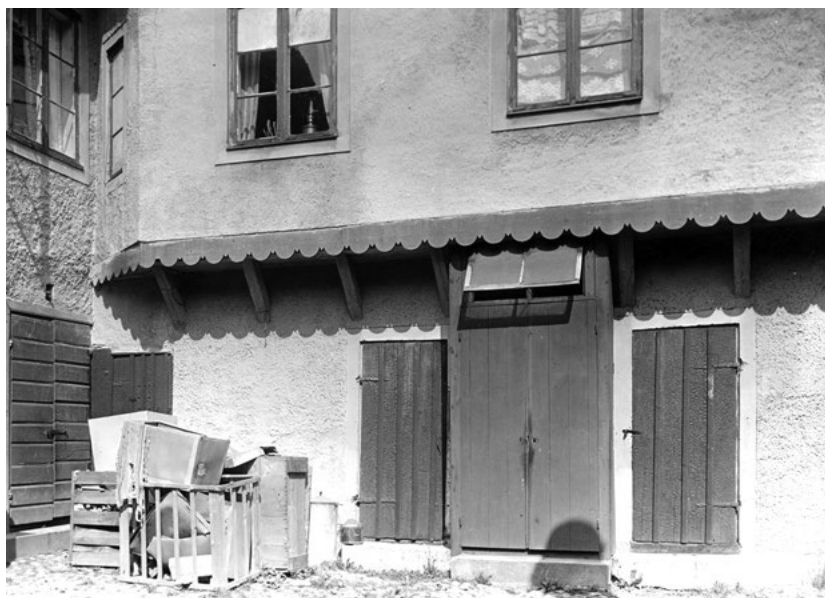
Figure 13. Fränkelska gården in Kalmar, a two-storey timber-framed house. Photo by Manne Hofrén 1928 in the Kalmar läns museums databas.

- Fränkelska gården in Kalmar,¹¹ is a two-storey, timber-framed house ((Figure 13)). The building has a plastered façade, with a jetty towards the inner courtyard. There appears to be a series of outhouses

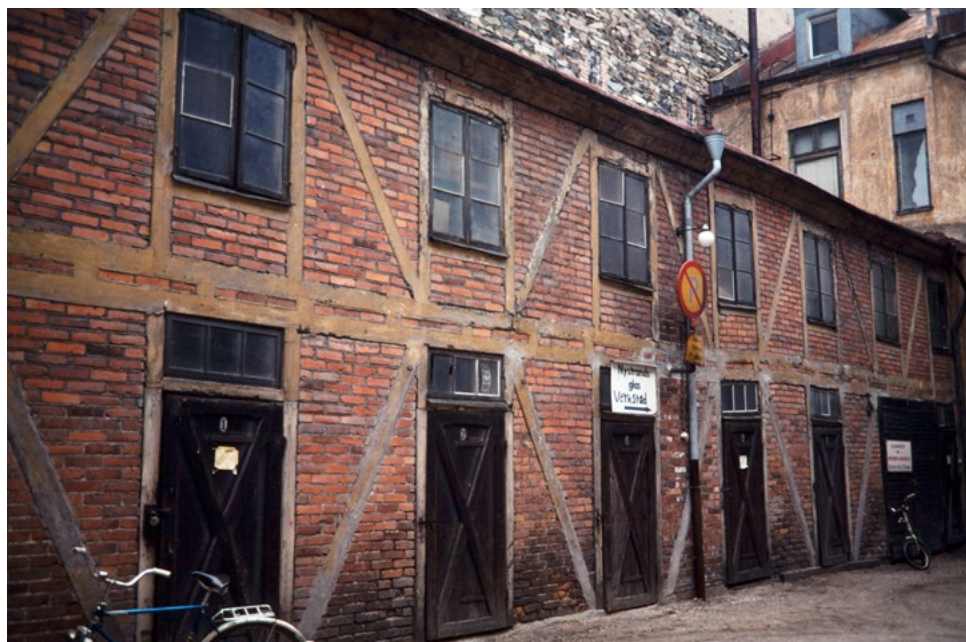
Figure 17 Norra Järnvägsgatan 4, in Växjö. Photo Inga Walde 1976. Kulturparken Småland.

- Norra Järnvägsgatan 4,¹⁵ in Växjö is a timber-framed warehouse. It is listed as Växjö's only timber-framed house in the museum database (Figure 17), nonetheless it is number two in this list. There is a girding beam running between the floors, up and down braces are used as well as fitted windows and doors to the bays. It is a two-storey house with six visible doors on the ground floor and six visible windows on the first floor. The house has brick infill and the timber-frame appears to be of regular structure. Pad stones seem not to be used.

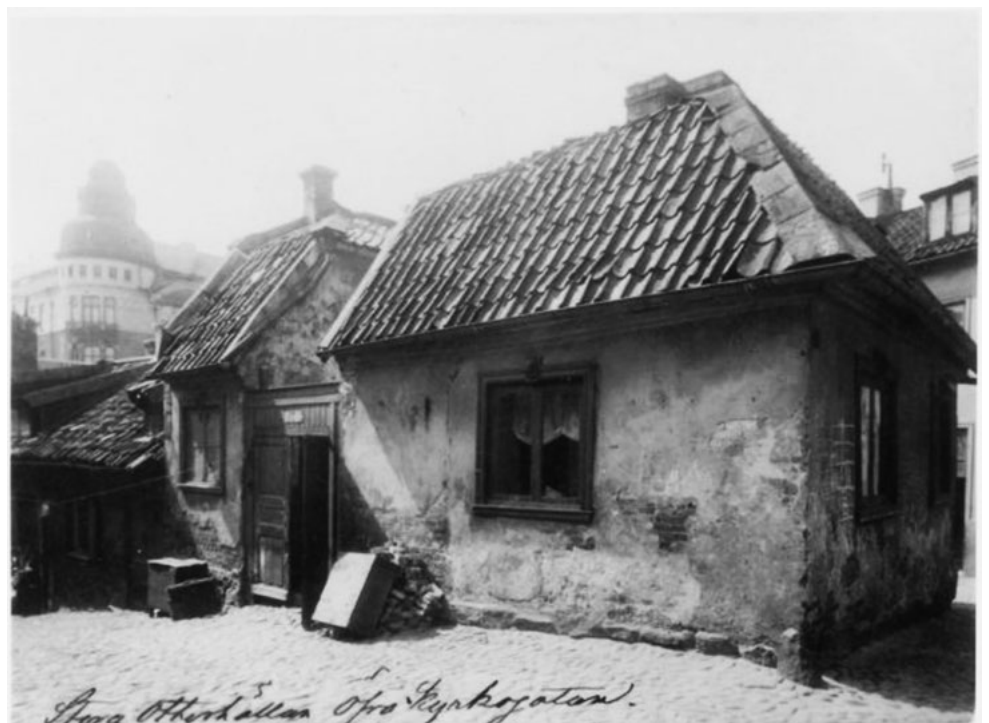
Figure 19 Queen
Kristina's hunting
lodge in Gothenburg.
Photo Otto Thulin,
Public domain mark,
Carlotta Gothenburg city
museum.

- *Drottning Kristinas Jaktslott* (Queen Kristinas' hunting lodge), in Gothenburg is situated on the outcrop Otterhällan within the city's fortifications (Figure 19). It has been moved from another street within the city centre. The building is constructed in timber-framing technique, built in 1731. It was remodelled in 1806, after the fire in 1804. The ground floor was used as a pub from the 1770s to 1804. The name of the house suggests a connection to Queen Kristina, or that it had functioned as a hunting lodge. There is no merit to the name; the closest connection to the queen comes from the house being situated close to the city gate Christina Regia and being frequented by pub-going soldiers in the city watch in the 18th century. The house has been remodelled several times, but it is the only one of its kind within the city fortification. It has small windows

and a hipped roof, and the house has plastered façade and rests on pad stones (those originates from the relocation of the building to its current location in 1972). The house is now one of its kind from before 1800, within the fortification (Lönnroth et al. 2003: 425).

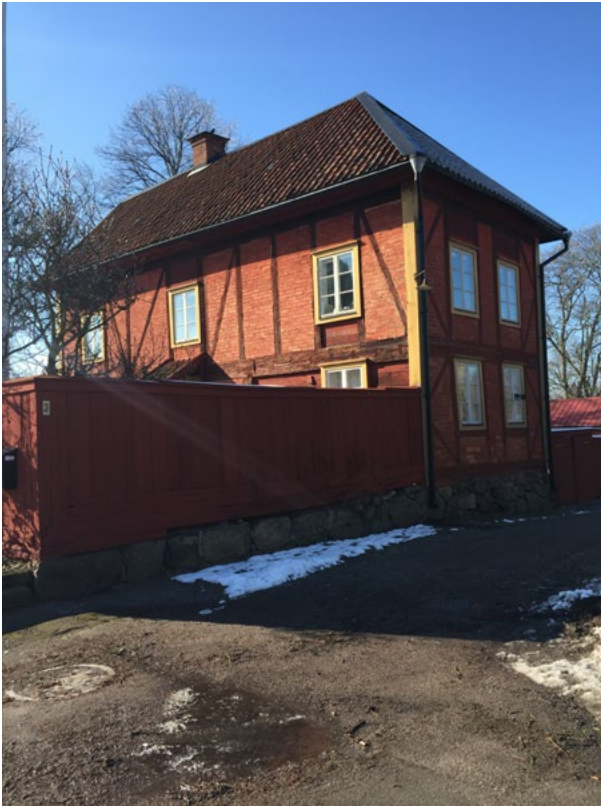
Figure 21 The timber-framed building on Korpogatan in Skänninge. Photo A. Nilsen

- Korpogatan in Skänninge has a two-storey timber-framed building with brick infill (Figure 21). The building has up and down braces, a girding beam and fitted windows to the bays. The back of the house has a log timbered wall on the ground floor. There is a substantial layer of padstones to support the building and one chimney is visible on the photo.

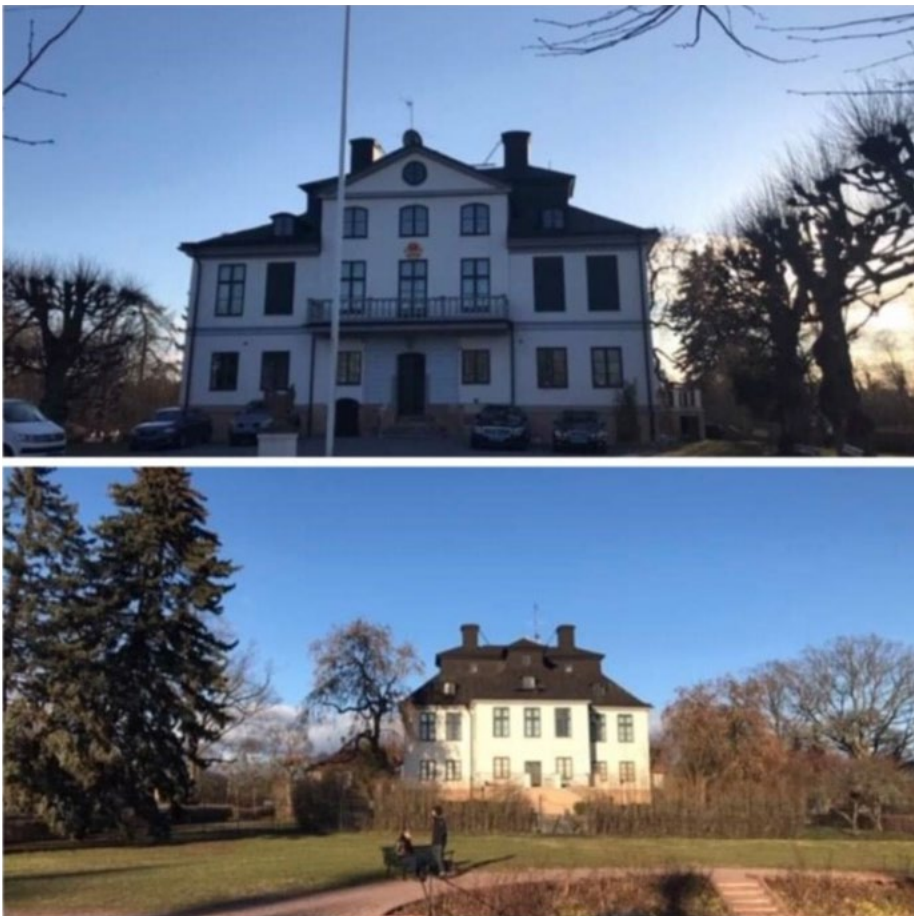
Figure 22 Örby slott in Stockholm, a manor house built in timber-framing technique. Photo Pia Englund.

- Örby slott (Örby gård 2, Älvsjö), in Stockholm is a two-storey manor house, built in the 1670s in timber-framing technique (Figure 22). There is a similar house built (the owners of the houses were brothers) called Sandemar, in Haninge. Örby slott, is built in a

Carolinian style (an architectural design named after the three kings Karl X, Karl XI, Karl XII in 1654-1718) with a manorial roof and plastered facades. There are two halls for entertainment, one on each floor. There is front gable with a balcony on the first floor (Stadsholmen 2013).

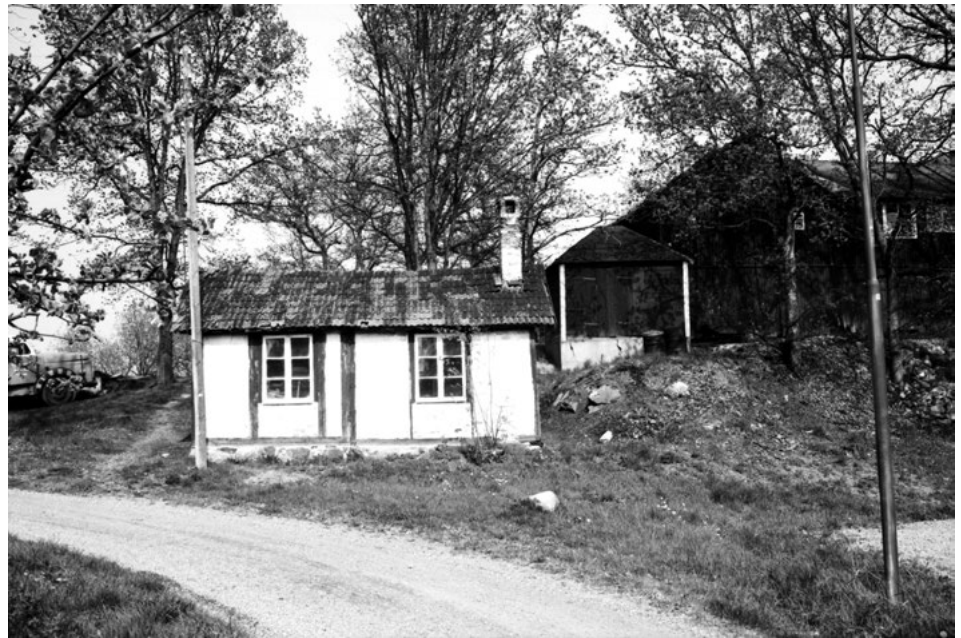
Figure 24 A small timber-framed building in Vrena, Nyköping. Photo Ulla Walukiewicz. Sörmlands museum.

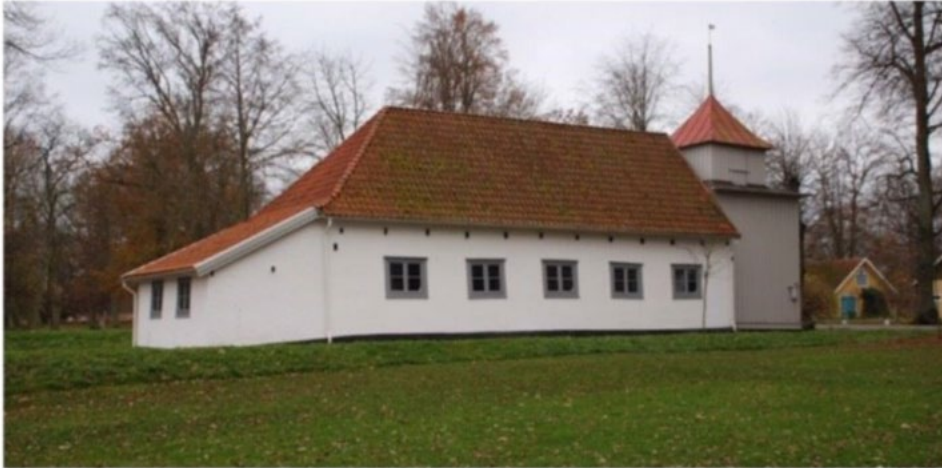
Figure 27 Elleholms church built in timber-framing technique.

- Elleholms kyrka, is a church with the porch and tower built in timber, while the nave and the sacristy were built in timber-framing technique in either 1705 or 1713. There is a regular timber-frame with brick infill and fitted windows and the church rests on pad stones.²⁵

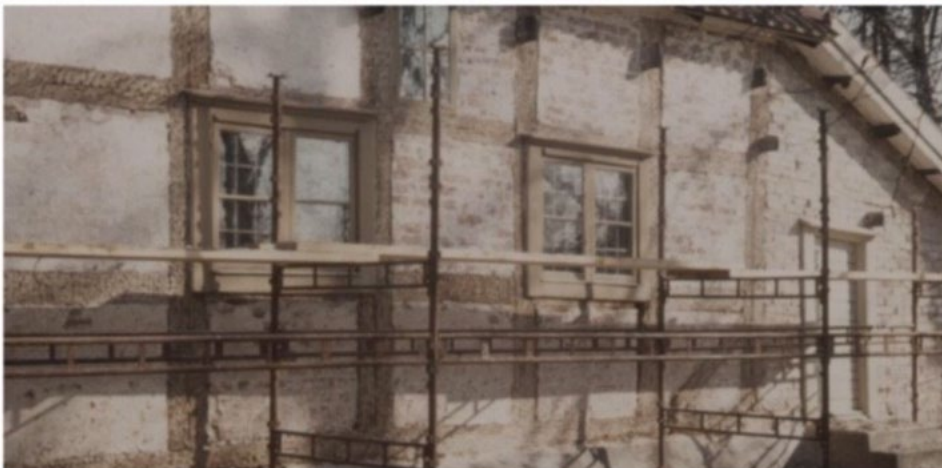
Figure 28 The timber-framed building in block Ceres in Sölvesborg. Photo Ingemar Atterman, Karlskrona. Blekinge museum.

- Block Ceres 6-7, Sölvesborg, has yet another regular timber-framed construction of two-storeys. It has up and down braces and fitted windows and doors to the bays. The building rests on a cellar with several entry doors and a set of steps leading up to the main doorway to the house. A timber-framed outhouse with wooden panelling is attached to the gable, perhaps a cart shed of sorts.²⁶ It is not clear as to when the house was built.

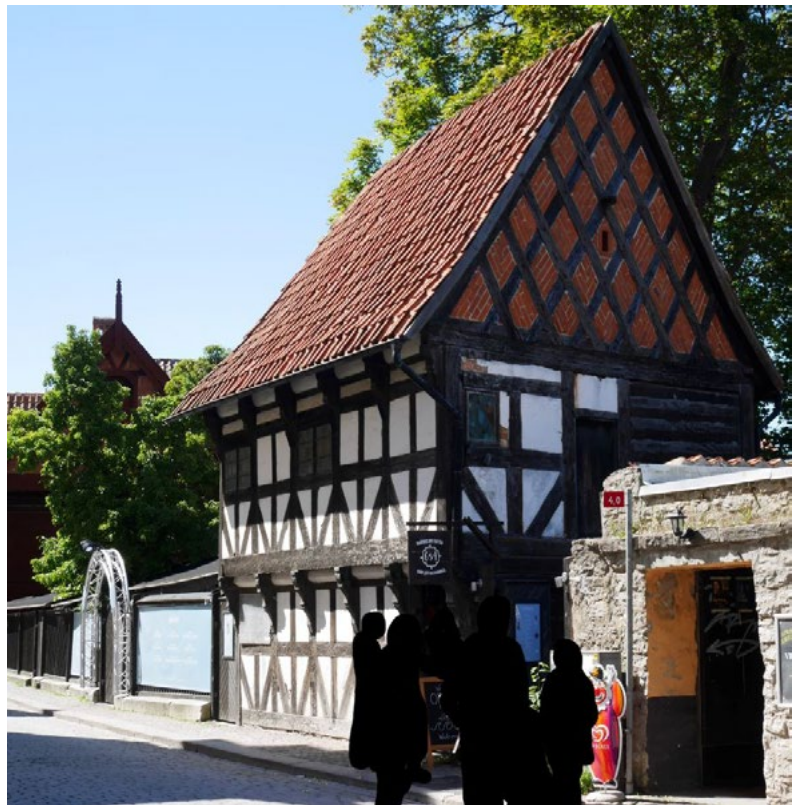
- Burmeisterska timber-framed house, in Visby (Figure 29), which is constructed in a mix of building techniques, was built in the 16th century. The house was moved to its current location in 1905, from the property *Städet 1*. The sidewall of the house, facing the street is built in timber-framing technique with a jetty bressumer, up and down braces and a regular timber-frame. The first floor is jettied and there are three small

Figure 29 Burmeisterska timber-framed house in Visby, Gotland. Photo A. Nilsen

windows, two on the long side and one on the gable end. The side of the house and the timber-framed part of the lower gable has been plastered but the wooden frame is visible. Half the gable is constructed in post and plank technique and the upper gable has a timber-frame construction with red brick infill. The frame has crossing timbers in an x-pattern. The roof is a steep gable roof, the house is placed directly on the ground with no traces of pad stones.²⁷

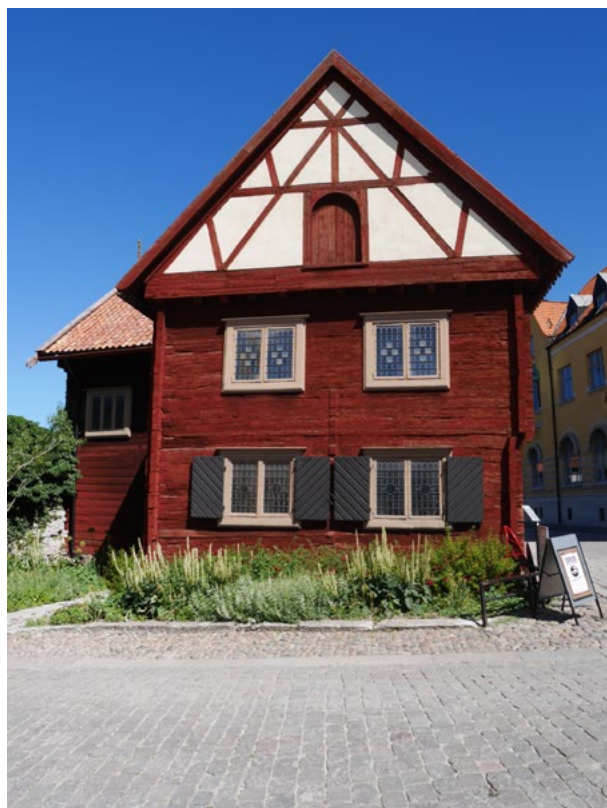
- Burmeisterska house, in Visby, was built in 1654 (Figure 30). A two-storey log timber house with timber-framed upper gables. There is a centrally placed hatch in the gable, giving access to the attic supposedly for storage. The timber in the timber-frame is coloured red as the rest of the house and the infill is hid behind plaster.²⁸

Figure 30 The Burmeisterska log timber house with a timber-framed gable in Visby, Gotland. Photo A. Nilsen
