Vernacular Buildings and Urban Social Practice

Wood and people in
early modern Swedish society

Doctoral thesis
Department of Historical Studies, University of Gothenburg,
defended on the 18th of September, 2020

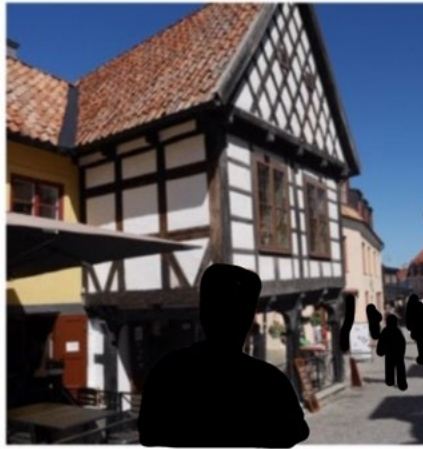
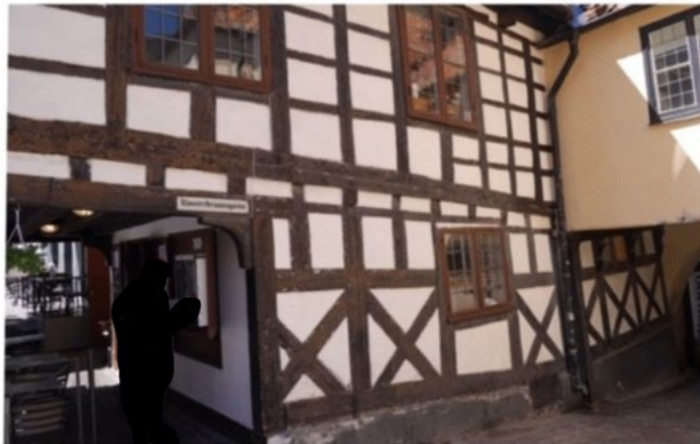
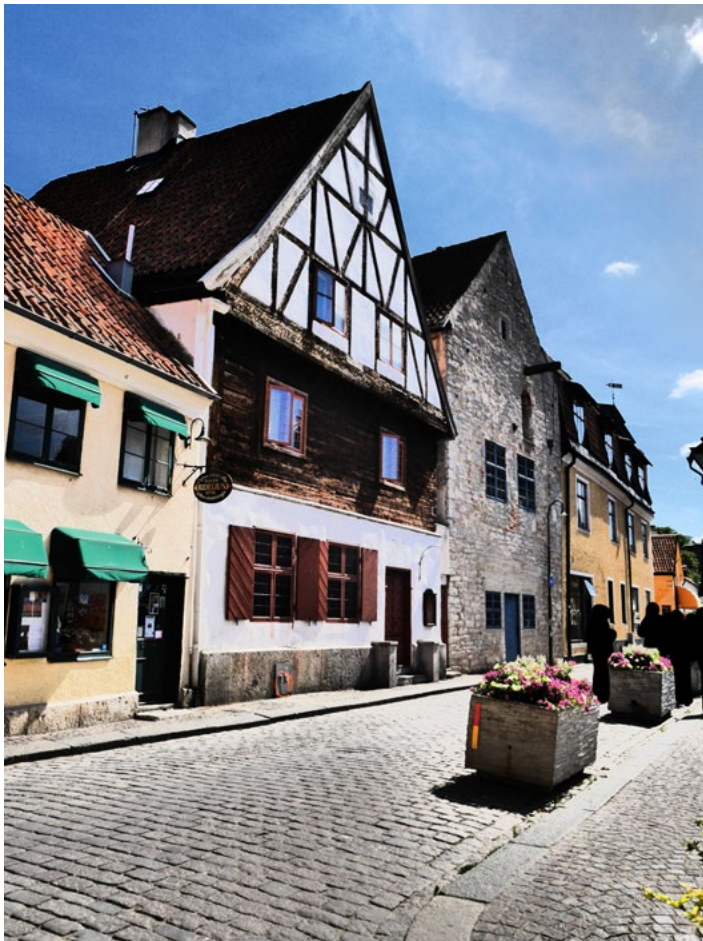
- Laboratorn 4, in Visby are essentially four attached two-storey buildings (Figure 31). In the 15th century the burgare plot consisted of three stone houses

Figure 31 Laboratorn 4 photographed from the front with the verge and of the sidewall with the jetty connected to the property on the other side of the street, in Visby, Gotland. Photos A. Nilsen

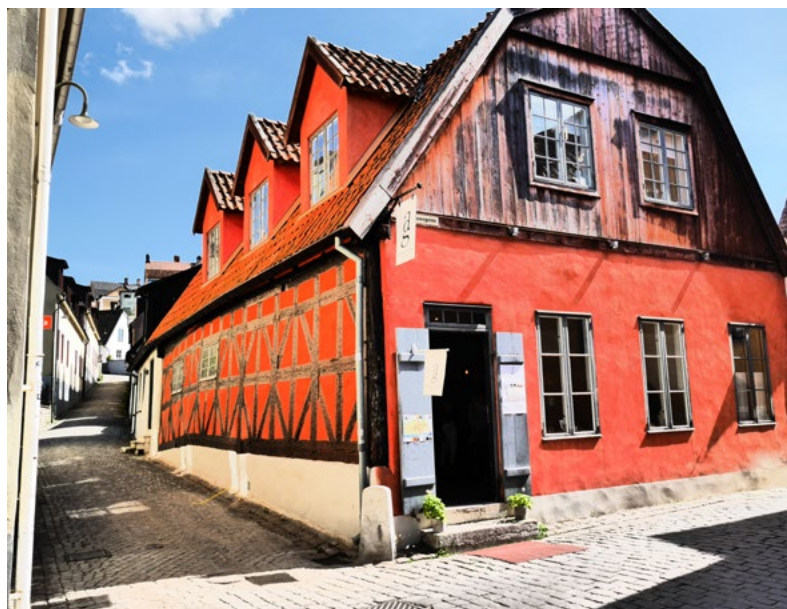
- Gråbrodern 7, Visby, which is situated on a corner plot, is one-and-a-half storeys high (Figure 33). The property includes five buildings forming a closed unit burgare plot. The residential house is built in roughcast timber-framing technique, most likely in the 17th century.³¹ The timbers in the timber-frame are visible and painted black, the infill is plastered in a red tone, along the long side of the house towards Hamburgergränd. Up and down braces and two fitted windows and a girding beam have been used in the construction and three projecting windows in the furnished attic have been built. The gable towards S:t Hansgatan has been plastered thus not showing the timber-frame, yet the three windows on the ground floor are much larger than on the side wall. The entrance is placed on the gable and the house is now a shop. The upper part of the gable has a wood panel,

Figure 33 Gråbrodern 7 in Visby, Gotland. Photo A. Nilsen

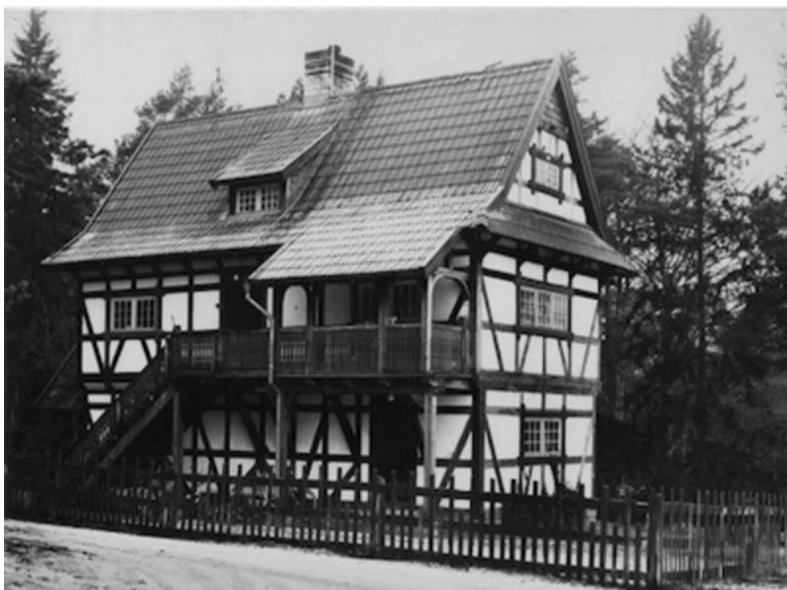
- Brucebo, Visby, is situated outside of town (Figure 34).³⁴ A family of artists, the Bruces from Canada, built several houses in 1900-1906, one of those was a timber-framed residence for the gardener. The houses were built in the national romantic style of the time (yet it is difficult to know which nation was intended). It is a two-and-a-half storey building, the first floor and attic slightly jettied with jettied bressumers. Up and down braces, small fitted windows and an external stair and balcony can be seen in the photo. The roof is built as a steep gable roof, and the house has a chimney. It looks like the building has one ground floor entrance and one, possibly two accesses leading onto the balcony.

Figure 34 Brucebo, Visby. The gardeners lodge. Photo Raymond Hejdström. Gotlands museum.

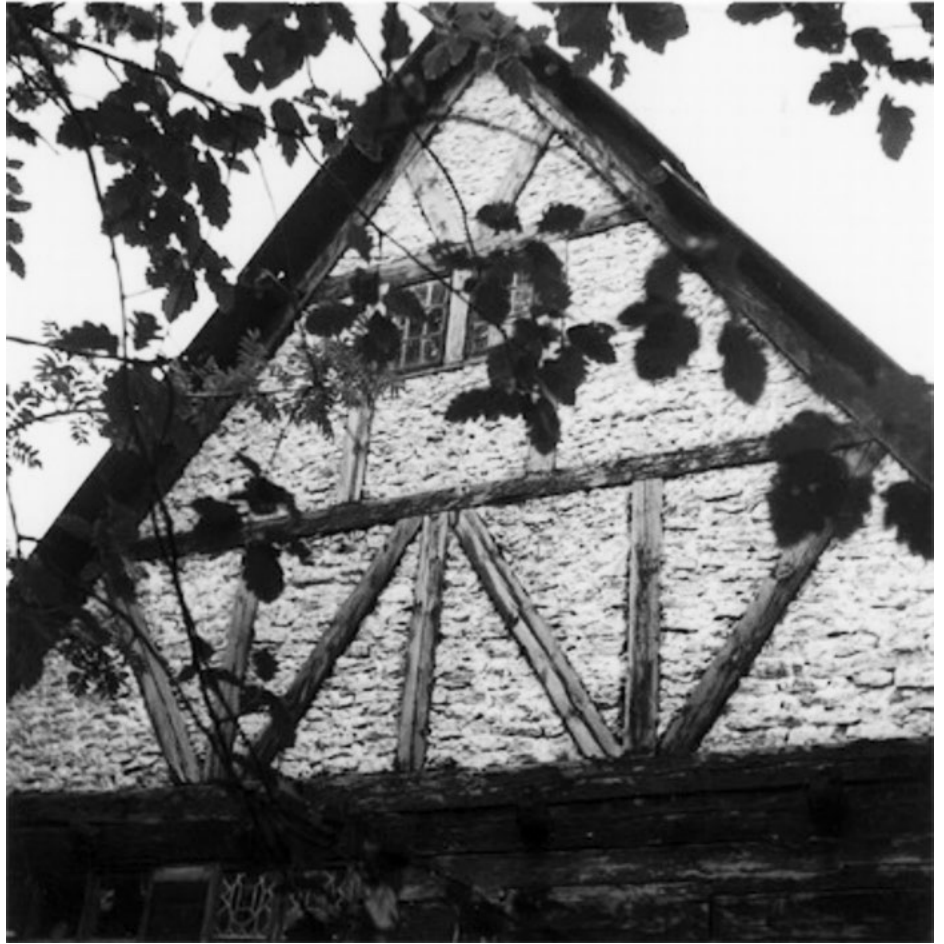
• Lundarhagestugan, at Bunge museum, is an example of a house built in a mixed technique (Figure 35). The body of the building is built in beautifully ornamented post and plank technique while the upper gables are constructed in timber-framing. The gable has up and down braces, a centrally placed window. The infill used appears to be in stone (it is however hard to make out on the photo).³⁵

Figure 35
Lundarhagestugan, at
Bunge museum. Photo
Åke Meyersson. Gotlands
museum.

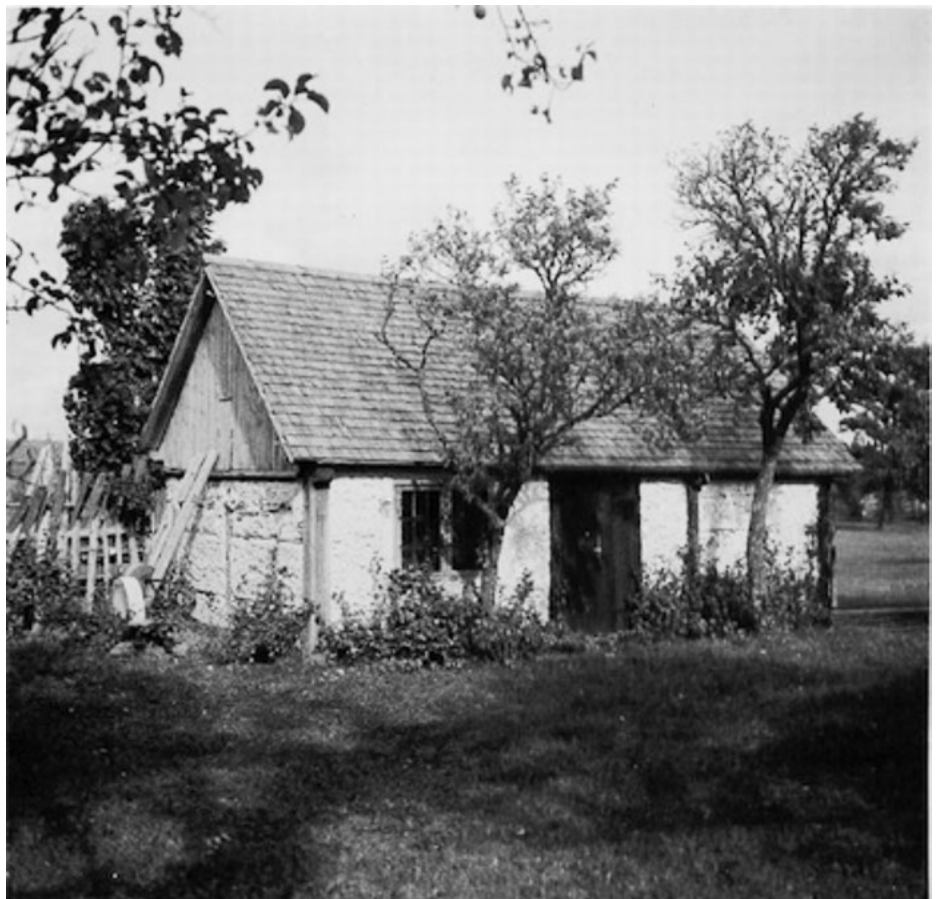
• In Lamskvie, the smithy is constructed in a sort of timber-frame construction (Figure 36). Probably with

Figure 36 Lamskvie, a
sort of timber-framed
construction, locally
called Gutmur. Photo
Gunnar Jonsson.
Gotlands museum.

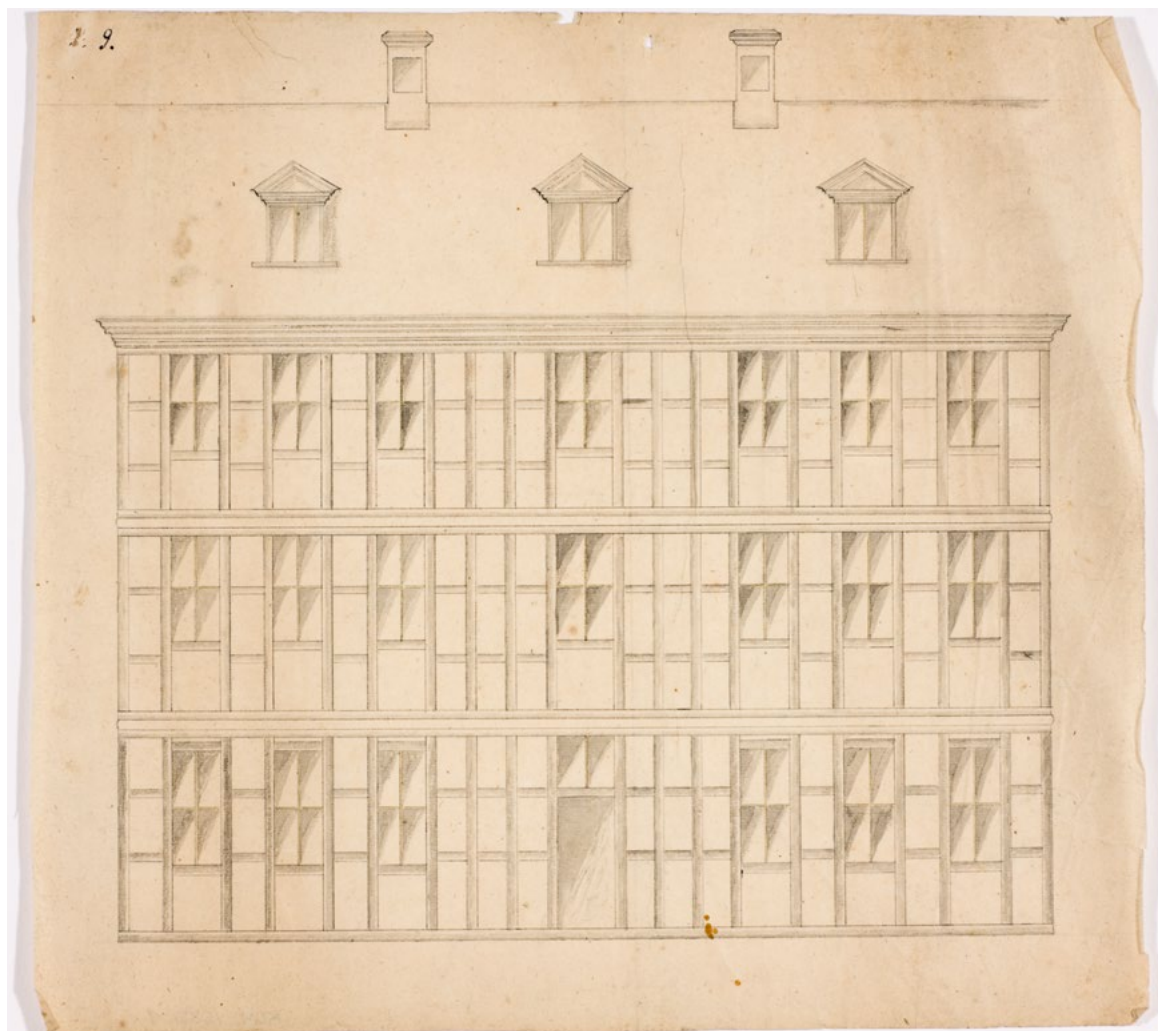
Figure 39 KLM 15851:9. Drawing. A construction drawing on paper. A facade of a three-storey building in timber-framing technique. Unsigned, undated. Kalmar Läns Museum, digital archive. Fotografher Pierre Rosberg, Kalmar läns museum.

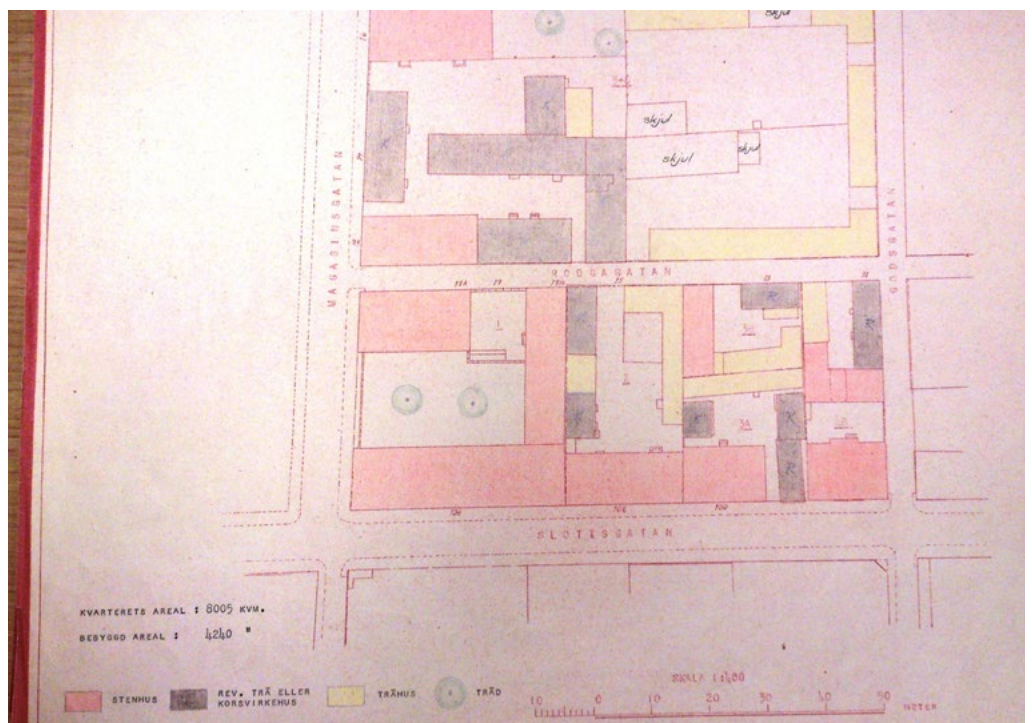
Figure 41 City planning committee/ Stadsplanekommittén, Norrköping. City clearance stocktaking/ Saneringsinventeringar i Kv. Ruddammen. Map from Kv Mässingen, Saltängen. Grey indicates timber-framed buildings

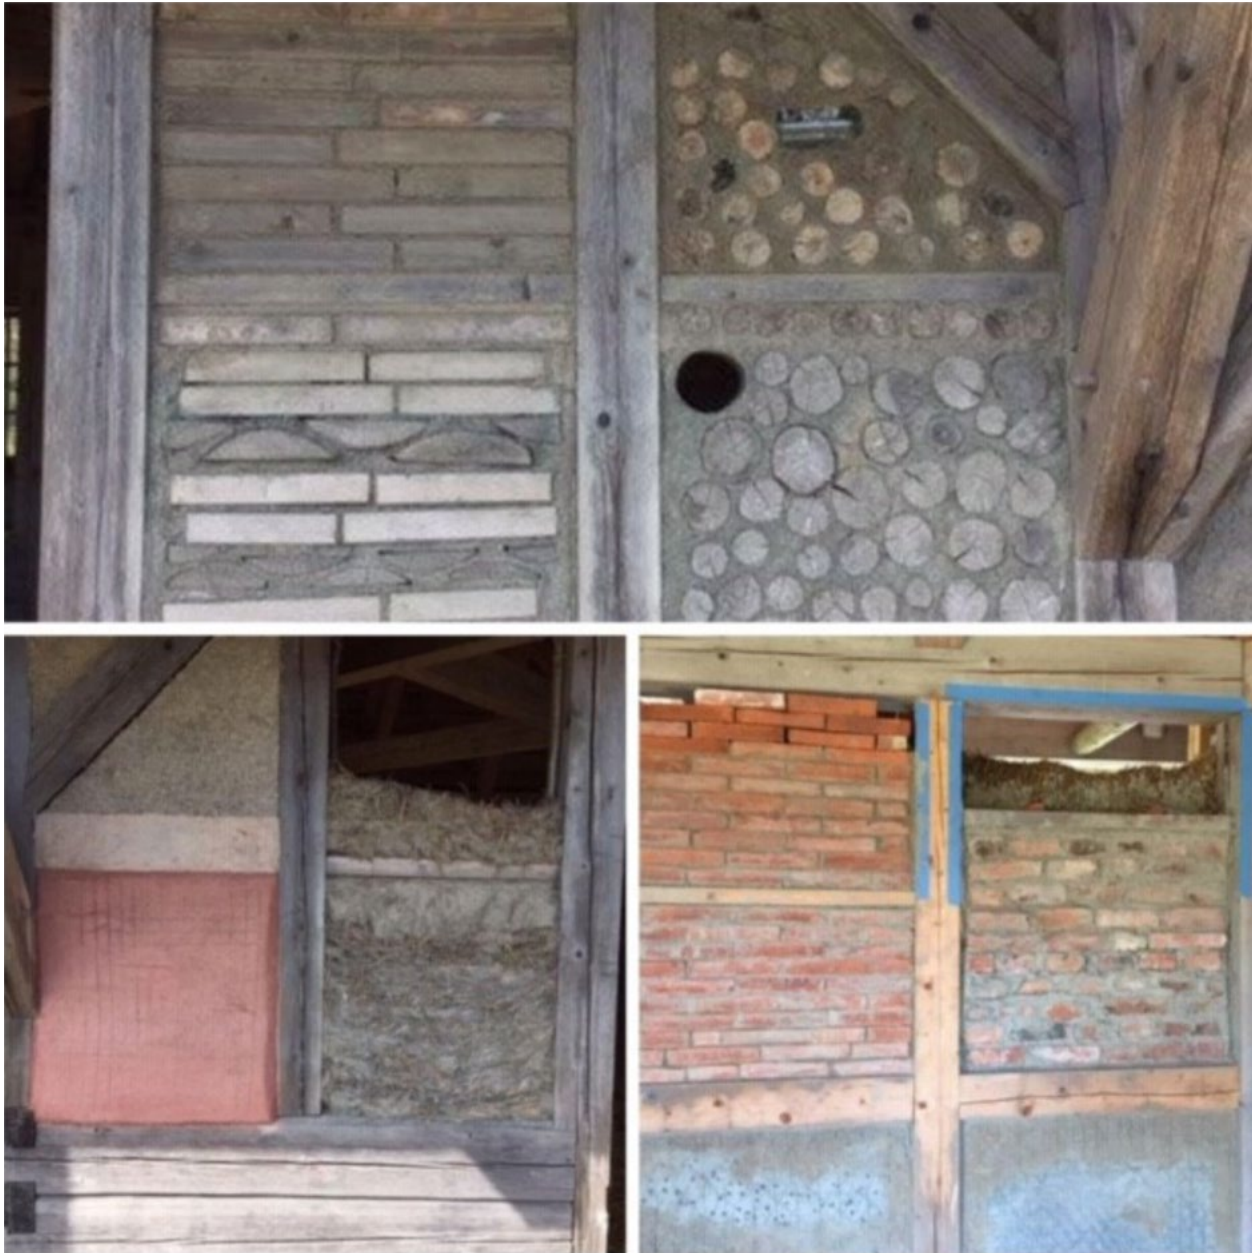
Figure 42 The infill used in timber-framing can come from an array of sources i.e. brick, wattle and daub, logs, rubble and mortar or limestone. Slöjd and byggnadsvård, Nääs Slott. Västarvet, Västergötland. Photo A. Nilsen.

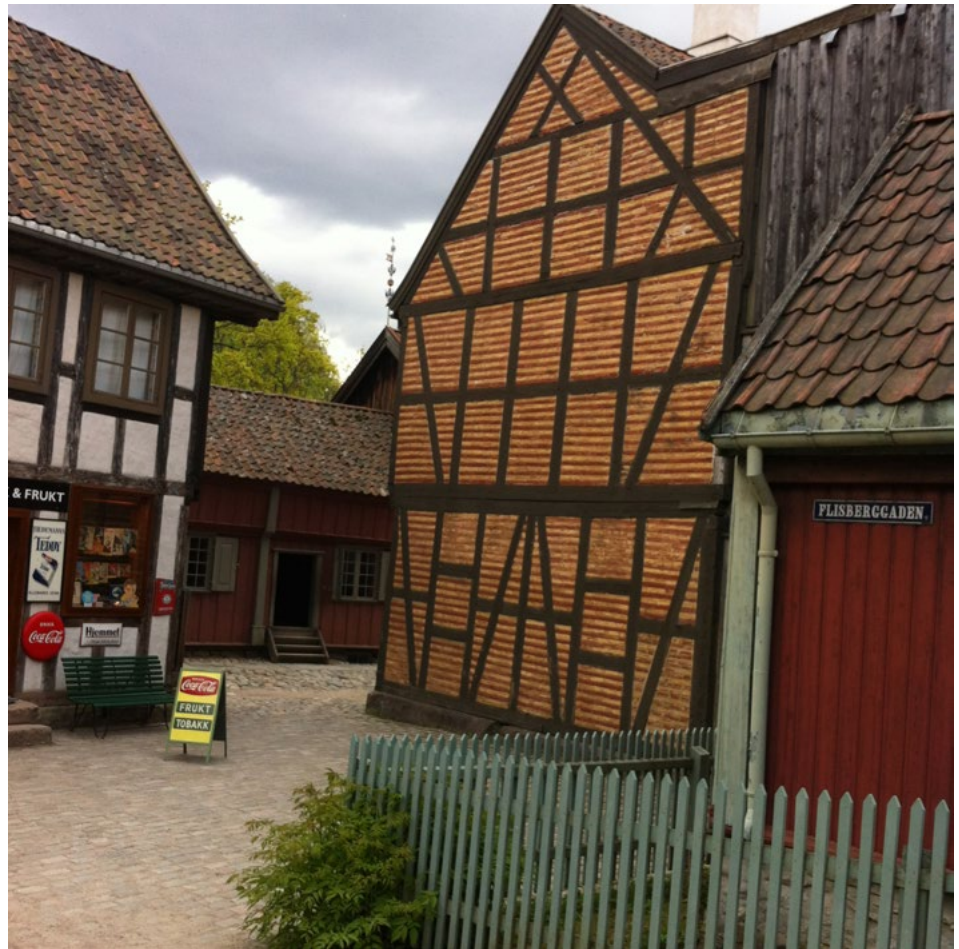
Figure 43 A timber-framed house from Christiania in Norsk Folkemuseum (The Norwegian Museum of Cultural History) in Oslo.
Photo: A. Nilsen

Roede (2001) describes the Norwegian timber-framing culture (Figure 43) in the following terms:

Roede's theory is that this adaptation or combination of foreign and domestic building techniques can be seen as a form of creolization (Figure 43) (Andersen 1983; Fox 1983).

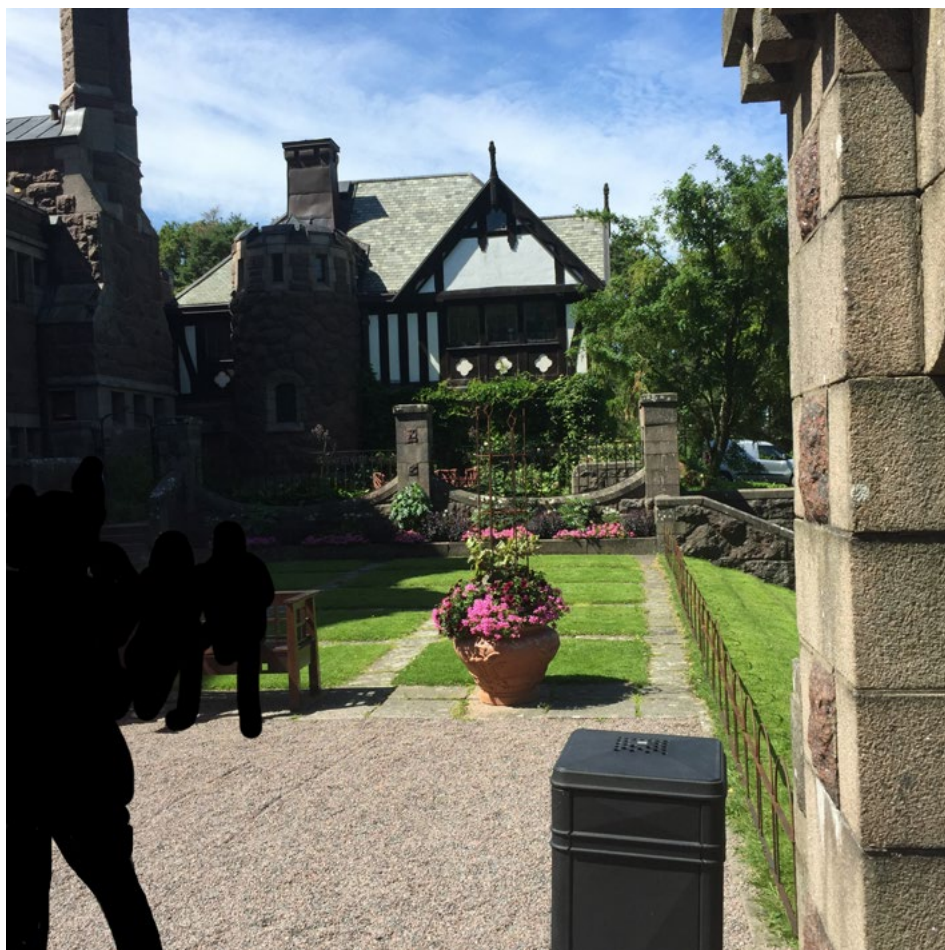
Figure 44 Images of the gatehouse at Tjolöholm in Sweden with an example of close studding.
Photo: A. Nilsen.

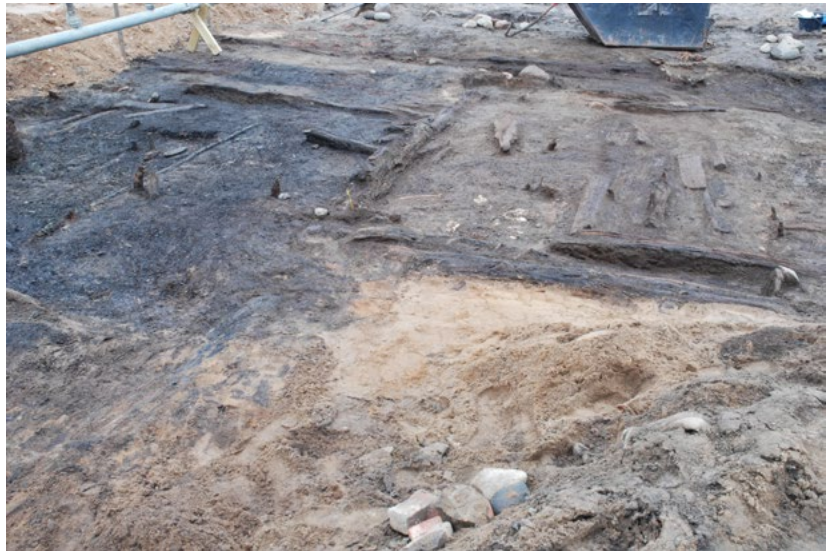
Figure 10 Partitions for animals in house 368 on plot 218 in Block Diplomaten in Jönköping. (Nordman and Pettersson 2009).

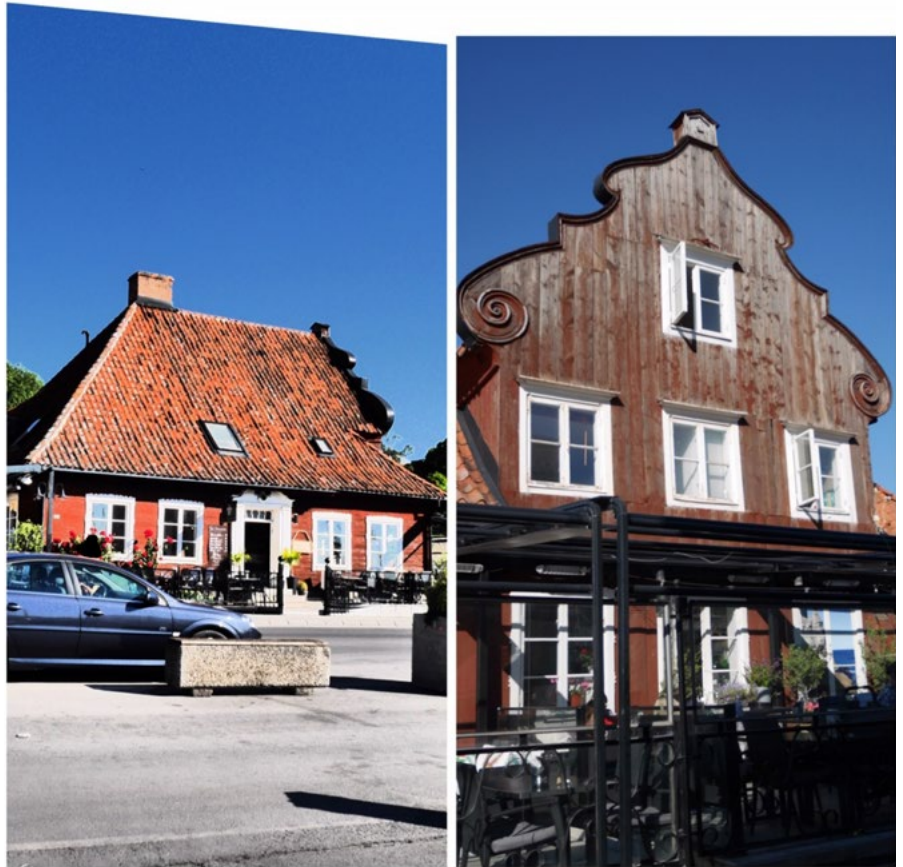
- The house, Torsmanska huset,¹⁰ was erected 1700-1745 by the bailiff Johan Gustaf Camitz or his father Johan Niclas Camitz (Figure 13). The façade of the building is a striking volute-shaped or Dutch gable, of three storeys that brings Amsterdam to mind, and slightly higher than the building itself (Figure 14). The

Figure 13 Two views of Torsmanska huset, Visby, Gotland, Sweden. Photo A. Nilsen.

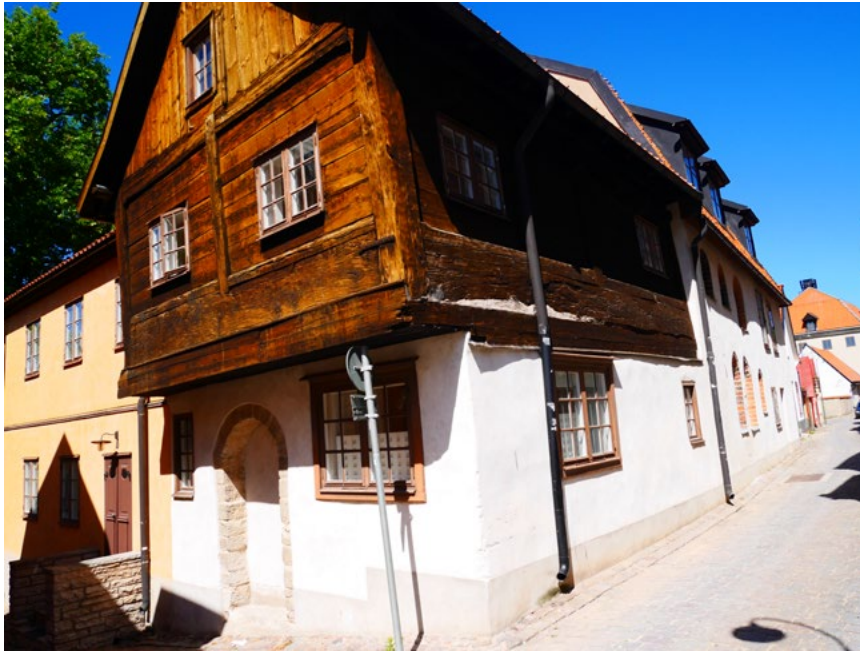
Figure 15 Post and plank building at Mellangatan 35, Visby, Gotland, Sweden. Photo A. Nilsen.

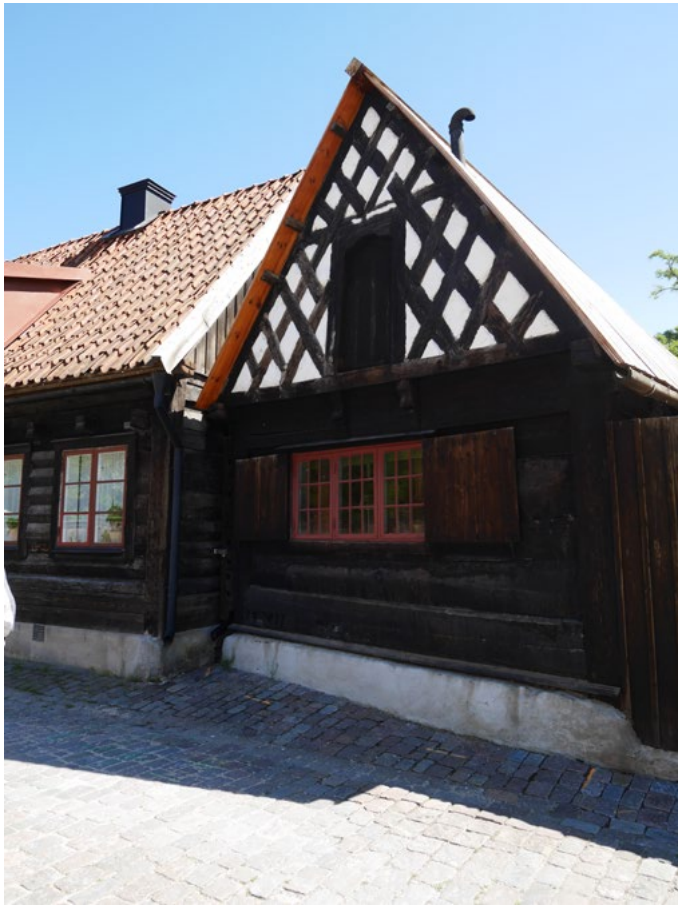
Figure 17 Post and plank building in Mellangatan 4, Visby, Gotland, Sweden. Photo A. Nilsen.

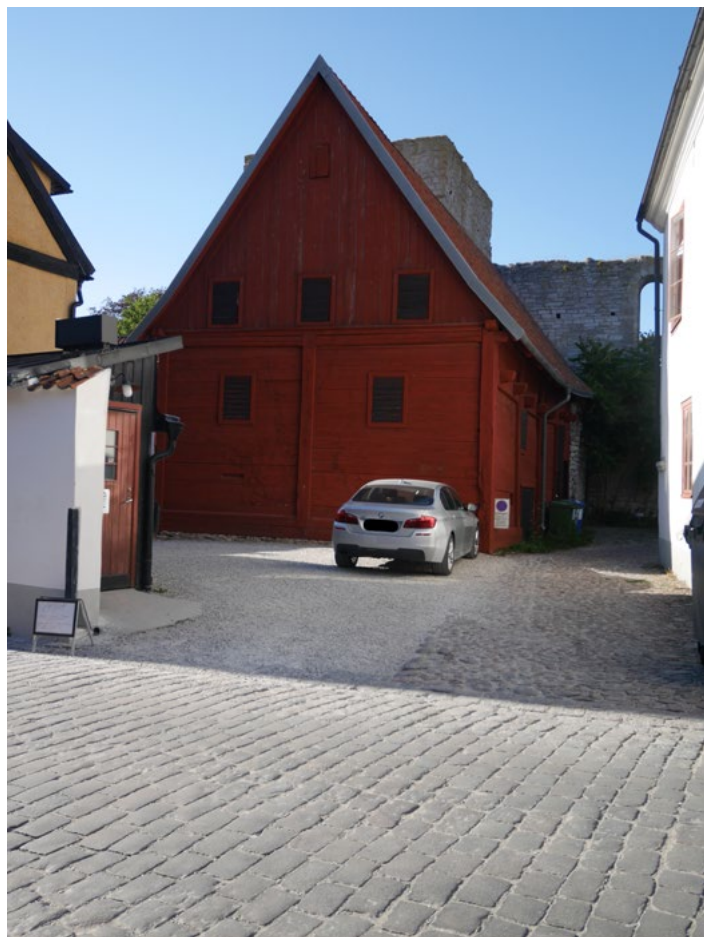
- This warehouse close to the city wall and the square Södertorg represents a building function for post and plank constructions in urban settings (Figure 20). It is a tall building of one-and-a-half storeys with five closed ‘windows’ or openings on the gable end and additional ones on the long side.

Figure 20 Post and plank building in Visby, Gotland, Sweden. Photo A. Nilsen.

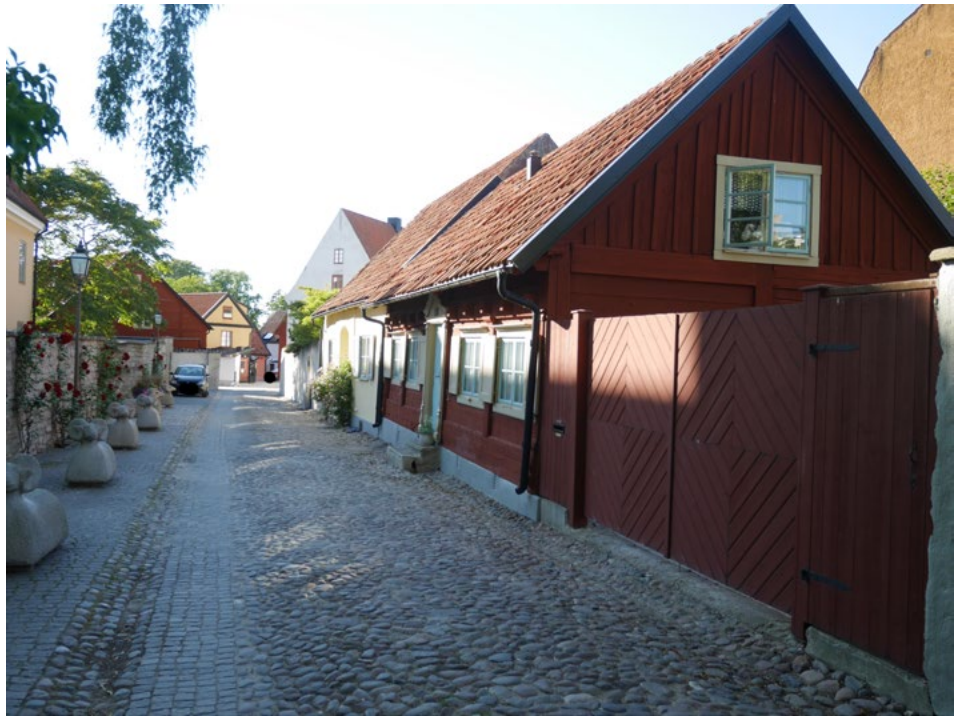
- According to Kjellberg (1924: 8:56–58) the house on Biskopsgatan 3 (number 1 according to current address system) Figure 21 within the city walls, was built in the 18th century in one-and-a-half storeys. It has some architectural features that warrant further consideration. The house has a symmetrical façade with a rococo portal and a further two set on each corner of the building. There are four sets of windows facing the street, one on the gable and two windows to the back in the drawing from 1924 (Figure 21), on the photo there is another window on the first floor, perhaps added later, the drawing does not include a layout of the first floor. Kjellberg describes the building according to Sigurd Erixon’s ideas as a *parstuga*, which is what I would refer to as two base modules (for a closer description and discussion see Chapter 5.2) usually with a joint central vestibule. The layout had originally two equally-sized rooms with a central vestibule. One room was used in its entirety; the other side of the building was divided into two rooms, one slightly bigger than the other. The focus of the layout is the central fireplace and the chimneystack, which heats three of the rooms. The vestibule, thus, was cut off by the chimney and a space behind it creates a room, which functioned as a kitchen with a door to

Figure 21 Biskopsgatan 1, Visby. Photo A. Nilsen.

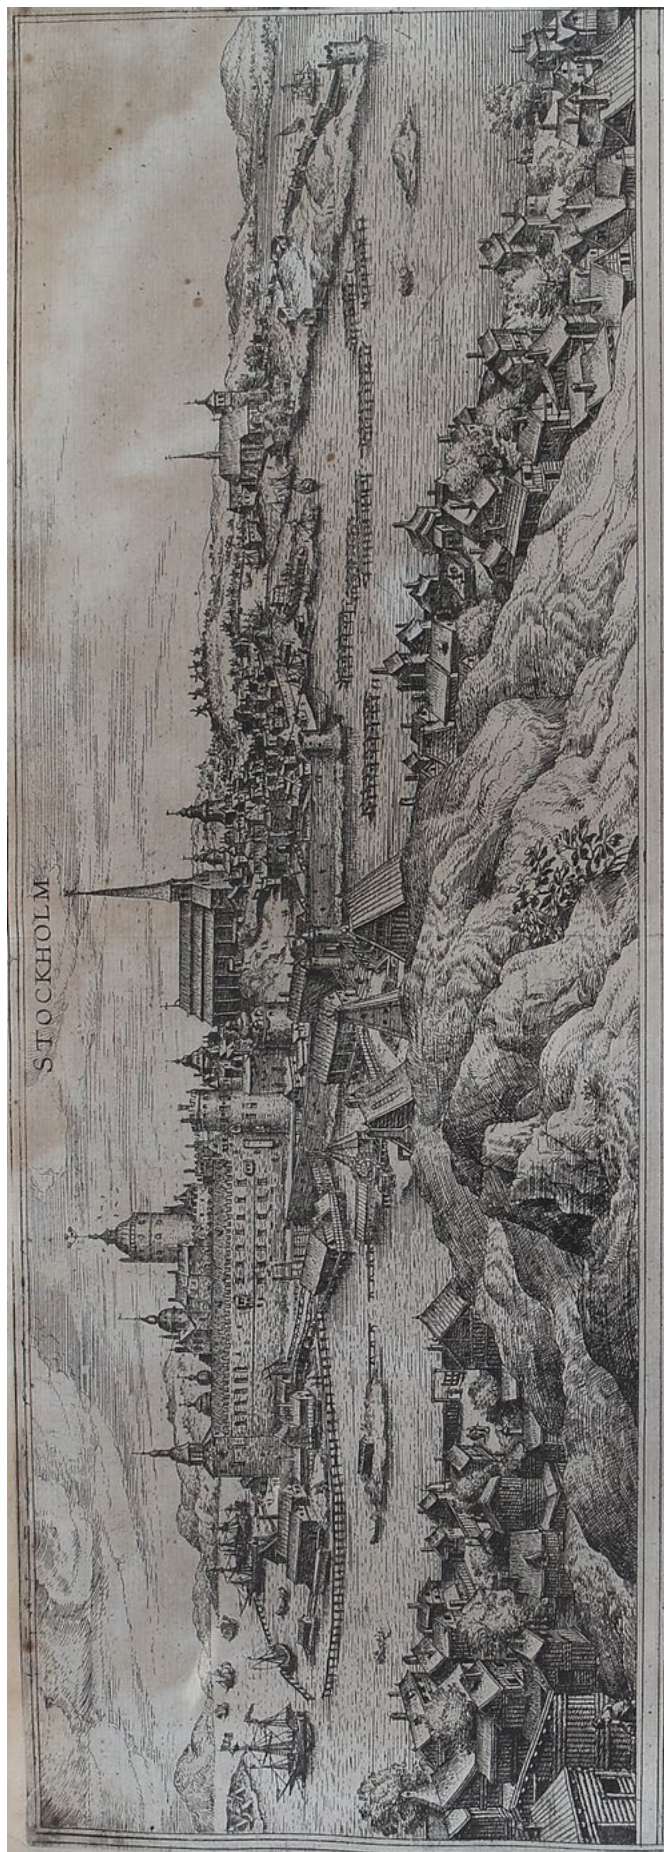
Frans Hogenberg made this copperplate in the 1580s picturing Stockholm from Brunkebergsåsen on Norrmalm, facing the royal castle on Stadsholmen (Figure 24). I would like an attempt at following Martin Olssons’ (1968) critical evaluation of historical images. On the eastern shore of Norrmalm there are a multitude of wooden houses one to two-and-a-half storeys high. They are pictured rather generically generating an unclear sense a construction of vertical planks and prominent wall-plates. That sort of construction does not make much sense and is probably to a large extent the artist’s way of saying that the houses were constructed in wood in more than one storey and densely situated on the shoreline.

Why then does the construction not make sense? Outer panelling was not yet prevalent in the 1580s so that does not explain the upright planks. It could be post and plank construction with vertical planks, but that technique was largely abandoned for dwellings in the mid-1200s probably because it does not provide for a draught free indoor environment (Nilsen 2011). The girding beam, visible between every floor could suggest post and plank technique but then the planks should be horizontal. The construction could possibly be interpreted as close studded timber-framing (for a closer description see Chapter 5.3) but the houses give a more wood like character. However, the buildings are depicted as ‘modern’ for the time,

Figure 24 Copperplate by Frans Hogenberg, Stockholm in the 1580s.

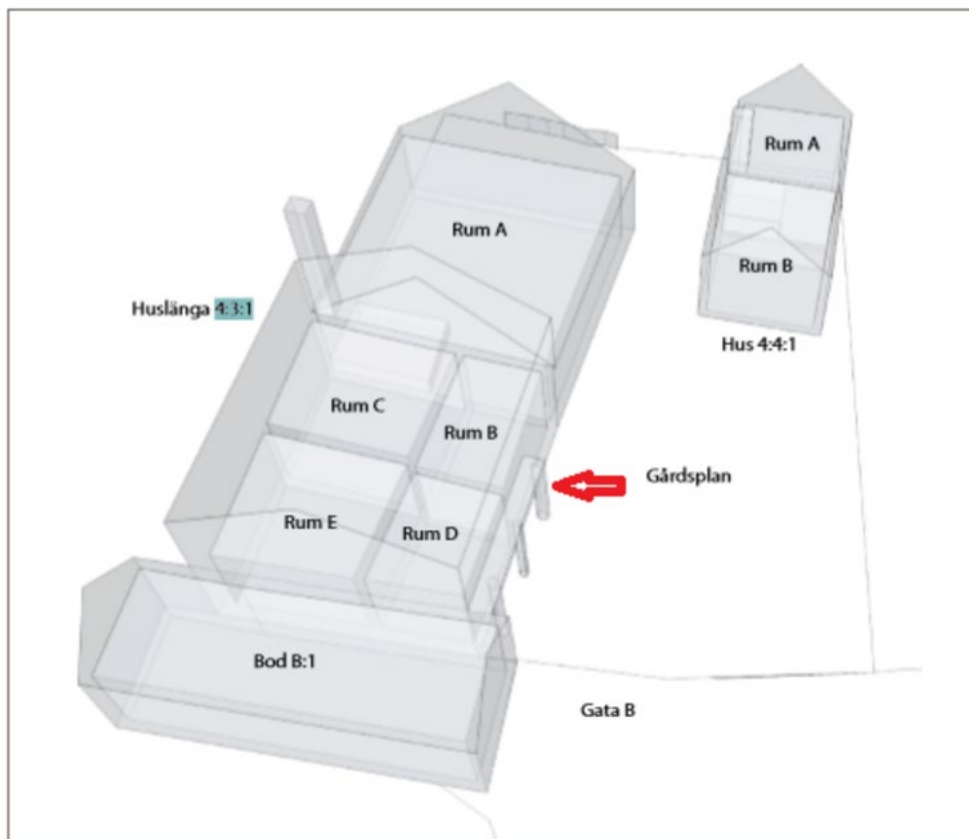
Figure 1 A possibly storeyed house in burgage plot 4:3:1 in Nya Lödöse with postholes situated in a parallel line at some distance from the outer wall of the house. (Rosén and Öbrink 2017, 52)

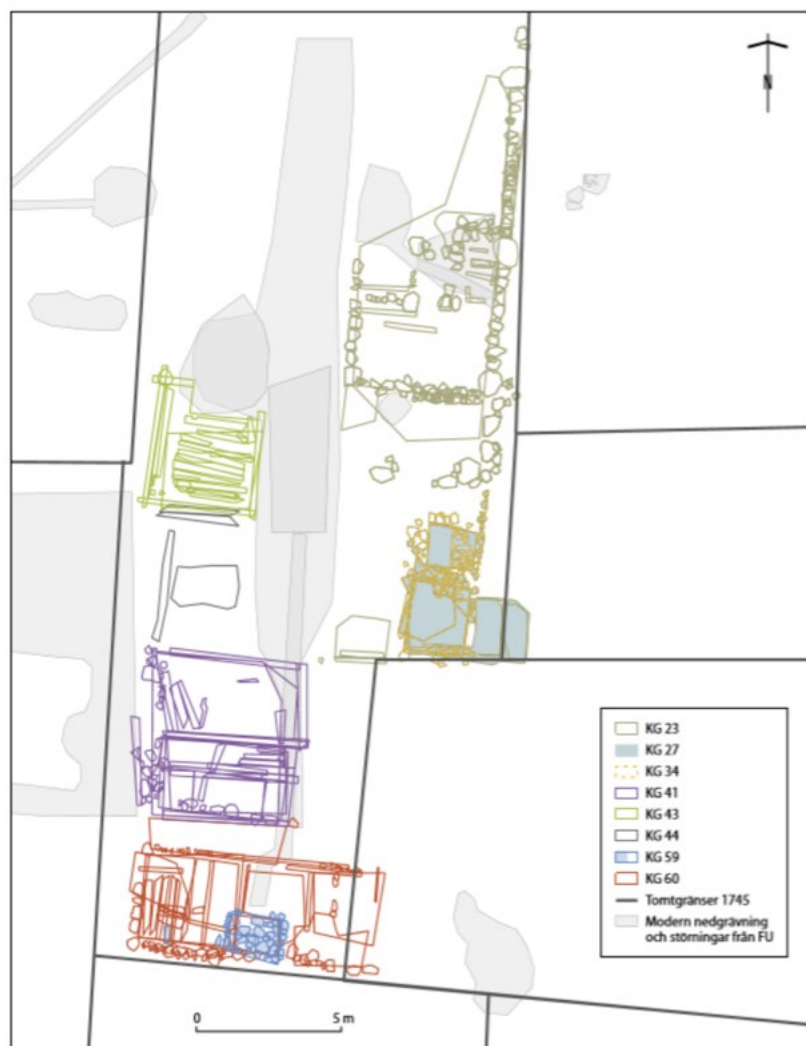
Figure 2 The remnant of building KG 27/34, dated to ca 1720. Scale 1:150. Kv. Dovhjorten, Jönköping with possible remains of an external staircase (Bramstång Plura et al. 2012: 38)

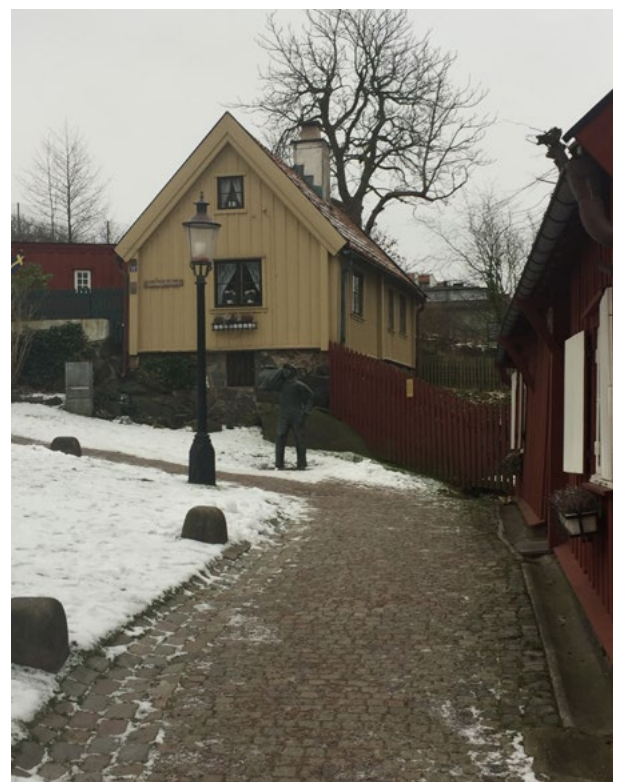
Figure 4 A small building with an over-sized foundation i.e. in this case a substantial cellar. In Gatenhielmska reservatet, Gothenburg. Photo: A. Nilsen

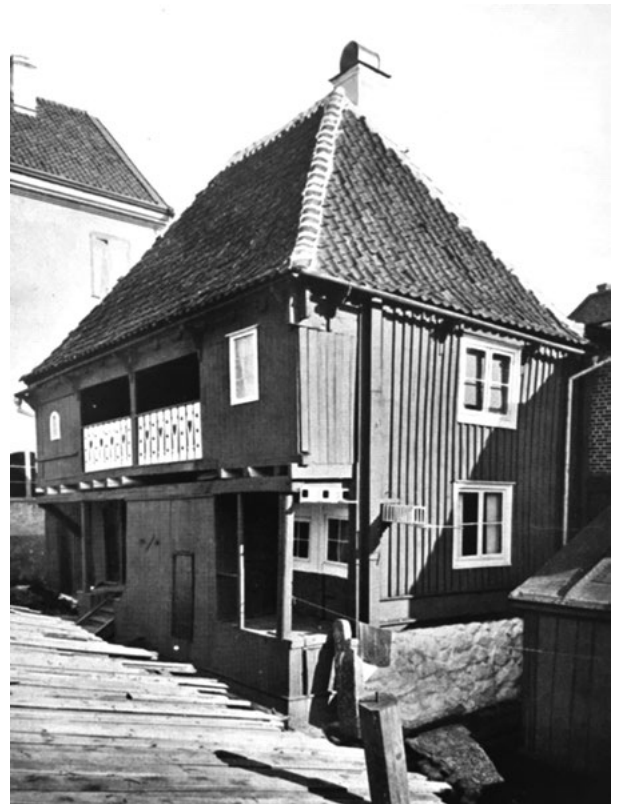
Figure 7 Vinbergska gården, Karlshamn. A house with a balcony that is supported by posts (Bäckström and Wallin 1911, 15).

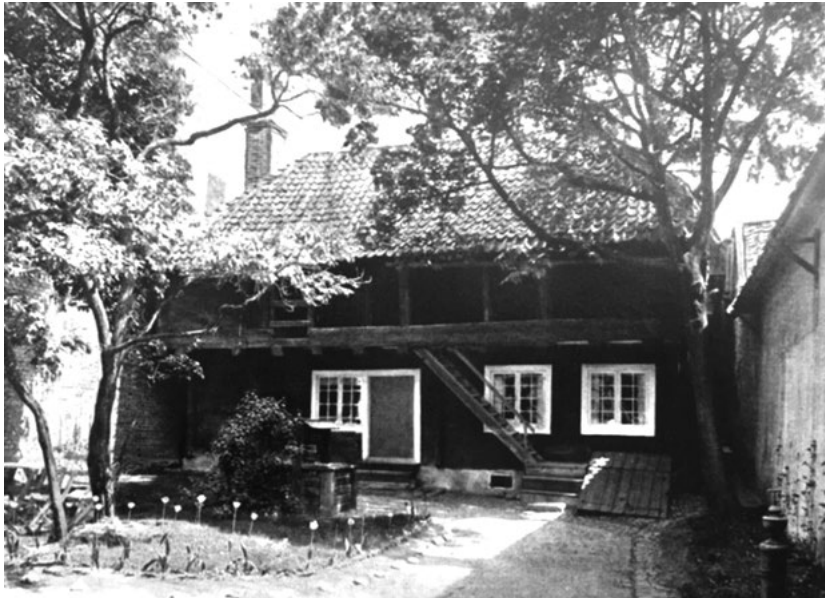
Figure 8 Stadsarkitektens gård, Kalmar. A house with a balcony and a foundation for a staircase (Bäckström and Wallin 1911, 19).

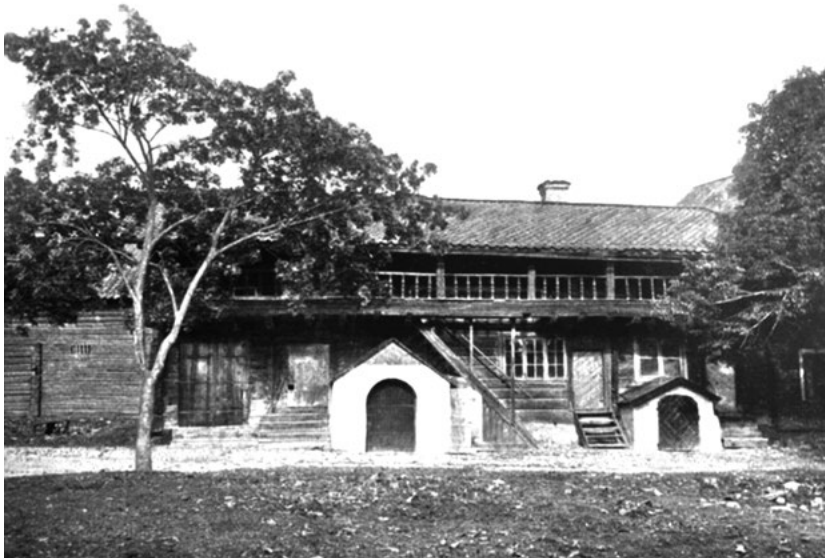
Figure 9 Kungsstugan, Örebro is a two-storey building with an open gallery and a staircase (Curman et al. 1908, Häfte 1, 1908:33).

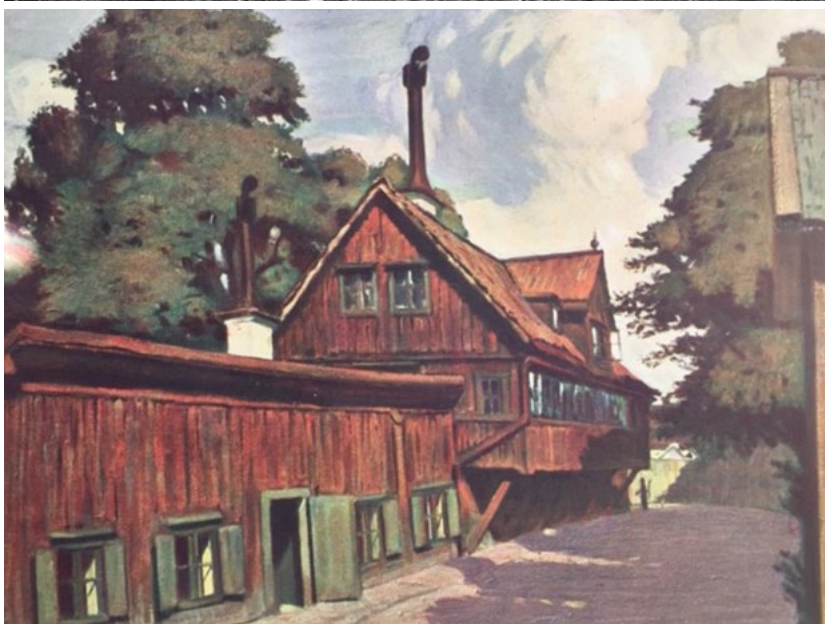
Figure 10 Gröna Lund, Stockholm, the building has braces holding up the balcony (Curman et al. 1908, Häfte 1, 1908:49)

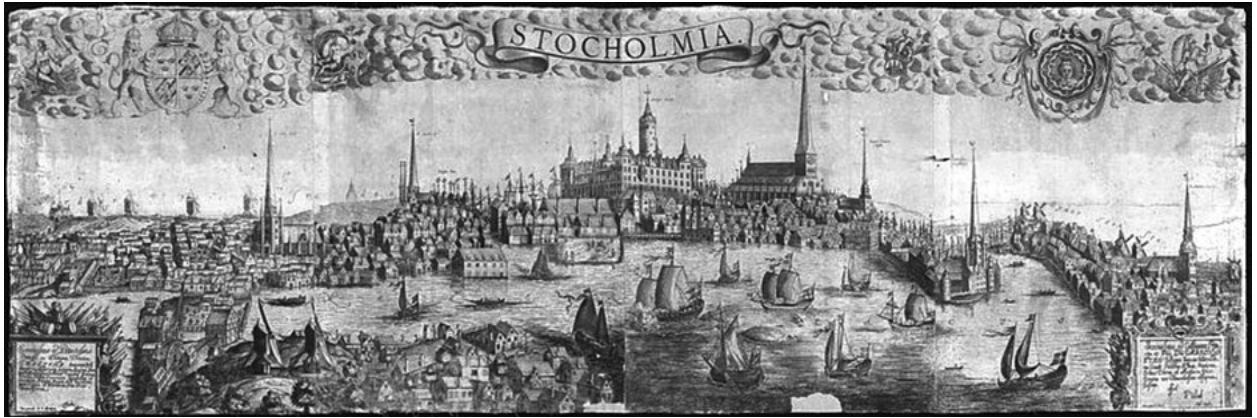
Depictions of Swedish towns such as Johan Sasse's copper plate of Stockholm in 1652,¹¹ showing a multitude of storeyed buildings (Figure 11) is another kind of source material to understand the lost townscapes of the early modern.

Figure 11 Johan Sasse's copperplate of Stockholm in 1652 (Public domain no known copyright).

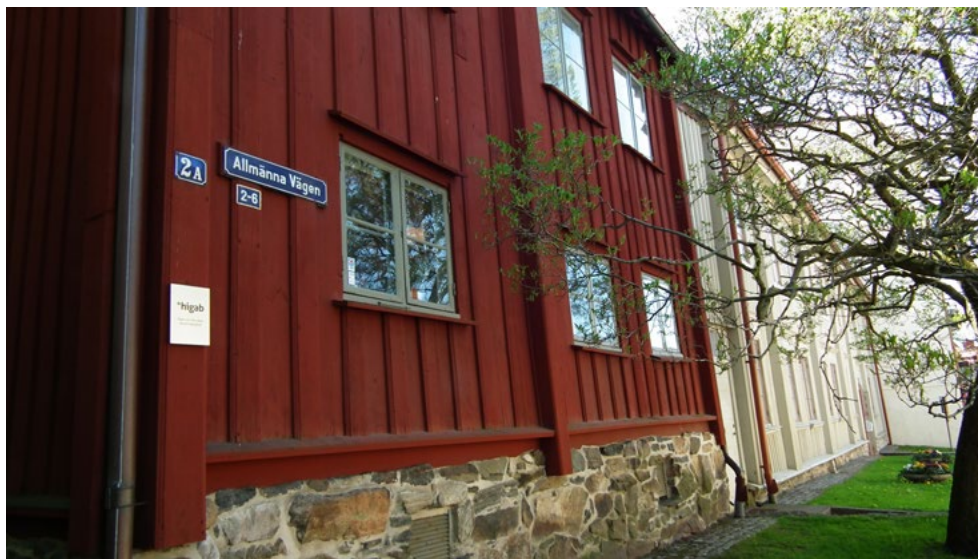
The house was built in a mix of pine and spruce, predominantly spruce. The dendrochronological dating of the building turned out to be problematic with bad quality samples. Of eleven samples, only five were datable and two of those were inconclusive. Nonetheless, all the data points towards the wood having been felled in the winter months of 1740/42 in the region of the

Figure 14 Dahlströmska huset (red). See how it connects to Jedeurska huset nextdoor (with a white facade) Photo A. Nilsen

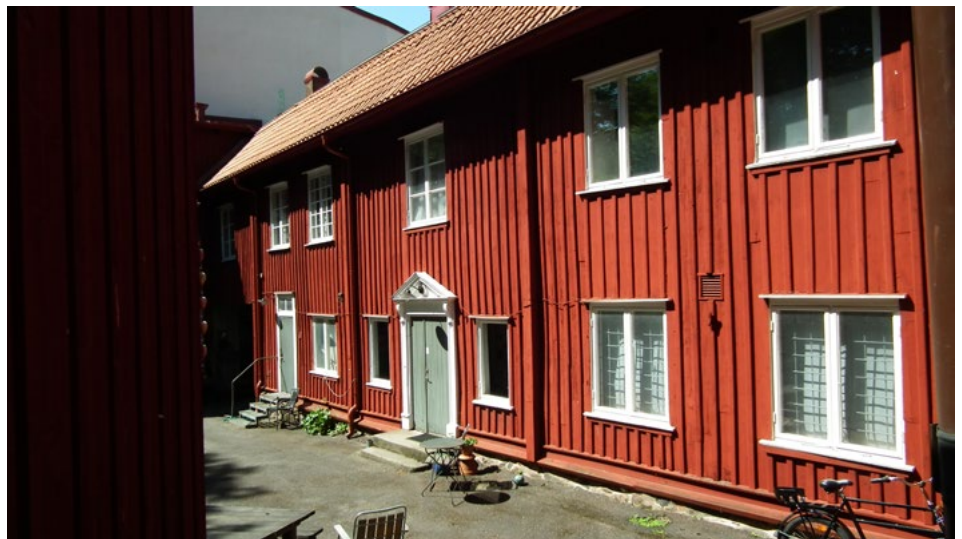
The house called *Jedeureska huset*, is the next house down the street to the west of *Dahlströmska huset* (Figure 16). The building is L-shaped and was constructed in two storeys in log timber with the gables in timber-framing technique (Figure 17). It has panelling on the street front as well as a small, town-garden, in front of the house. There is a gate, with the first floor above, leading into the courtyard. A large garden adjacent to the house is called

Figure 16 Jedeureska huset with a red façade towards the courtyard (see the photo of *Dahlströmska huset* for the white front facade). Photo: A. Nilsen
