Vernacular Buildings and Urban Social Practice

Wood and people in
early modern Swedish society

Doctoral thesis
Department of Historical Studies, University of Gothenburg,
defended on the 18th of September, 2020

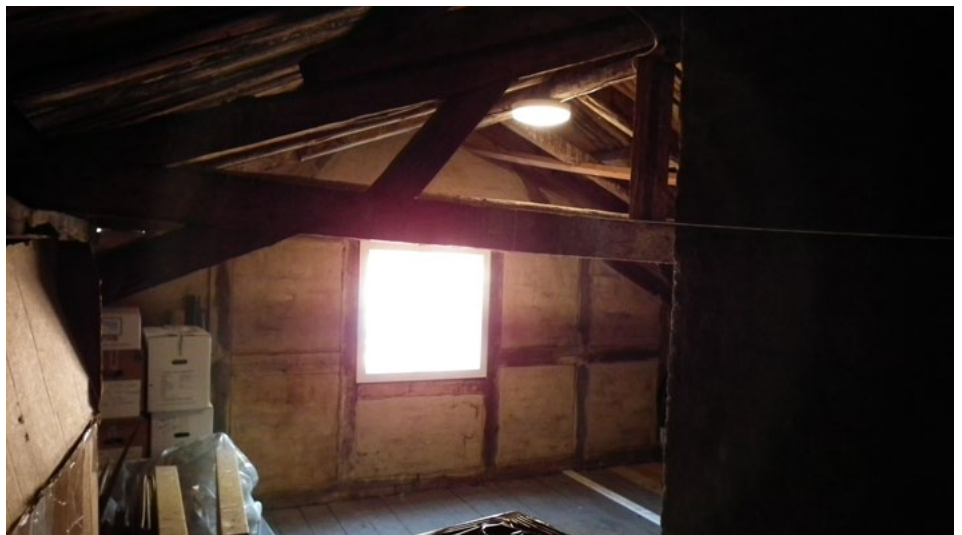
Figure 17 The timber-framed gable in Jedeureska huset, Gothenburg. Photo: A. Nilsen

The house called *Jedeureska huset*, is the next house down the street to the west of *Dahlströmska huset* (Figure 16). The building is L-shaped and was constructed in two storeys in log timber with the gables in timber-framing technique (Figure 17). It has panelling on the street front as well as a small, town-garden, in front of the house. There is a gate, with the first floor above, leading into the courtyard. A large garden adjacent to the house is called

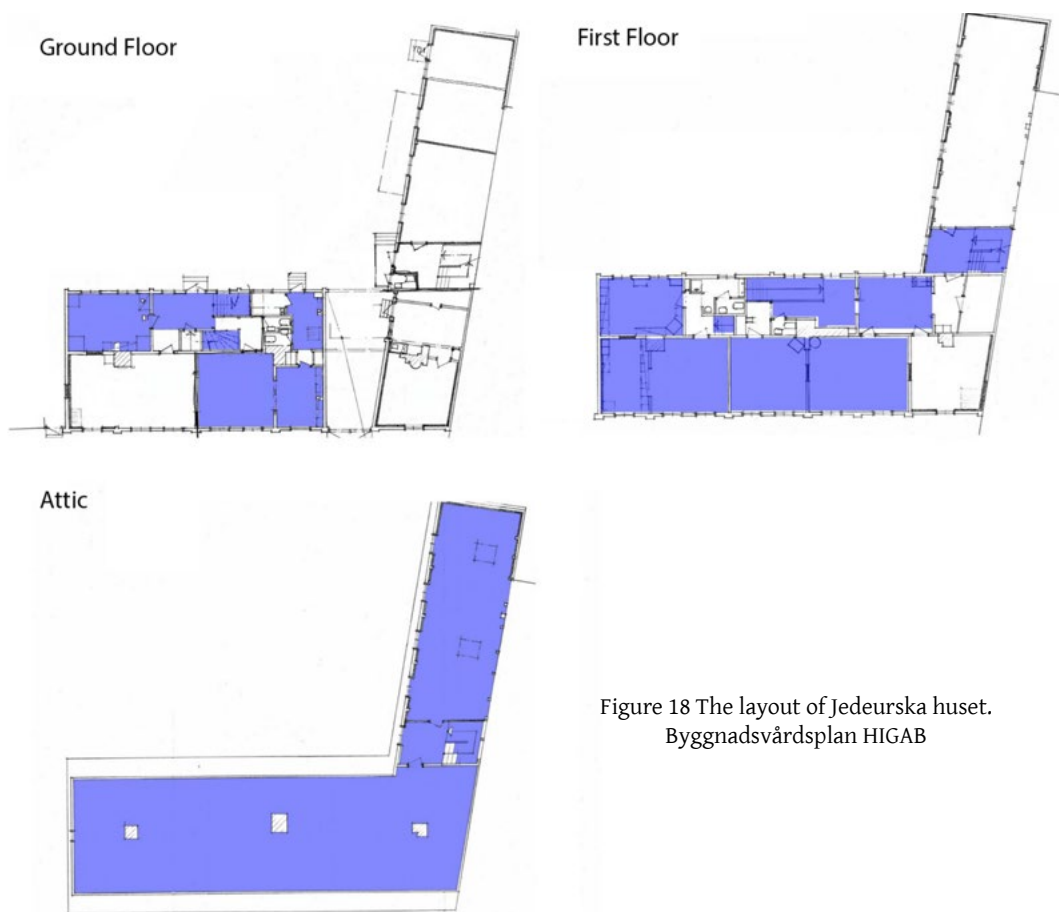
Figure 18 The layout of Jedeurska huset. Byggnadsvårdsplan HIGAB

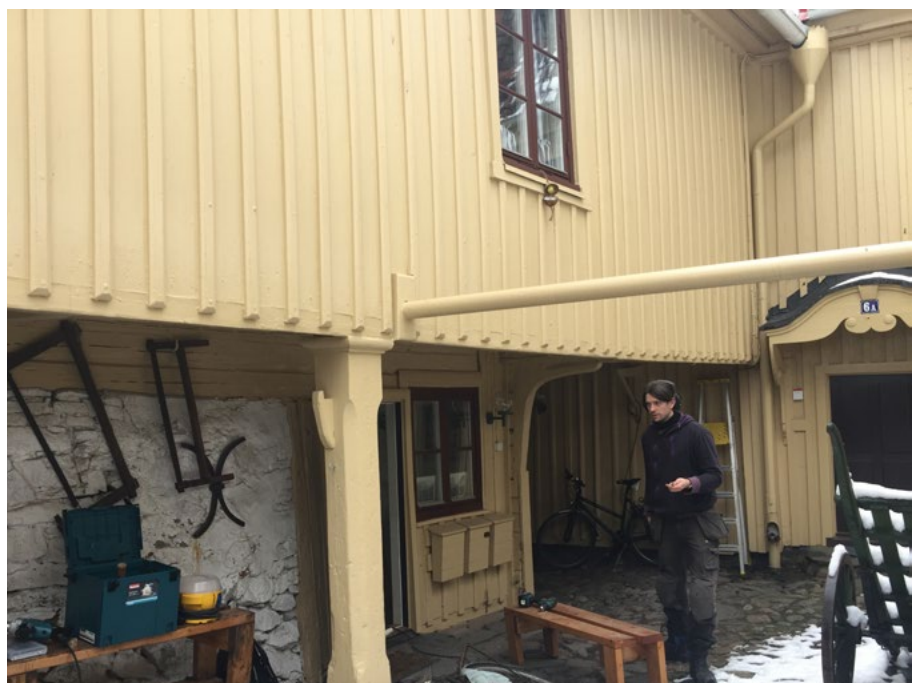
Figure 19 *Kullen*, with the pier holding up the closed balcony. Carpenter Ulrik Hjort Lassen who helped collect the wood samples for the dendrochronological analysis. Photo: A. Nilsen.

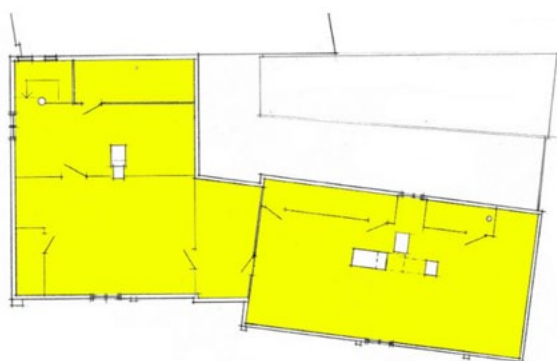
Figure 20 Layout of the floors in the house called Kullen. Byggnadsvårdsplan HIGAB.

The chamber has been altered into a modern kitchenette and toilet. There is an external staircase leading up to a jettied first floor. The jetty is strengthened by a pier (un-datable, possibly from eastern Europe, as mentioned above). The first floor has also seen a bit of modernization with a modern kitchenette towards the neighbouring house/gate room. There are three additional rooms, a storage unit, toilet and a hallway on this floor. The sizes of the rooms differ slightly from the rooms downstairs. All three rooms have ceramic stoves. The attic covers the entire house. This part of the house rests on a simple stone sill (no cellar).

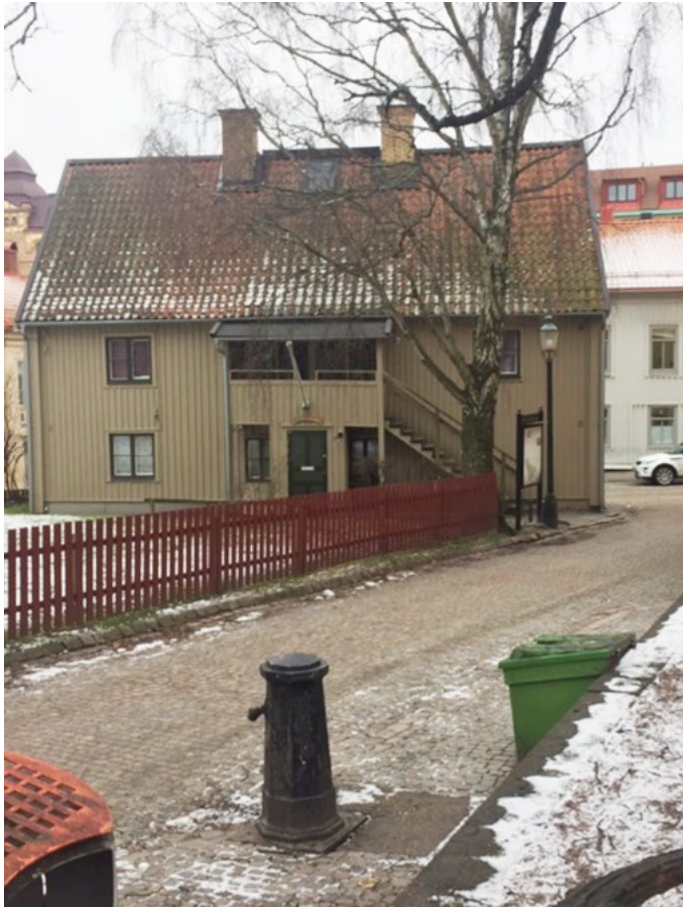
On the other side of the street Pölgatan and continuing along Allmänna vägen, there is the house called, *Hälleberget A* (Figure 21). It is a two-storey building with a stone cellar. Today the entrance goes through an external stair and a balcony on the back of the building, built in the 1920s. Originally, however, the entrance went through the front of the building with a flight of steps leading onto the main road, Allmänna vägen. Those stairs are now gone but the door is still there but not in use.

Figure 21 Hälleberget A towards Pölgatan. Photo: A. Nilsen

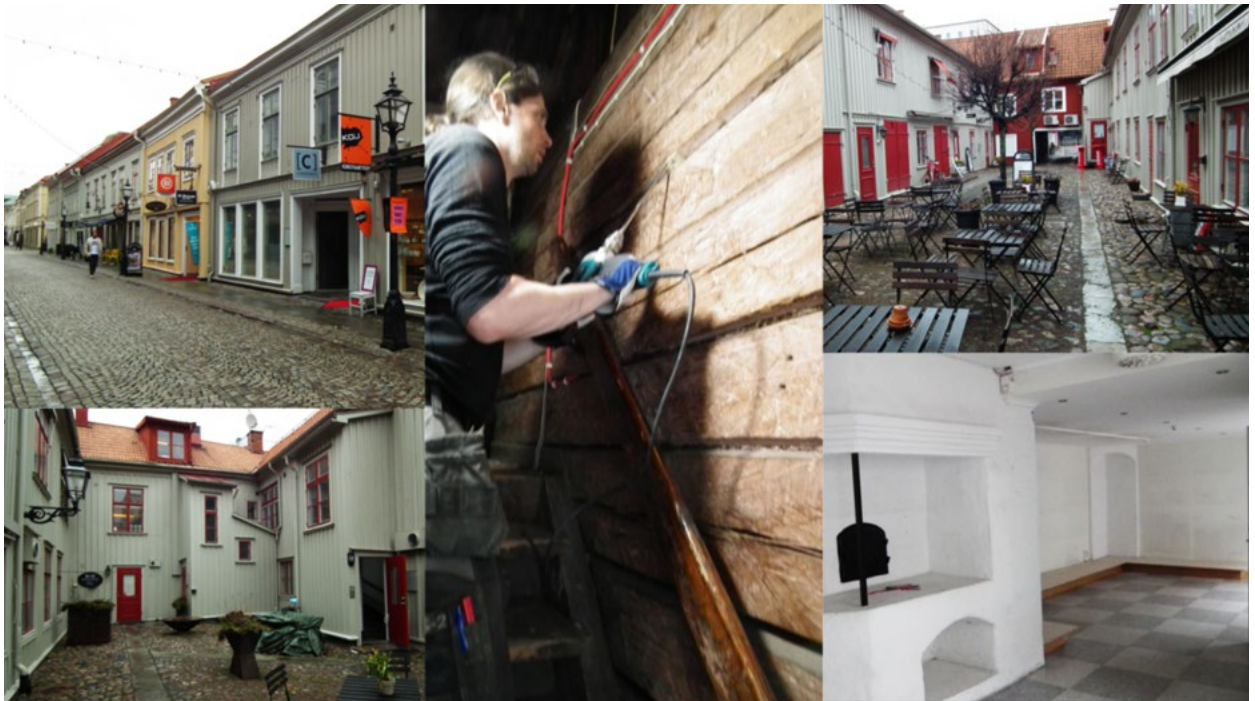
The house on *Smedjegatan 22* is typical for a Swedish burgrave plot within the commercial centre of town (Figure 23) an L-shaped two-storey house, which formed part of a row of houses around an inner courtyard. The house was believed, prior to this study, to have been built in 1700 and then altered in the late 19th century (Hallberg 1989: 59–60). The entrance to the building is situated directly onto the street with a shop front with large windows (a late addition). Behind the shop to the left of the entrance there was a former kitchen with a very big fireplace and in one corner a recess for a ceramic stove. The gable of the inner room was made of stone masonry. Access was originally not given to the first floor in that part of the house.

Dendrochronological analysis reveals that the building was built in log timber with pine. The first sample from the ground floor has been felled sometime during 1802-1826, but most likely in 1807/1817. Sample two had an uncertain dating. The samples from the first floor and the attic point towards a felling during the winter of 1815/16 and the building was most likely erected in 1816, or soon thereafter. The wood has been taken locally from a forest in the county of Jönköping or south Östergötland (Hansson and Linderson 2018f). The previous dating to the beginning of the 18th century is thus a miscalculation of more than a hundred years and there was no evidence within the wood core samples of the assumed rebuild in the end of the 19th century.

Figure 23 Smedjegatan 22 in Jönköping and carpenter Ulrik Lassen drilling for wood core samples. Photo by A. Nilsen

The house on Smedjegatan 22, is situated with its street front towards a busy merchant street and has two shops on the ground floor today. The traditional look of the surrounding houses within the burgage plot suggested potentially old buildings, analysis of the dendrochronological samples provided results for a much younger construction than expected which was around 1807/1817. The ground floor and

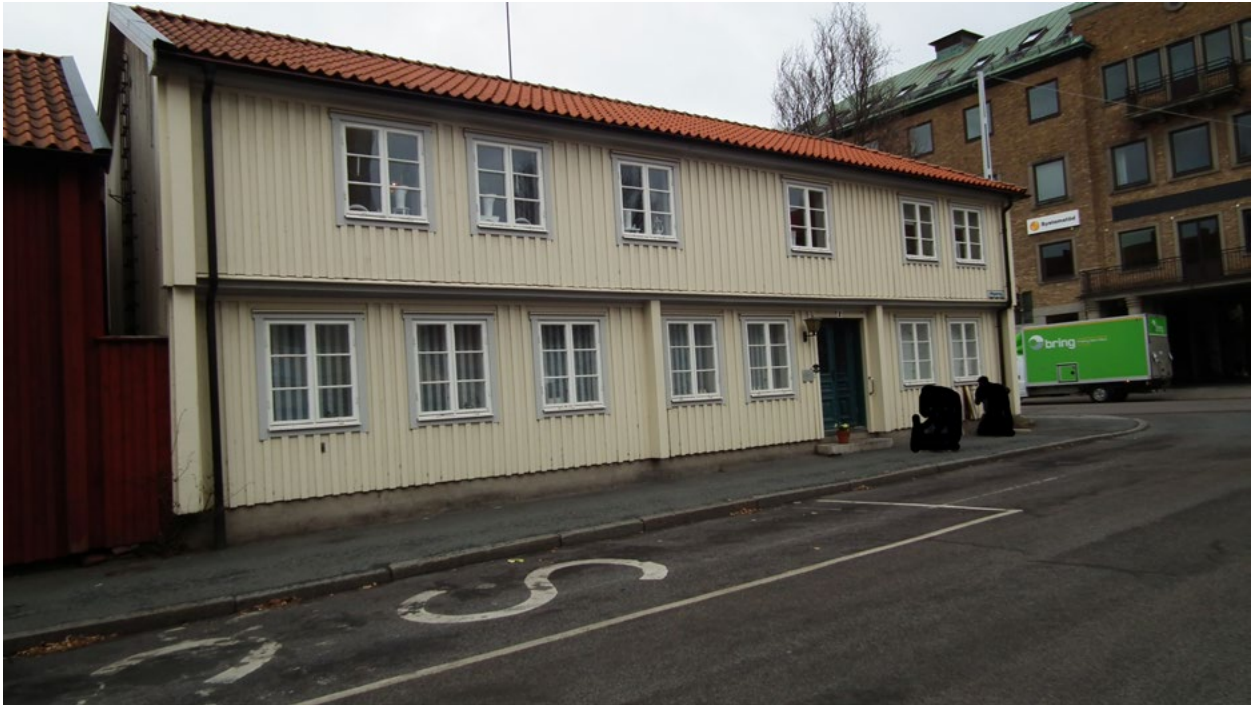
The house was previously located at Östra Storgatan 76 but was relocated to Ulfsparrgatan 2 and restored in 1961-63 (Figure 25). It is a building with two levels with yellow panelling. It has a slightly jettied first floor and has been interpreted as likely originating from the first half of the 18th century (Hallberg 1989: 68). The interior of the house has been altered and modernised (Figure 26).

Figure 25 Ulfsparrégatan 2 in Jönköping. Photo by A. Nilsen.

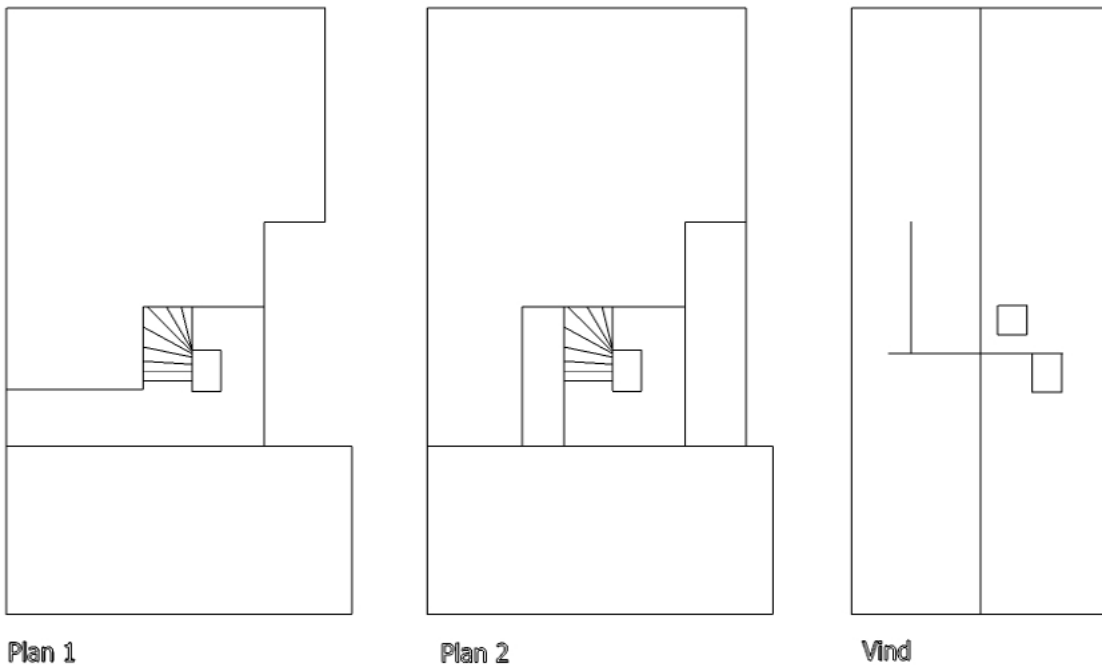
Figure 26 Ulfsparrégatan 2, layout. By Ulrik Hjort Lassen.

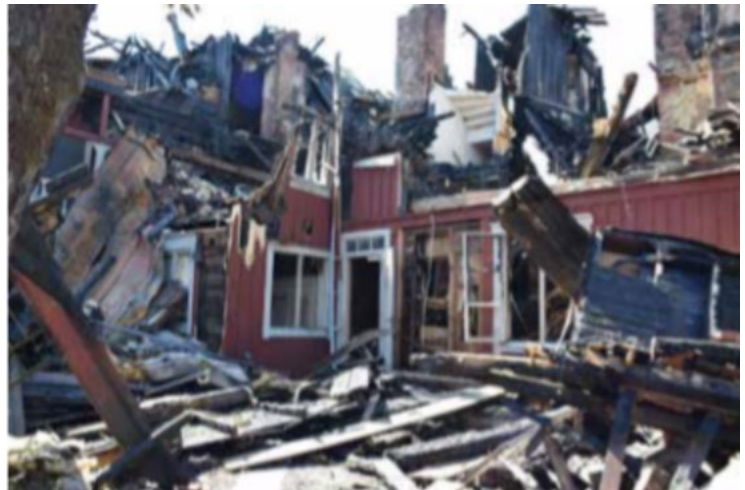
On the 16th of August in 2015, a violent fire destroyed the burgage plot Forssellska gården, with one fatal outcome (Figure 27). In the aftermath of the fire, the building antiquarian Britt-Marie Börjesgård managed to document those parts of the house, which were not completely destroyed, before the building was torn down.

Figure 27 Forssellska gården after the fire (Börjesgård 2017: 8).

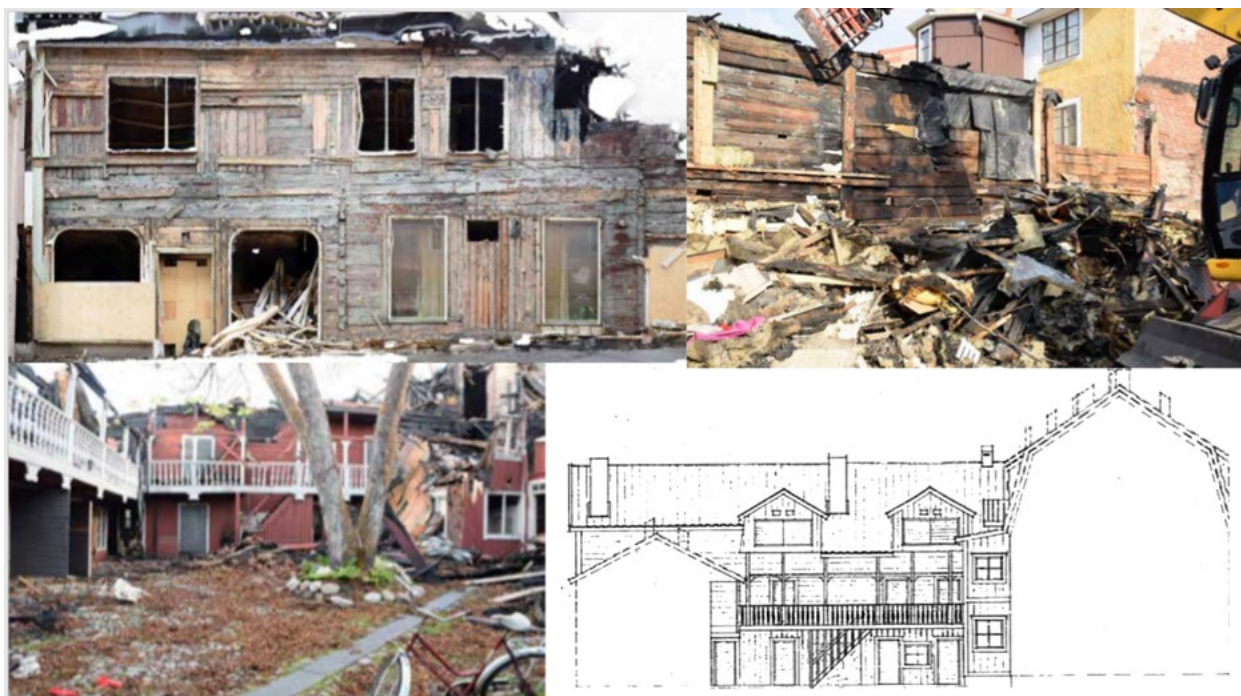
Figure 29 The image at the top left shows the patchwork construction behind the panelling. The image at the top right shows the post and plank construction. The two images in bottom depict the inner courtyard with balconies in Forsselliska gården in Eksjö. (Börjesgård 2017).

The house towards Norra Storgatan was the oldest and the most complex building (Figure 29). The ground floor was constructed in log timber technique, while the first floor was constructed from a patchwork of vertical and horizontal planks. The gable towards *vreten/dropprummet* (the space, between two buildings in adjacent properties, wide enough to ensure that roof drippings did not fall on the neighbouring building) was built in post and plank technique. There were several shopfronts facing onto the street (Börjesgård 2017: 30–33). The northern gable was constructed in log-timber and interestingly the timbers on the upper floor level were longer, 6.53m, than the timbers on the ground floor, 4.8m. The projecting timber had a hole underneath that might be a trace from a post. On the top of the timber there was a mark from a head of a log-timber construction. Together, this might indicate that the timber had been the base of a balcony. The projecting timber was 1.82 m from the wall beneath. In the northern part of the building the ground floor was scientifically dated to 1655 while the first floor had subsequently been added in the 1770s (Börjesgård 2017: 38, 40). Seventy-six samples were sent to the lab, only three samples were of spruce; the rest were pine (Hansson and Linderson 2017).

Forsselliska gården, is interesting for the patchwork constructions hidden behind panelling, the mix of building techniques, the possible remains of a balcony and the associated pier, possibly archaeologically recoverable in the ground. The courtyard comprised four rows of houses around a courtyard, one of the houses was two-and-a-half storeys while the others were two. The pad stones of the buildings' foundations differ in size and construction. The oldest came from a building with a ground floor from 1655 with a first floor later added in the 1770s. The eastern building was erected in the 1840s and a further building dates from the 1830s; the buildings built in post and plank do not seem to have been dated. It is possible to follow how the urban environment became slowly more dense over time. The timbers in the construction are almost entirely pine and many of these timbers seem to have been re-used.

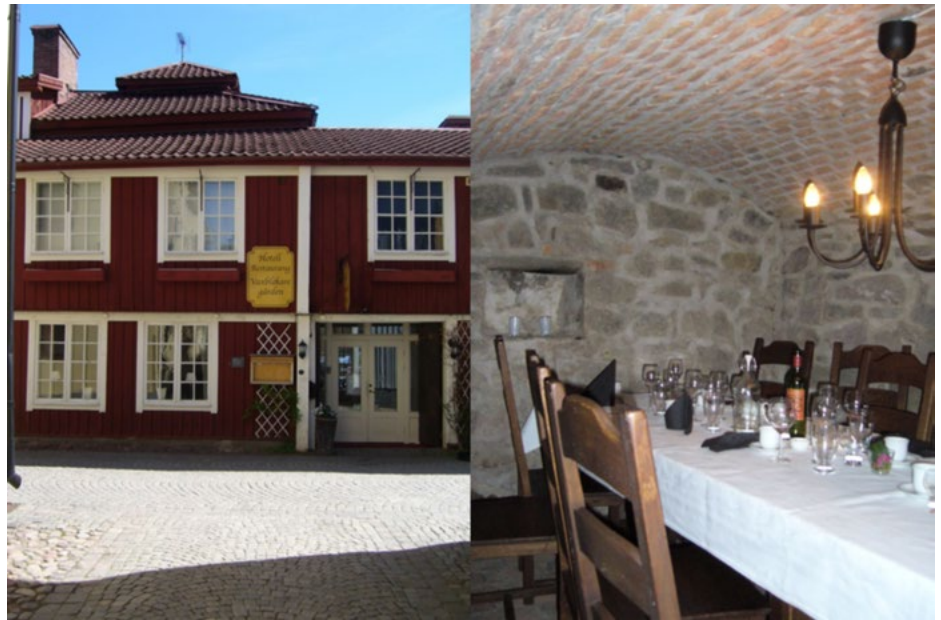
The burgage plot called Vaxblekaregården (presently a hotel) is a two-storey, jettied house with, for the area, an unusual roof construction consisting of a hipped roof with an inserted wall-line, raising the upper part of the roof from the lower (*Sw. valmat tak/säteritak*) (Figure 30). The house has a large stone cellar with a vault, similar to the medieval cellars in central Stockholm. The house was constructed from pine logs of the highest quality (the wood being at least 300 years old), and collected from forests north of Eksjö (such as Göberga gård in Tranås). The interior and layout of the house has been heavily altered during the 20th century.

Figure 30
Vaxblekaregården, Eksjö
with a jettied first floor
and an unusual roof.
Photo: A. Nilsen.

The walls of the house and wall paintings have been dated through dendrochronological analysis, which indicated that the building was built after 1706/07. There are two wood samples with older datings - 1687 and 1647 - which are thought to be reused wood within the construction (Linderson 2002a). The paintings were of the five senses and are now part of the collection, and on display at, Eksjö museum. The burgage plot has been associated with various crafts during the 17th century i.e. tailor and pearl-stitching and in the 19th century it was turned into a wax bleaching industry (the only one in the country outside of Stockholm) (Agertz and Grandelius 2003).

Vaxblekaregården is a two-storey building with a jettied first floor and an unusual roof. Added with the large and professionally crafted vaulted cellar and the beautiful wall paintings the house gives an impression of a well-to-do burgage property from the first decade of the 18th century. The wood used in this log-timber building was of the highest quality and predominantly pine.

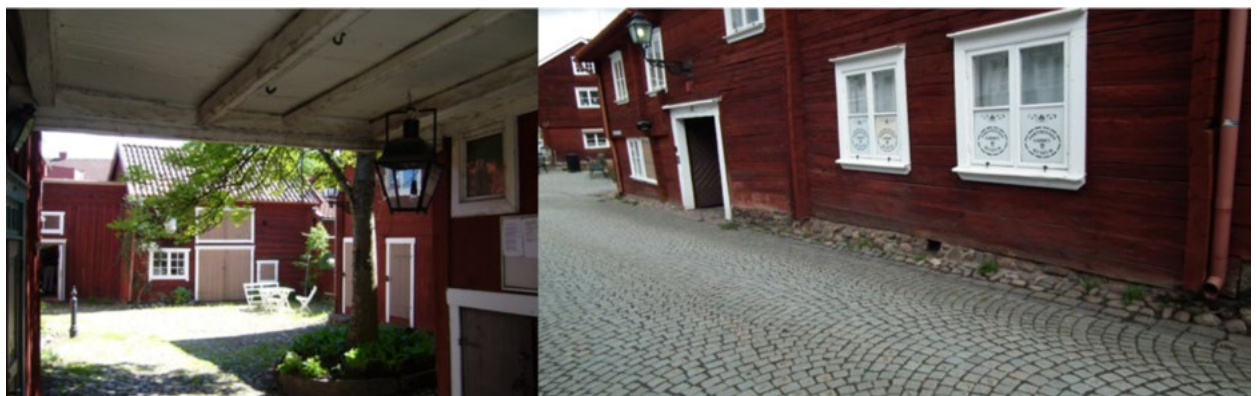
The burgage plot called *Fornminnesgården* is a jettied two-storeyed row of houses, connected in an L-shape around an inner courtyard, constructed in log-timber technique of pine (Figure 31). Additional outhouses complete the circle around the yard. CTH/ Byggnadsvård did a lot of research into fire insurance records and other historical sources in 1998/99 (Figure 32) relating to changes to the property over time (Berger et al. 1998).

Figure 31 Fornminnesgården in Eksjö. Photo by A. Nilsen

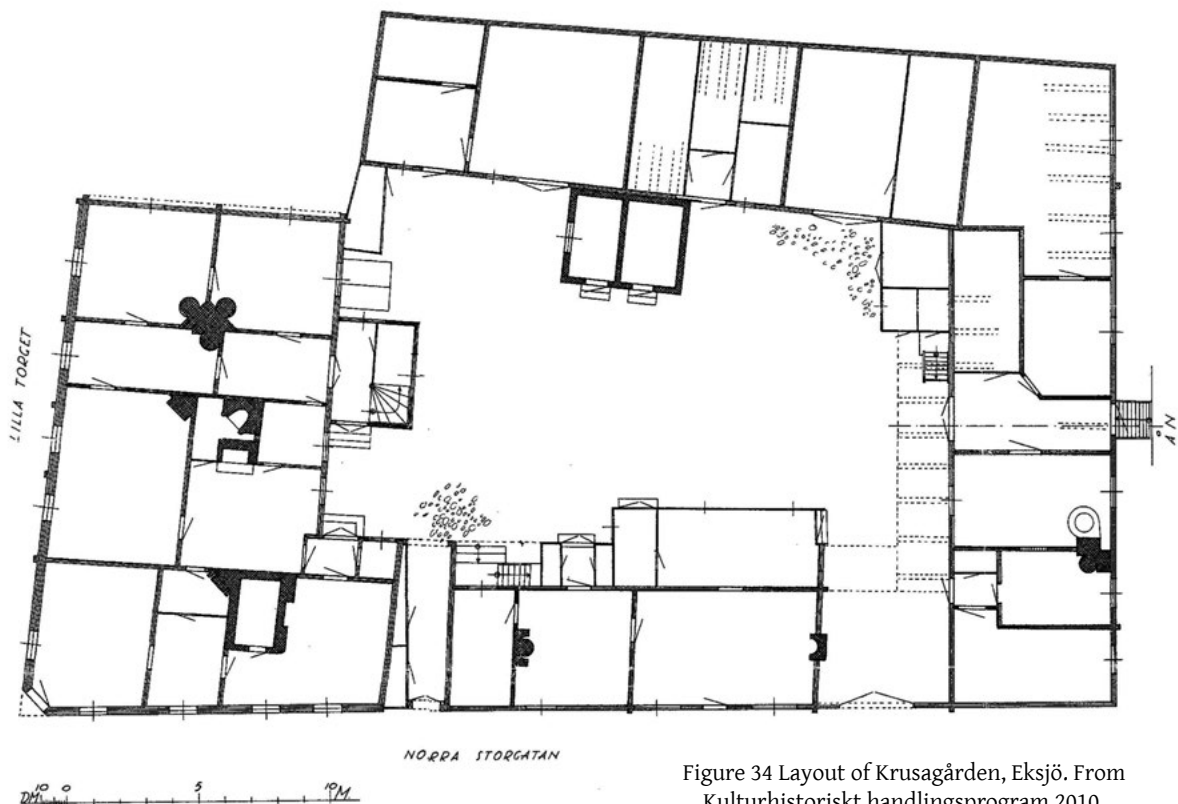
The burgage plot *Krusagården*, is a two-storeyed log-timber building surrounding an inner courtyard (Figure 34). King Gustav VI Adolf planted an oak in the courtyard while on his coronation tour of Sweden in 1954, which is still there. The building has a first-floor open balcony, built during the 19th century. There have been various

Figure 34 Layout of Krusagården, Eksjö. From Kulturhistoriskt handlingsprogram 2010.

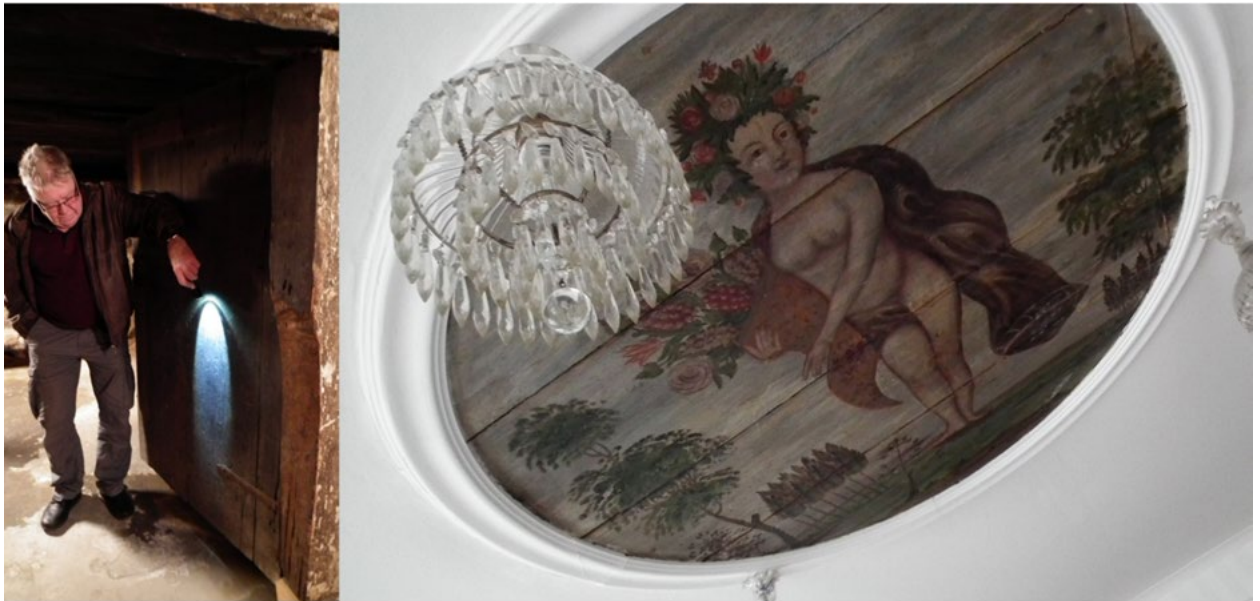
Figure 36 Lennart Grandelius showing on an imprint on a door in the cellar. A painted ceiling on the first floor, Kv. Vinskänken 2, Eksjö. Photos A. Nilsen

The samples can probably be seen as cluster sampling from the building pointing to a long building history with the attic added quite late in its existence (Linderson 2016). More samples on the lower floors would clarify this. The flat on the first floor had a beautiful painted ceiling and on the ground floor, there is a shop.

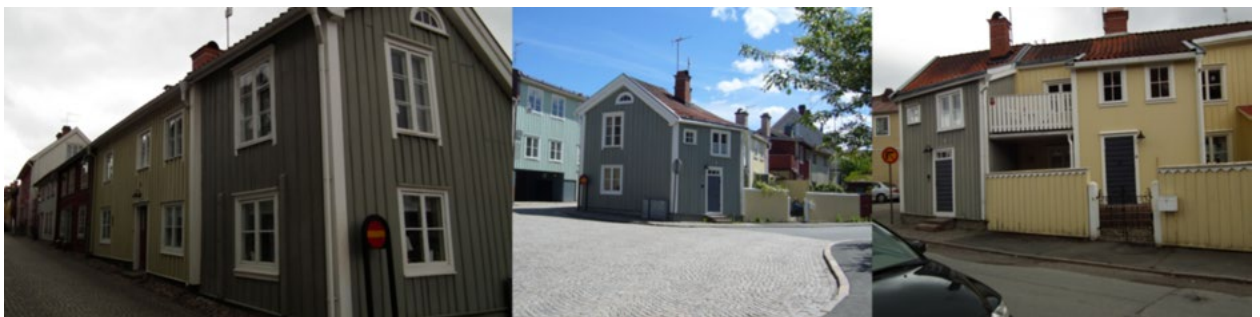
There are two, two storeyed houses at *Boktryckaren 9-10*, that Lennart Grandelius has taken samples for analysis from and subsequently generously shared with me. For clarity, let us call them ‘*the corner house*’ towards Västerlånggata and Nygatan, and ‘*the street house*’. situated on Nygatan (Figure 37). The

Figure 37 Boktryckaren 9-10, Eksjö. Photo by A. Nilsen

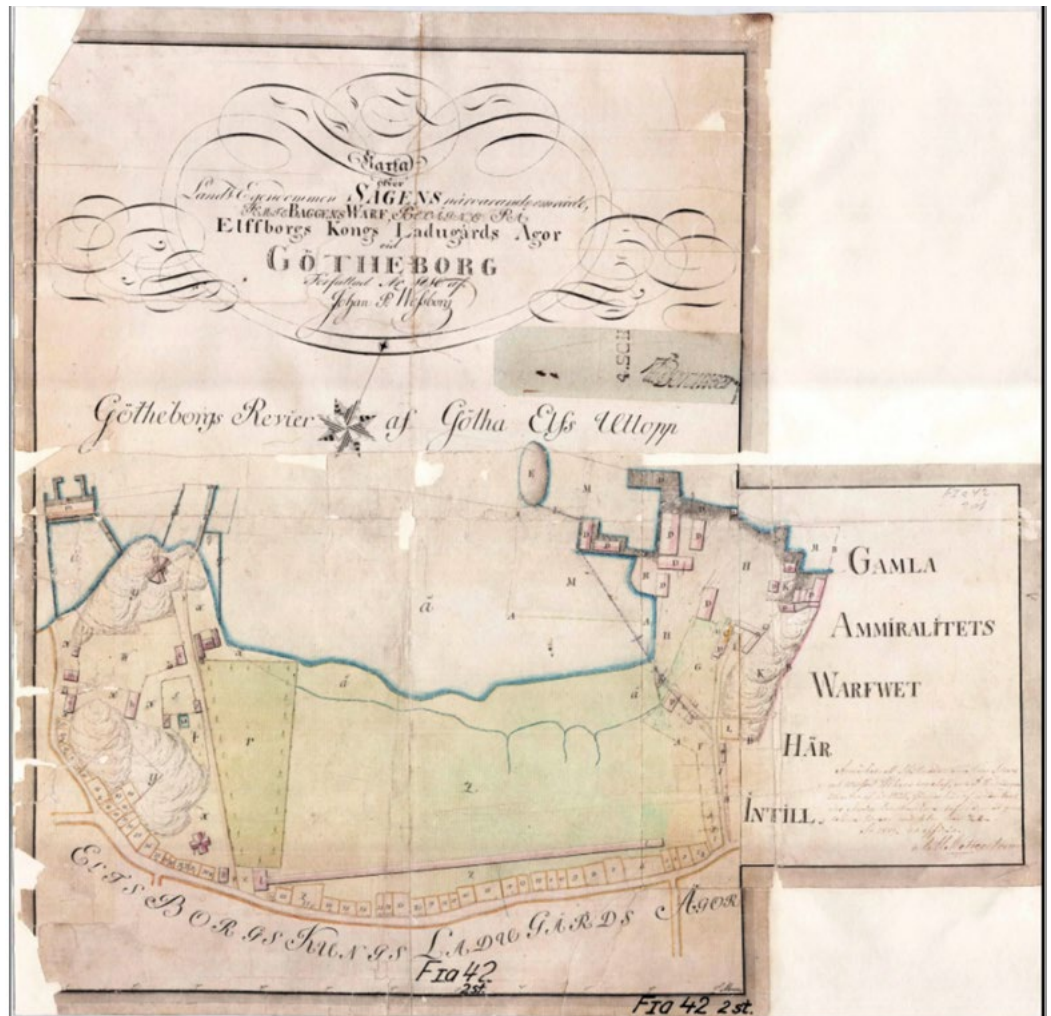
Figure 5 Example of plot charters from fire insurance records from 1816, from the property Sågen on the land of Elfsborgs Kungs Ladugård close to Gothenburg (i.e. in Majorna).⁹

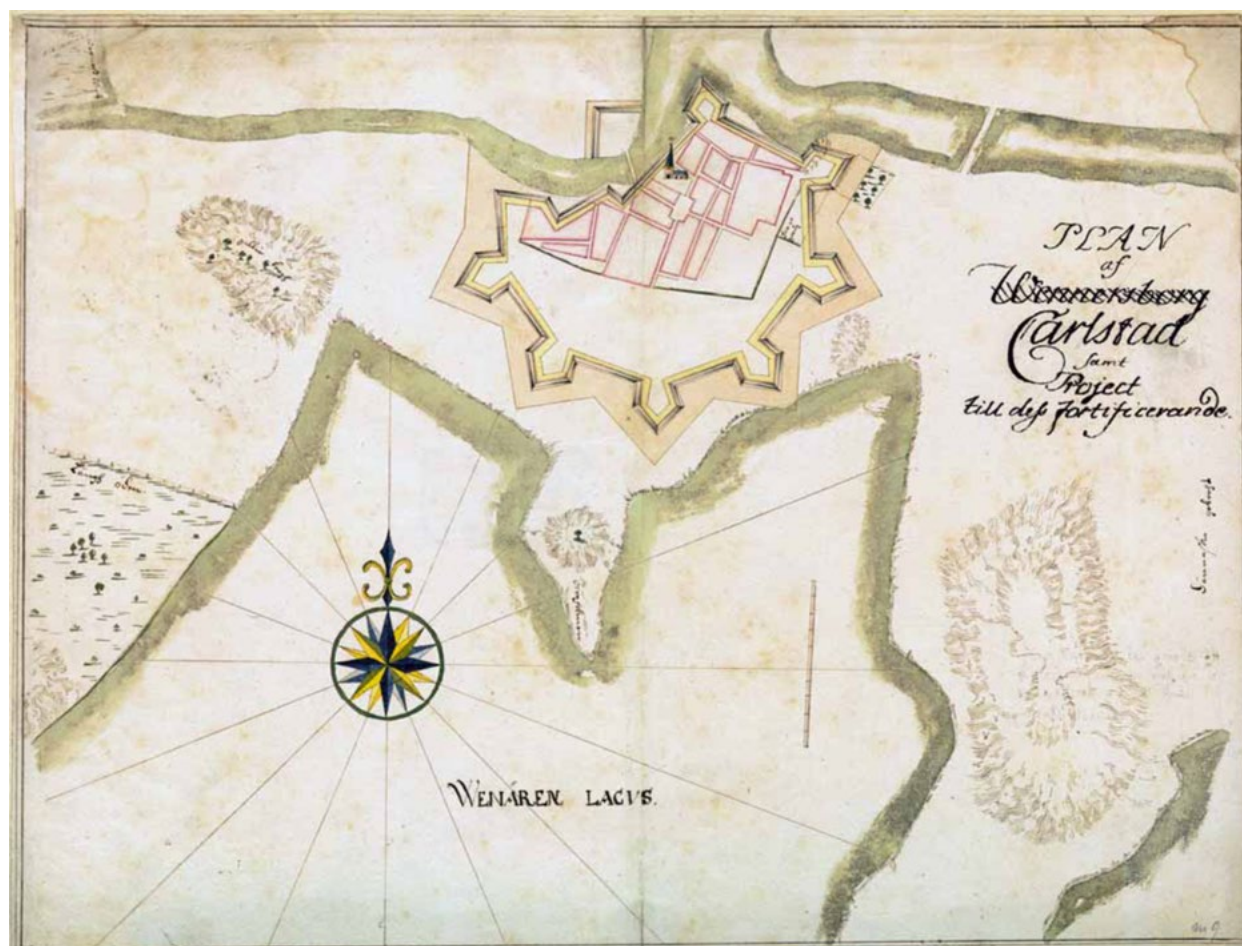
Figure 1 5 Karlstad. A drawing of how Karlstad should be fortified from the 22nd of April 1648. Mattias Monson Blom. The War Archive.

wet to build on (Nilsen 2013: 68–74). Karlstad suffered the same problems as Jönköping, it did not get the city wall that had been planned and it could not fully develop the city to its intended size due to problems with marshy underground, nonetheless, its street grid was regularised (Nilsen 2013: 74–82). One of the plans for the town formation and fortification of Karlstad had been reused, the name of the town Vänersborg had been crossed over and Karlstad had been written instead (Figure 1) (Nilsen 2013: 75).¹

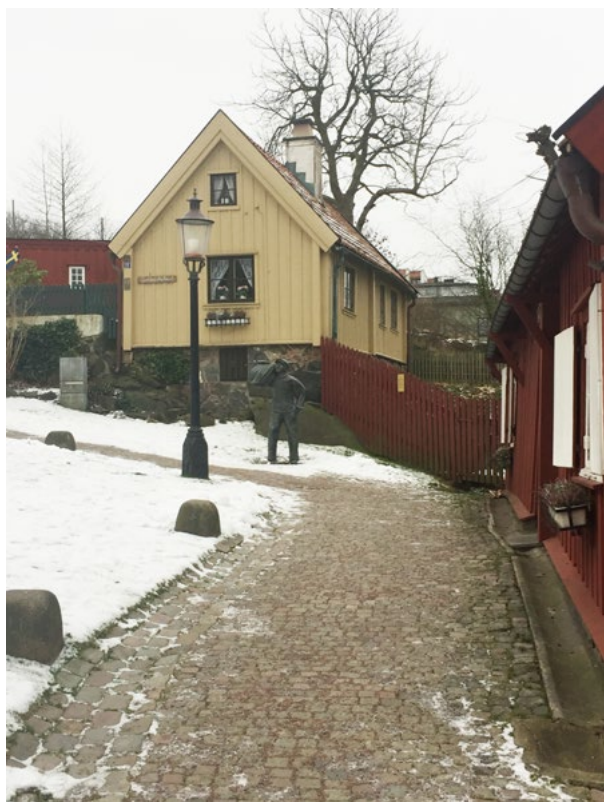
Figure 2 As an example, see this small wooden building on top of a substantial cellar. Gatenhielmska reservatet Gothenburg. Photo: A. Nilsen.

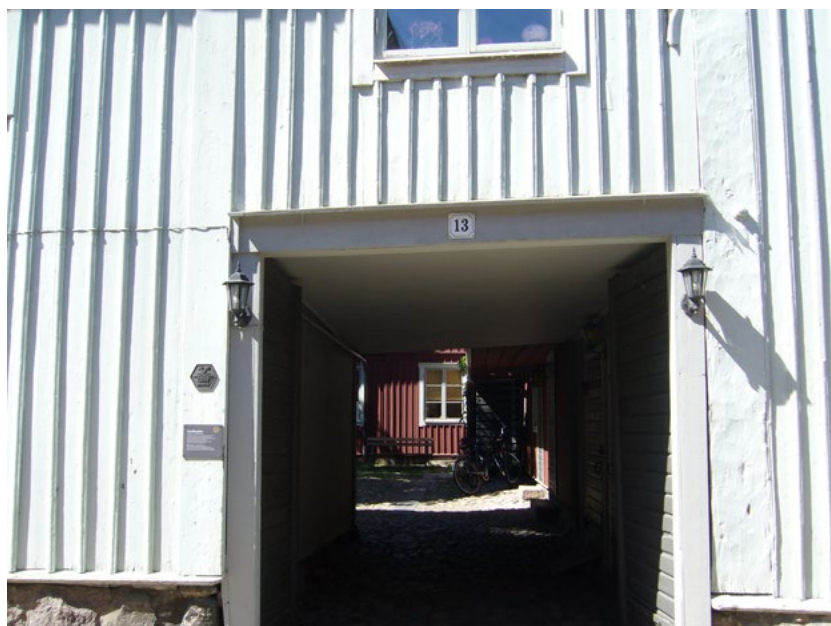
Figure 3 A covered passageway with living quarters on top, Forssellska gården, in Eksjö, before the fire. Photo A. Nilsen.

The covered passageways were foremost constructed in log timber technique or timber-framing technique, apart from stone- and brick buildings.

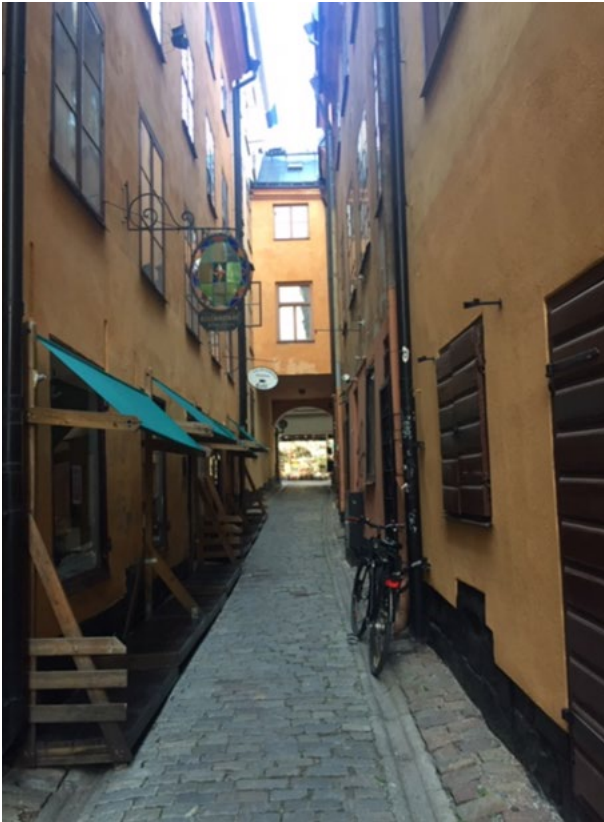
Figure 4 A covered passageway to an alley, Stockholm.
Photo by A. Nilsen.

Another way to produce more space can be seen in for example Visby and Stockholm where frequently two buildings were joined over alleyways gaining some extra space (Figure 4).

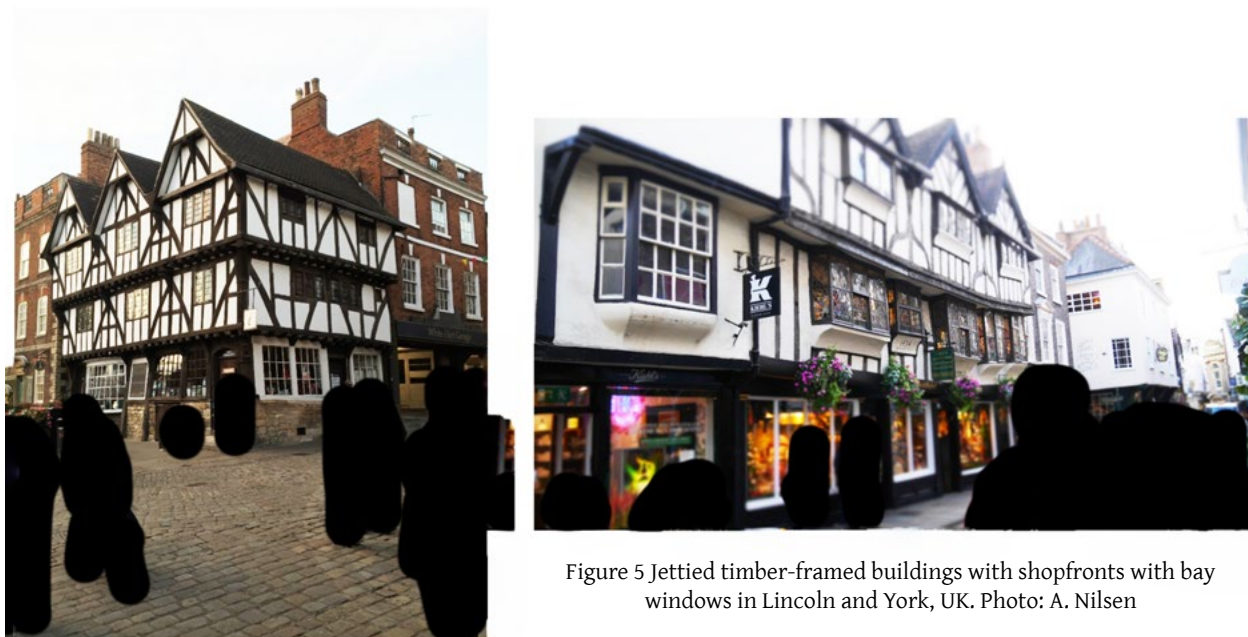
Figure 5 Jettied timber-framed buildings with shopfronts with bay windows in Lincoln and York, UK. Photo: A. Nilsen

Jetties were a common feature of the early modern house throughout Europe. There was a wider use of jetties on log timber buildings and timber-framed constructions than on post and plank buildings. The only example of a jettied post and plank building within this data, is the building *Apoteket 5* in Visby. It is a building with a ground floor constructed in stone and a first floor in post and plank, which protrudes from the ground floor in a jettie-like way. It does seem as jetties were foremost used for residential houses. Examples of the practice can be found in *Kullen* in Gothenburg as well as in *Vaxblekaren 13* and *Fornminnesgården* in Eksjö, all of which are log timber buildings. The photographic evidence of timber-frame buildings also has many examples such as the *Burmeisterska* timber-framed house in Visby or *Burmeisterska huset* for that matter, which is a building with mixed techniques with a jettied

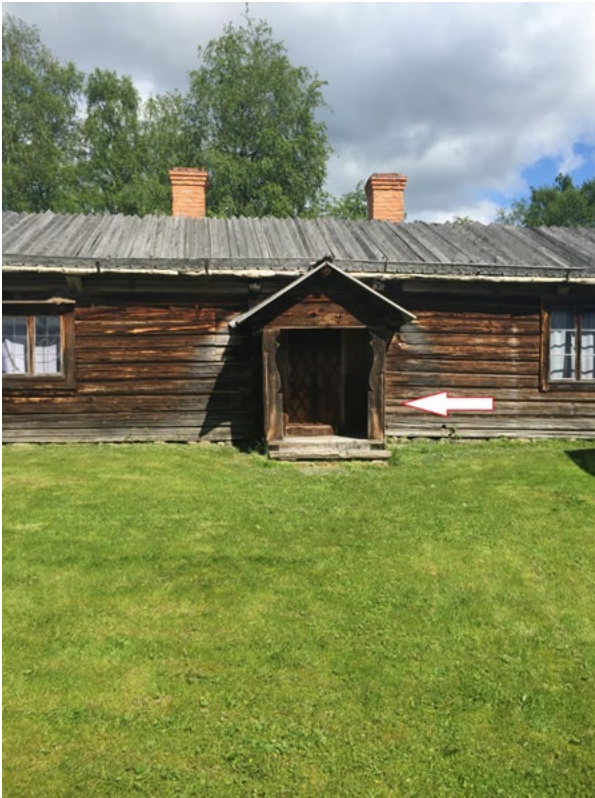
Figure 6 Bislag or porch i.e. a covered superstructure often including a bench to sit on, either side of the entrance.

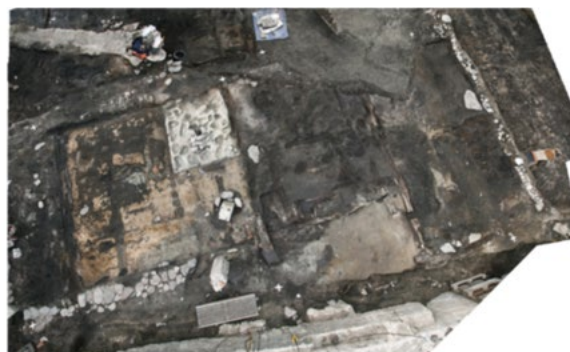
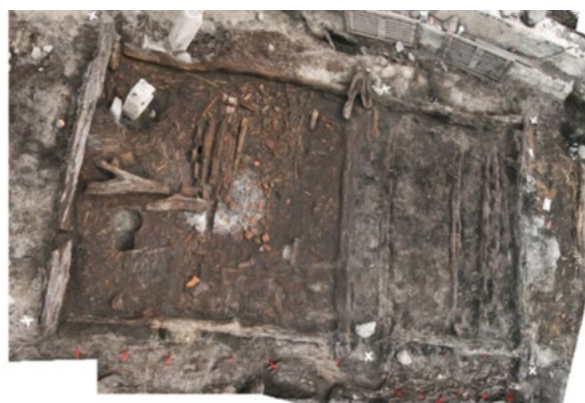
Figure 1 Two photos of 1:2:1 showing the layout and building technique and the corner fireplace, as well as the soleplate of the building. Photo The Nya Lödöse project 2013.

This is a house, dated to 1470-1480, that was built in a mix of techniques with six rooms and a storage unit, in total measuring c. 12.0 x 6.5m *Figure 1*. Towards the street there were two shops, rooms A c. 3.1 x 2.8m and B c. 3.0 x 2.8m, both constructed in timber-frame technique with a whitewashed façade and with wooden flooring. However, one room had previously had a clay floor; there were also the remains of what could be window glass. The shops did not have fireplaces; they had an entrance from the street. The rest of the building, rooms C-G, have been constructed in log-timber technique. Room C was a closed porch (entrance hallway) measuring 3.7 x 1.9m, which was insulated with a layer of sand and a wooden floor patched up with clay as well as a few sill stones that were used under the corner-notches. Next to the porch and adjacent to the shops was room D, a storage room with a clay floor measuring 3.7 x 2.0m. It had odd sill stones under the corner notches interpreted as a possible larder. There was also a drainage towards the *vret*, which is the Swedish word for a gap between buildings in close proximity, interestingly enough, frequently used for all sorts of activities. Another word for the same space is *dropprum* (*perhaps more used on the east coast*), which refers to the space and distance needed between adjacent buildings to minimise damage from rainwater dripping from one roof on to the other. Room E was the main room/ parlour, where all everyday activities took place and where everyone living in the premises slept (at least during the cold winter months) measuring

4.5 x 4.5m. The room had an insulated wooden floor, a fireplace and there were traces of window glass. Apparently, there were no sill stones supporting the main room. Room G identified as a storage room insulated with squares of peat with a layer of sand on top measured 1.7 x 2.6m. Room F had a levelling layer of sand and above that a wooden floor 4.5 x 3.3m (Öbrink and Rosén 2017: 83, 126).

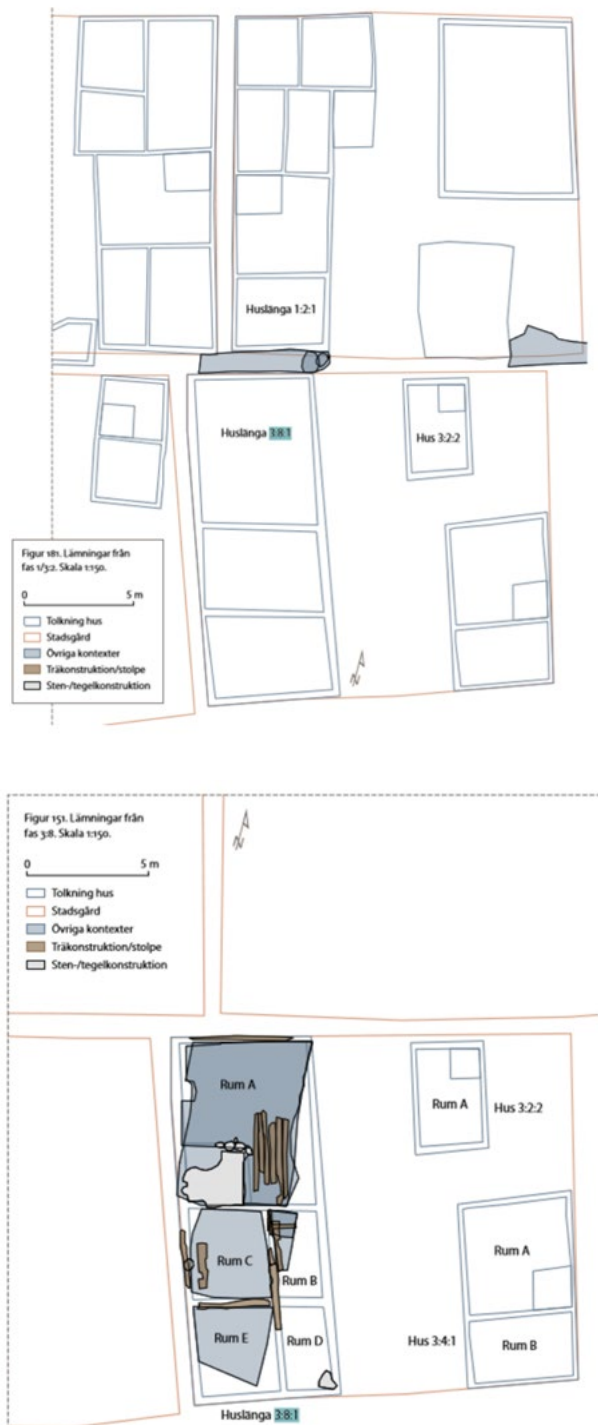
Figure 4 Building 3:8:1 in Nya Lödöse (Öbrink and Rosén 2017:233, 294).

This building was slightly more recent, from the beginning of the 16th century and was possibly built in log-timber technique (Figure 4). The house went through two conversions. Originally, there were three rooms, one main room and two slightly smaller. The first conversion divided the two smaller rooms into four rooms, thus creating enclosed porches/entrances to each room. Room A was, to begin with, built as a main room or parlour, but was in a third phase converted into a byre measuring c. 5.3 x 6.5m. Initially, the room had a wooden floor insulated with sand, which was later changed to a beaten earth floor. The room had a fireplace with a chimney, but the room construction did not rest on sill stones. Room B was a closed porch with a wooden floor c. 1.8 x 3.6m in size. Next to the porch

was room C, a storage room/chamber c. 3.2 x 3.6m. It had a wooden floor with an older clay floor underneath. Room D was a second porch with a stone floor 1.8 x 3.5m. The last room, E, was another storage/chamber with a clay floor c. 3.2 x 3.5m (Öbrink and Rosén 2017: 85, 232).

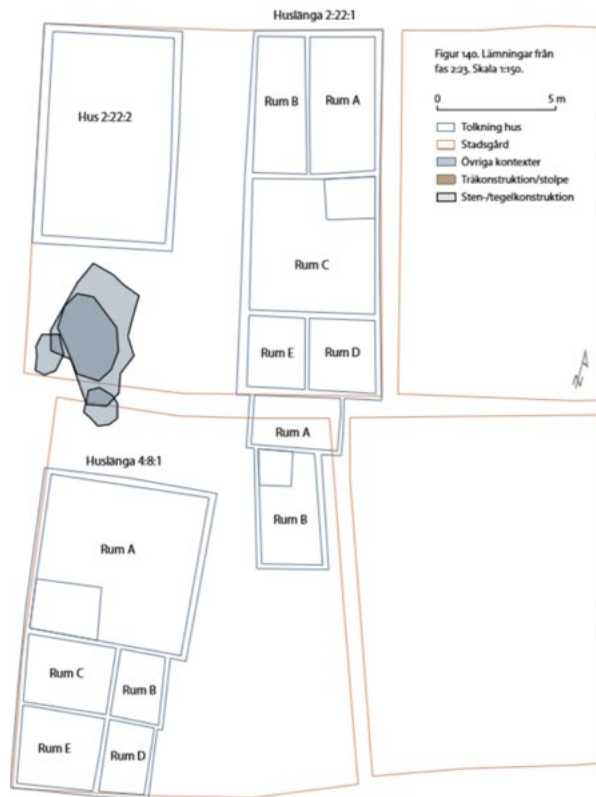
Figure 6 Building 4:8:1 in Nya Lödöse (Öbrink and Rosén 2017:211).

This is a five-room log-timber house, 13.5 x 5.8-7.3m in size, with the traditional main room/ parlour, porch and storage room (Figure 6). In addition, there were two shops or workshops as well, partly re-built from 4:3:1. The house was built sometime during 1560-1570s. The main room, room A, still used the old fireplace,

it did however have a wooden floor insulated with sand. The porch, room B, had no remaining floor. The storage room, room C, had a stone/tiled floor also with sill stones supporting the construction. Room D was a shop or workshop with no floor remaining. There was conceivably a paved entrance to the room. Room E was feasibly used as a byre with a clay floor layer. This room was re-built around 1587. The building was destroyed in a fire possibly in connection with the abandonment of the town in the 1620s (Öbrink and Rosén 2017, 269–80).

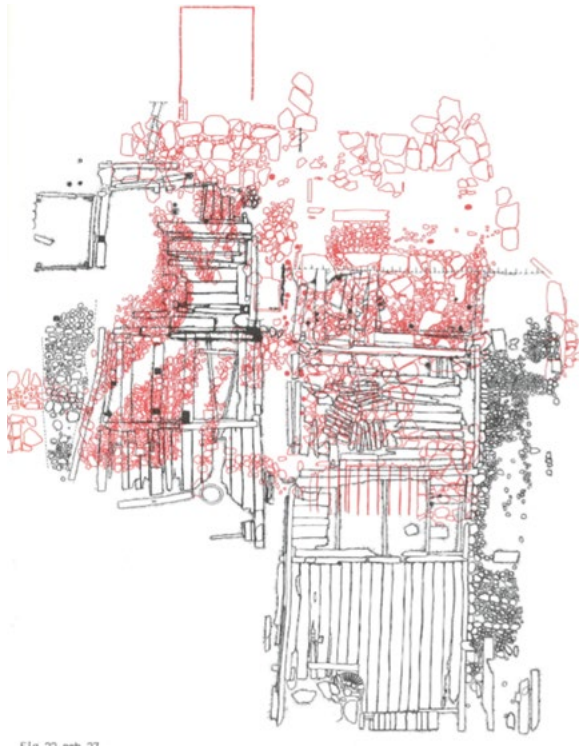
Figure 11 Plan of Site B. Building 1, phase 1, lying on beams supporting a plank floor. Between Sites A and B runs a cobble-stone lane. Phase 3 has a stone floor, divided into sections with surfacing of cobblestones, respectively flagstones. Plan of Building C:1, phases 1-2. The building lies on beams and boundary-stones and is partly provided with a plank floor. Phase 3 consists of a metallad yard or floor. Scale 1:100 (Lorentzon 1983).
