Vernacular Buildings and Urban Social Practice

Wood and people in
early modern Swedish society

Doctoral thesis
Department of Historical Studies, University of Gothenburg,
defended on the 18th of September, 2020

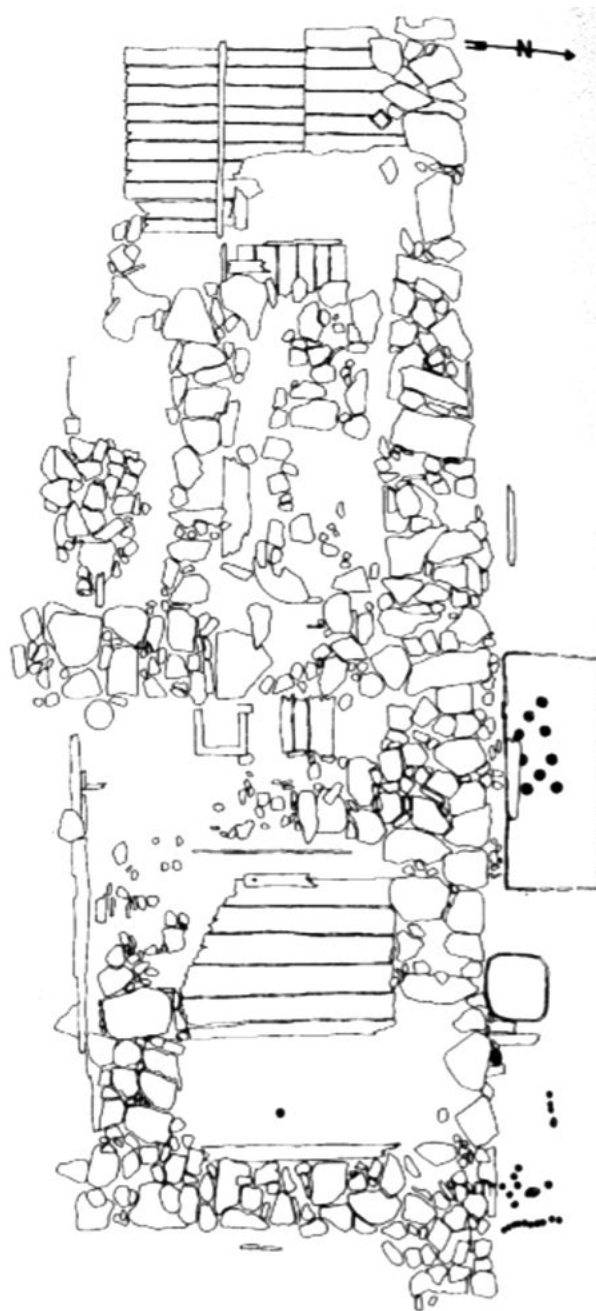
Figure 12 Building 3 in phase 2 consists of an elongated construction with a carbonized plank floor. Building 4 in phase 3 and 4 had a long stone foundation built in two stages (Lorentzon 1983).

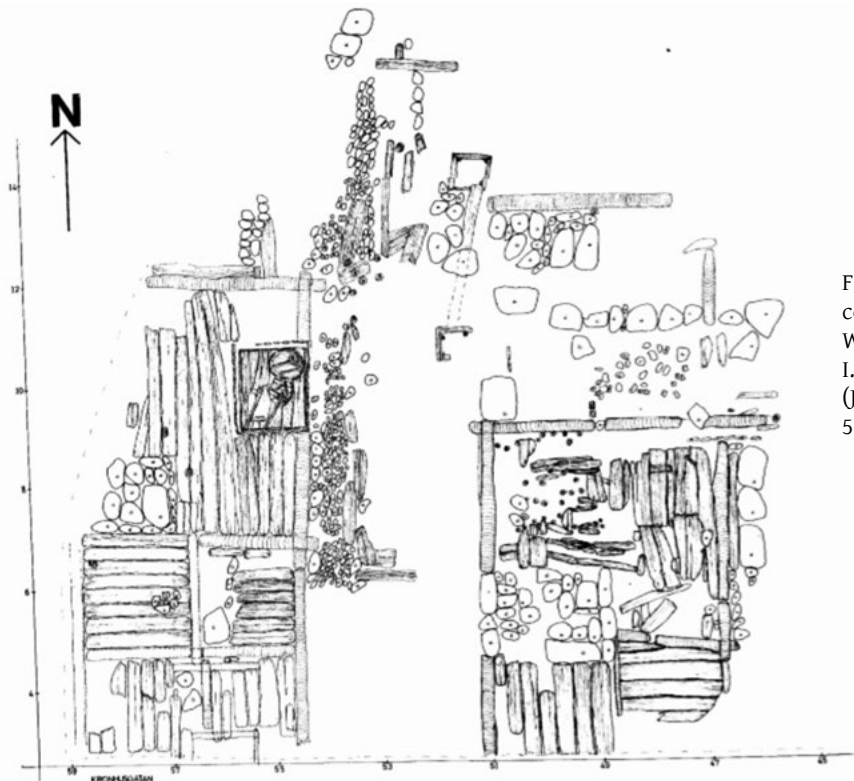
Figure 13 Kv. Enigheten, construction 15. The house in West and the house in the East I. Layout 1:100 EJ. SK. KO - 79 (Jönsson and Kihlberg 1981, 52)

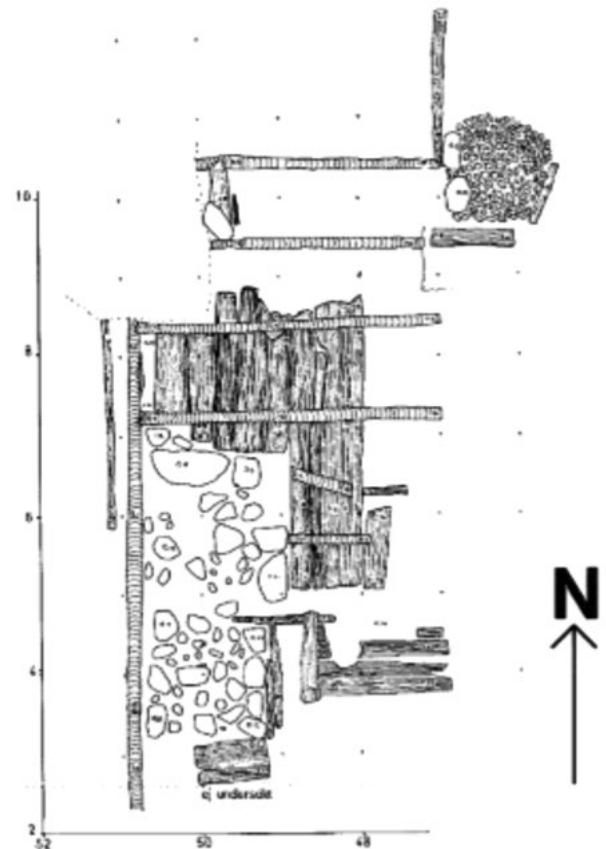
Figure 14 Kv. Enigheten, construction 15. The house in the east II. Layout 1:100 SK - 79 (Jönsson and Kihlberg 1981:57).

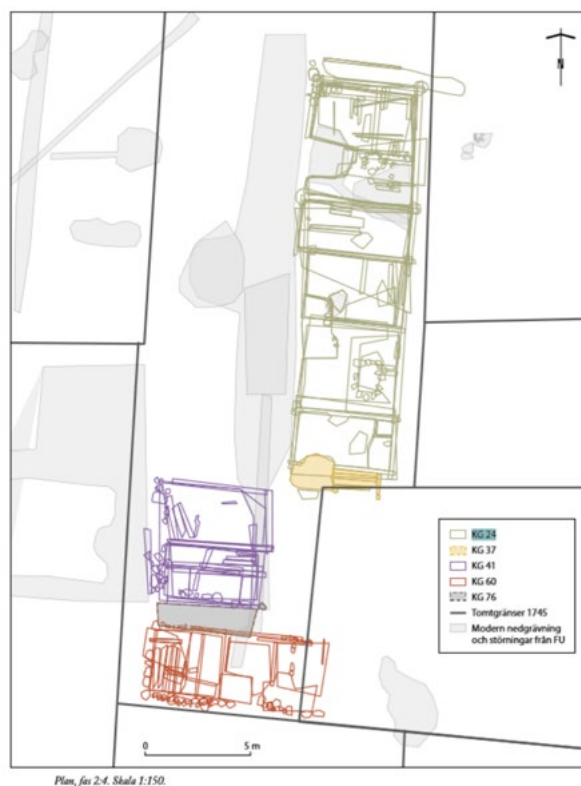
Figure 15 KG 24 in Kv. Dovhjorten (Bramstång Plura et al 2012).

KG 24 was a row of houses made up by KG 30-33 + KG 37 a privy (Figure 15). KG 30 was the room facing north, interpreted as storage or maybe a dwelling. The floor had been repaired on several occasions and was eventually built in two layers of wood planks with a layer of sand in between, possibly used as insulation. Some strengthening of the floor had occurred with additional clay perhaps as a way to bar off damp, new joists and some flat flagstones. There had been a fireplace in the southeast part of the room. There was no doorway connecting this room to the next (Bramstång Plura et al. 2012: 125, 31, 37). Perhaps this was a 'drängstuga' a servants' quarters? KG 31 was the next room, which was interpreted as a smithy or a workshop during the investigation, the entrance to the building had some metallised flooring. Part of the room had a remaining wooden floor. There was a fireplace in the southwest corner of the room, possibly a smithing hearth. The floor in the rest of the room resembled KG 30 with three layers of wood flooring and beneath that a clay floor, suggested to perhaps have worked as a barrier for damp. If it is not a smithy it might be a regular residential parlour (Bramstång Plura et al. 2012: 126, 35). KG 32 was a room interpreted as a kitchen with a clay floor and some large flagstones, the archaeobotanical analysis also points to its use as a kitchen. There was an entrance to the room in the south wall. The foundation for the fireplace in the smithy was connected to the stove in the kitchen, possibly indicating a cast iron stove (Sw. *biläggaruån*) (Bramstång Plura et al. 2012: 112). KG 33 had several traces of fish-related activities concentrated around a wooden box that was situated next to a fireplace and a well-laid stone floor, perhaps

this room functioned as a larder. There was also a small extension, KG 37, 4.5 × 1.2m in size that consisted of a latrine pit and a wooden floor most likely the remains of a privy (Bramstång Plura et al. 2012: 127, 129, 35).

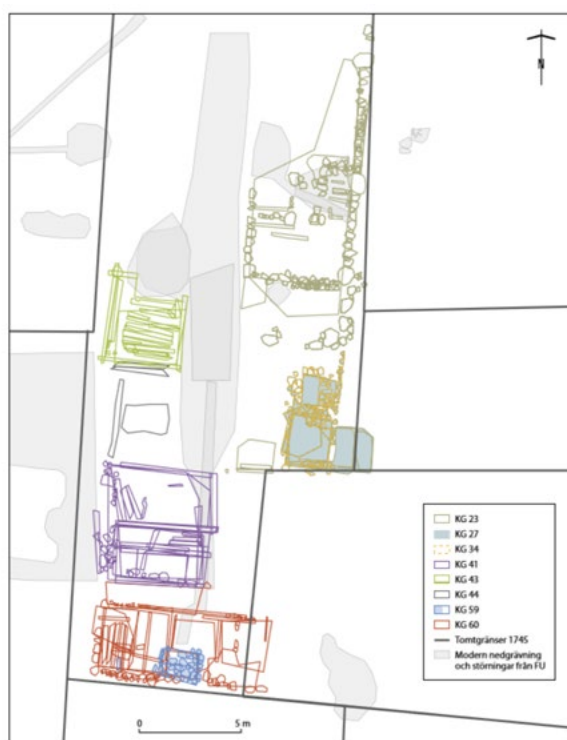
Figure 16 Buildings 23, 41, 43, 60 in phase 2:5, at Kv. Dohjorten (Bramstång Plura et al 2012:38)

The construction measured c. 4.5 × 5.8m and was interpreted as an outbuilding. There were two floor layers, the uppermost one had significant traces of manure, weed and hops, which is a probable indication of the building having been used as a byre. The floor was constructed of a sandy clay. A layer of slag could be found either under or next to the sandy clay floor. It was

not fully concluded whether the slag was connected to a workshop or if it was simply used as a consolidation layer. A layer of wood chips mixed with humic sand was situated under the slag (Bramstång Plura et al. 2012: 35, 132).

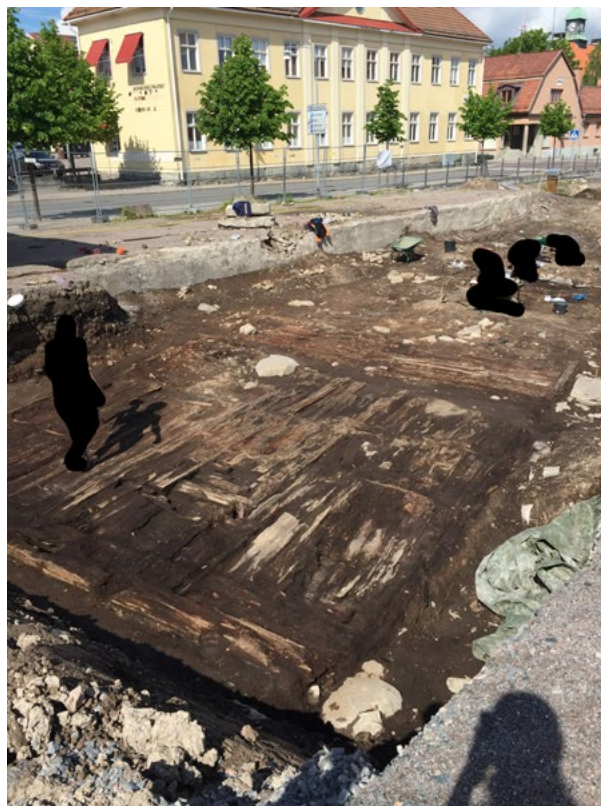
The building was 6.7-8.5m in size with two rooms i.e. a parlour (Sw. *stuga*) and a vestibule (Figure 18). The house was situated in a north-south direction and the entrance was located on the eastern side of the building marked by a large flat stone. The fireplace was placed at the corner of the parlour next to the entrance from the vestibule. The wood in the lower wall-timbers was well preserved apart from on the northern side. Dendrochronology dates the wall-timbers to 1595, 1582-96 and a fragmented part of the floor from 1607-1608. The wooden floor was laid out on a joist system, yet, parts of the floor were removed, for example around the fireplace. The remaining floorboards were laid in a north-south direction. Conversely, the floorboards towards the south wall in the parlour were laid in an east-west direction, which made the archaeologists, excavating the site, consider some kind of furniture fixed to the wall, such as for instance a wall bench, might have stood there at one point (Wehlin et al. 2018: 42-44). The north room did not have any remains of a floor construction left. There were many datable finds under the floorboards, from the period 1550-1675, including glass beakers of various kinds, as well as clay pipes and coin. The extended period does not entirely reflect the use of the building, but coins for example, may have fallen through a crack in the floor at a later date. The

Figure 18 The southern and northern house, Västra Falun. Photo A. Nilsen.

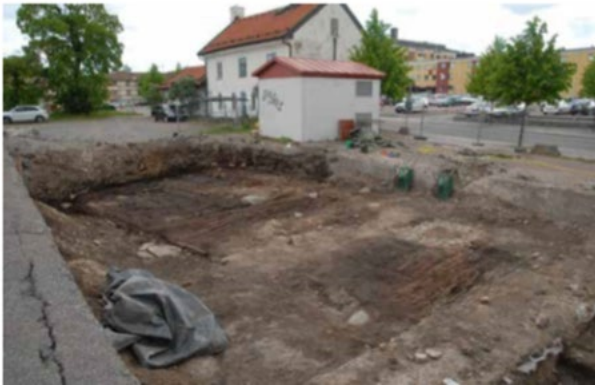
Between the south house and the north house there was a passage, 1.3 metres wide, with traces of a wooden structure (Figure 19). There was a smaller-sized patch of sand as well as some scattered planks. The latter were interpreted as some sort of wooden construction, or possibly used as stepping 'stones' in the cramped space. The report gives another suggestion to perhaps understand the space as a covered area with a roof or a staircase leading to an upper floor level/ balcony of the south house, thus connecting the two houses (Wehlin et al. 2018: 47).

Figure 19 The part that is lighter in colour has been interpreted as a passage between the southern and northern house. Photo by J. Wehlin (2018:47).

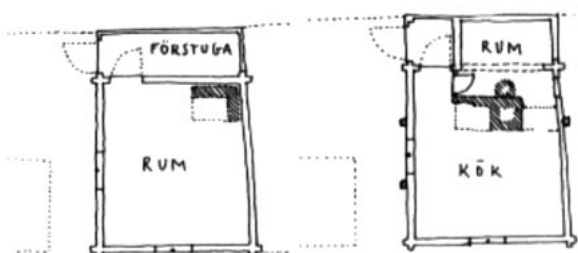
Figure 1. Reconstructions of MPg8b from fire insurance records from 1812 and 1860. (Blomberg and Linscott 2000).
