**CONSERVATION OF THE SWEDISH WARSHIP
VASA
FROM 1628**

Birgitta Håfors

2nd edition 2010

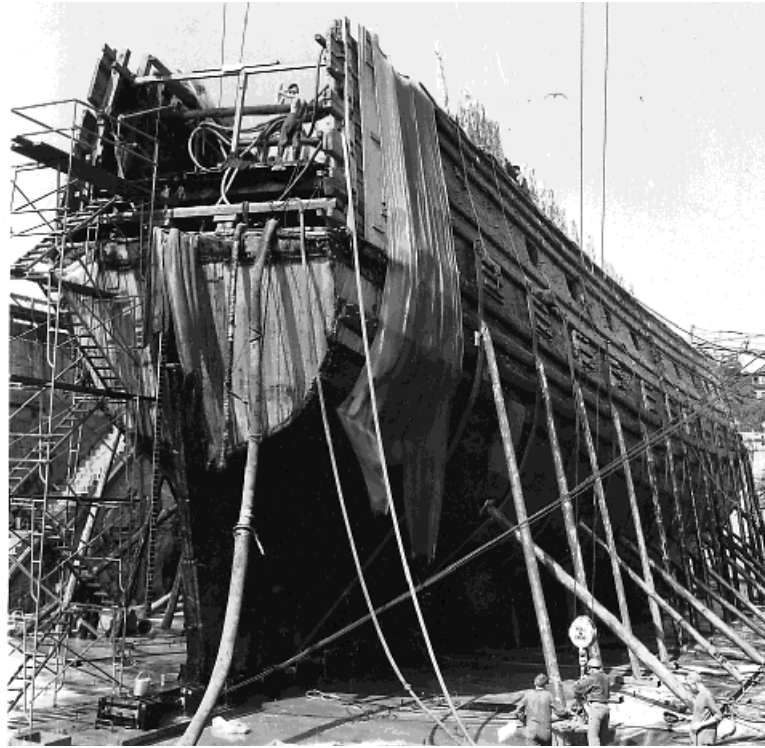
As the whole of the stern part had fallen away, this was repaired with planks to make it possible for the pumps to keep the hull floating during the transportation into the dry dock (figure 3-2). New gun port shutters of solid wood were constructed. Each of these was padded to fit exactly and sealed with leakproof fabric on the inner side. The temporary gunport shutters were put into place by the divers and secured with T-headed bolts.

Figure 3-2 The Vasa hull on the pontoon in the dry dock (photo from the archive of the Swedish National Maritime Museum)

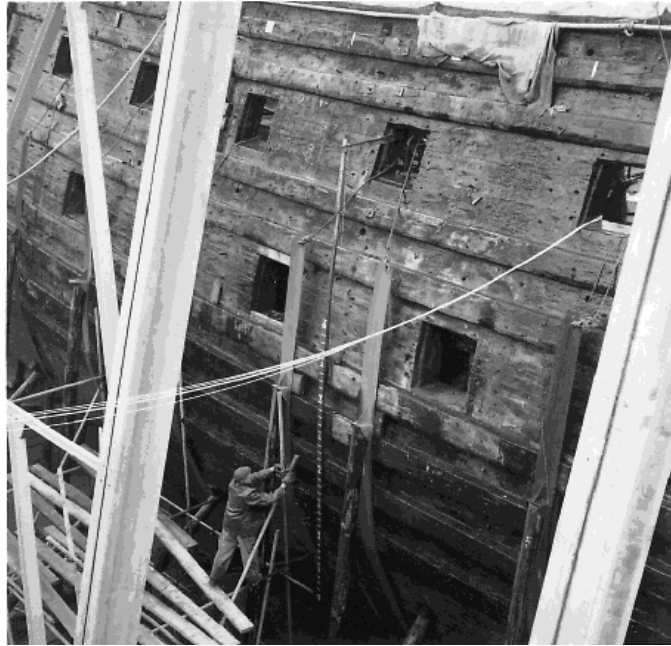
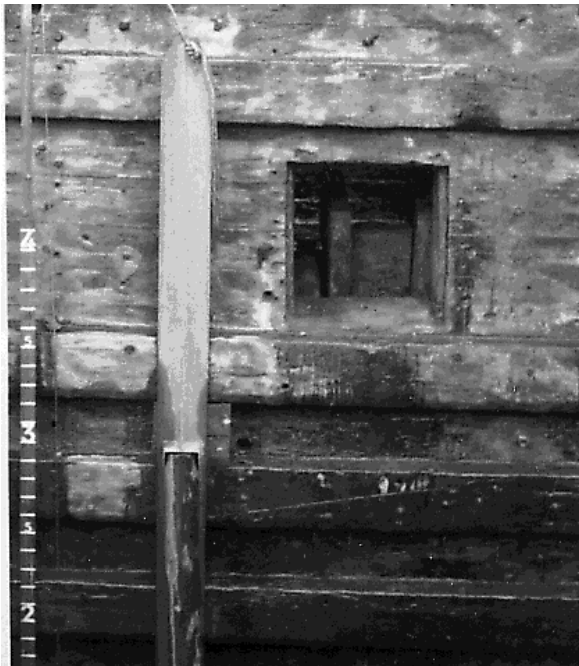
Figure 3-4 Props supporting the Vasa hull on the pontoon (photo: Gerhard Bauer)

Figure 3-5 Detail of construction of the fastenings of the props (photo: Gerhard Bauer)

The upper row of props reached about six metres above the roof of the pontoon. To enable the props to provide support without damaging the wood, their ends were put into special constructions in the shape of caps mounted on broad steel bands.

There were ten such steel bands hooked into loops mounted in the roof of the pontoon on each side of the hull with their ends reaching to the lower gunports at either side of the hull (figures 3-4 and 3-5).

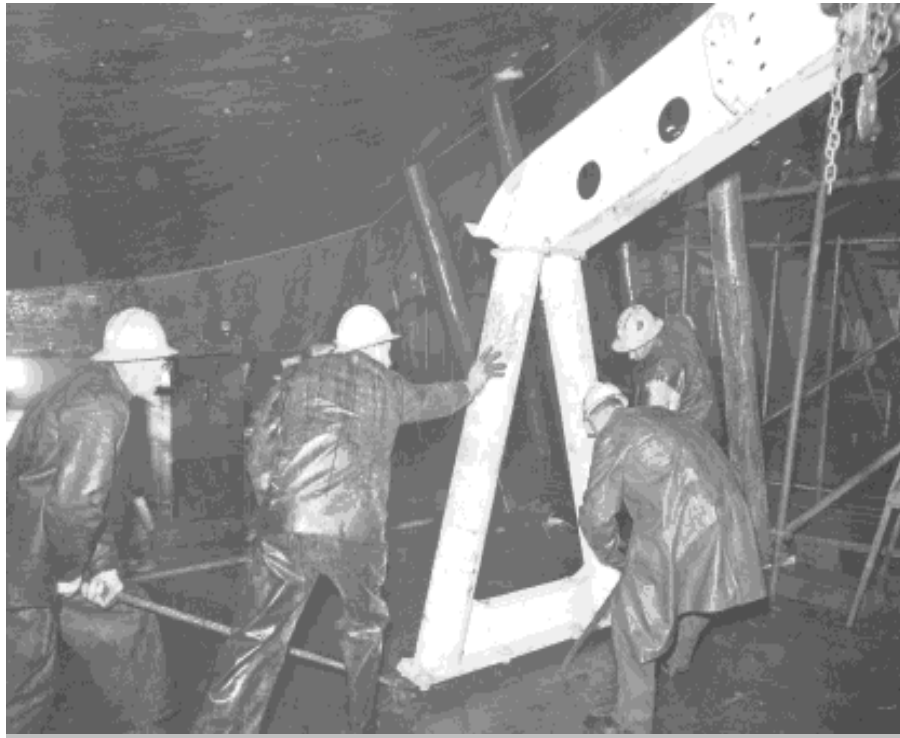
The cradle was mounted in place in the pontoon superstructure between September and the end of 1964 (figures 3-11 and 3-12).

Figure 3-11 Mounting of the cradle in the pontoon superstructure (photo: Göran Sallstedt)

As early as 1 September 1961, Schoerner had pointed out to the Board of the Vasa (68) that the present support of the hull had to be replaced by a more adequate one. To gain some information about the way other museum ships were supported, Barkman and Schoerner went to England to study the "HMS Victory". Referring to this, Schoerner suggested to the Board of the Vasa (70) that a support shaped as a cradle with horizontal bracings should be constructed for the Vasa hull. He undertook to discuss this with a suitable constructor (156) and, at the end of January 1962, he reported a plan for a cradle consisting of horizontal bracing and a number of perpendicular stays. After some adjustments, the cradle was manufactured (156). It was made of steel that had undergone anti-corrosive treatment.

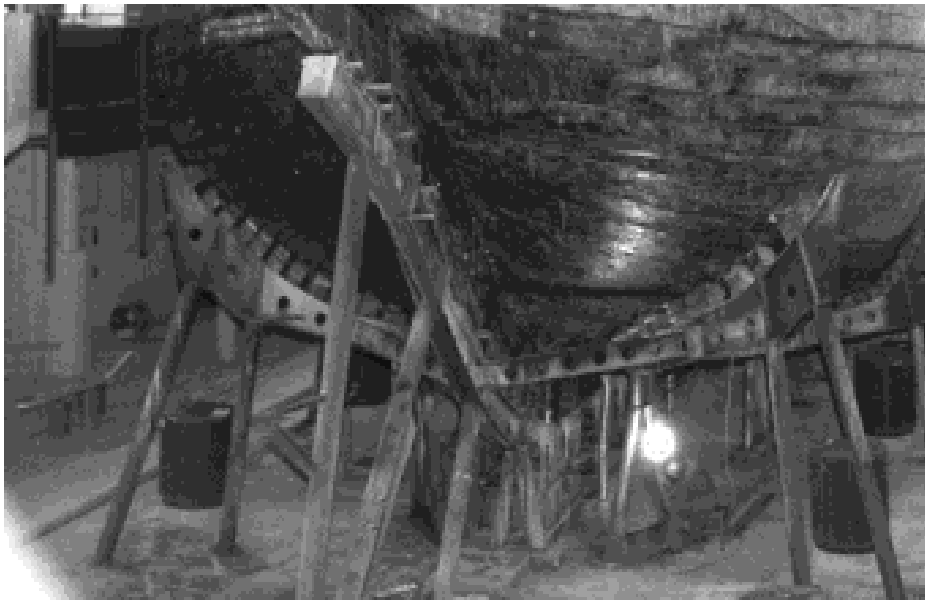
Since the exact shape of the shipsides was not known, the cradle was made somewhat wider than would have been necessary. The gap between the elements of the cradle and the ship was filled with units consisting of wedges. To achieve a suitable support for the ship, wedges could be taken away or added to a unit (figures 3-13 and 3-14). Manoeuvring the wedges also allowed for some flexibility when adjusting the position of bolt holes to get a bolt through a series of structural elements (figure 3-15).

Figure 3-14 The supports of the cradle with the units of wedges in the stem and fore part of the Vasa (photo: Sven Bengtsson)

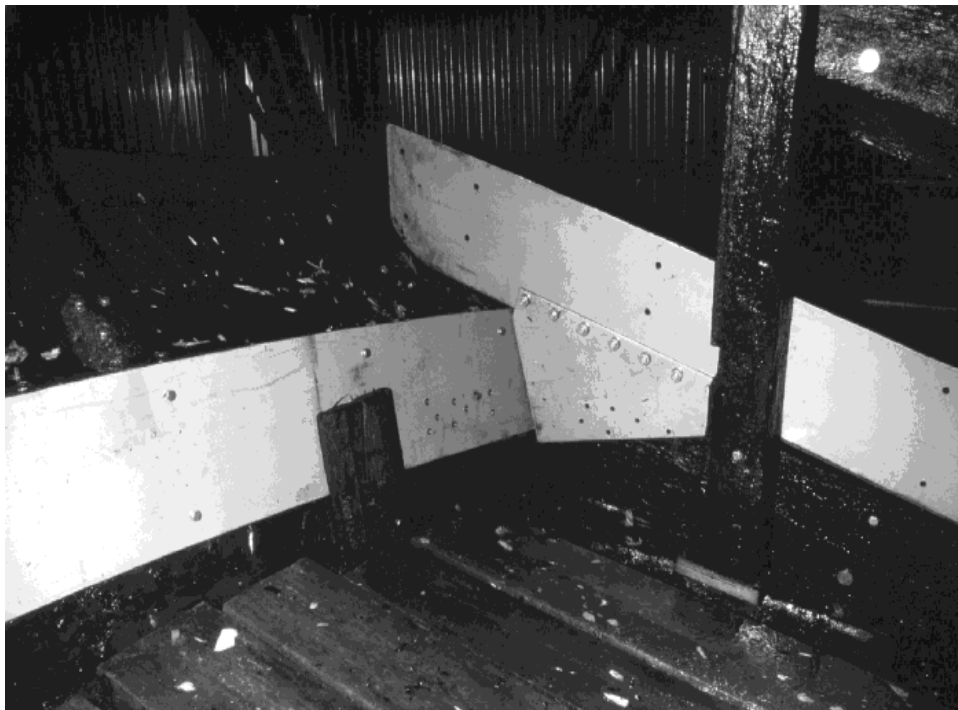
The starboard and portside leg of each construction were fastened to ribs in the main part of the hull and covered by the outer planking (figures 3-17 and 3-18). Thus the steel constructions create two shelves for the protruding parts of the stern (93).

Figure 3-18 The steel construction, detail (photo: Björn Hedin)

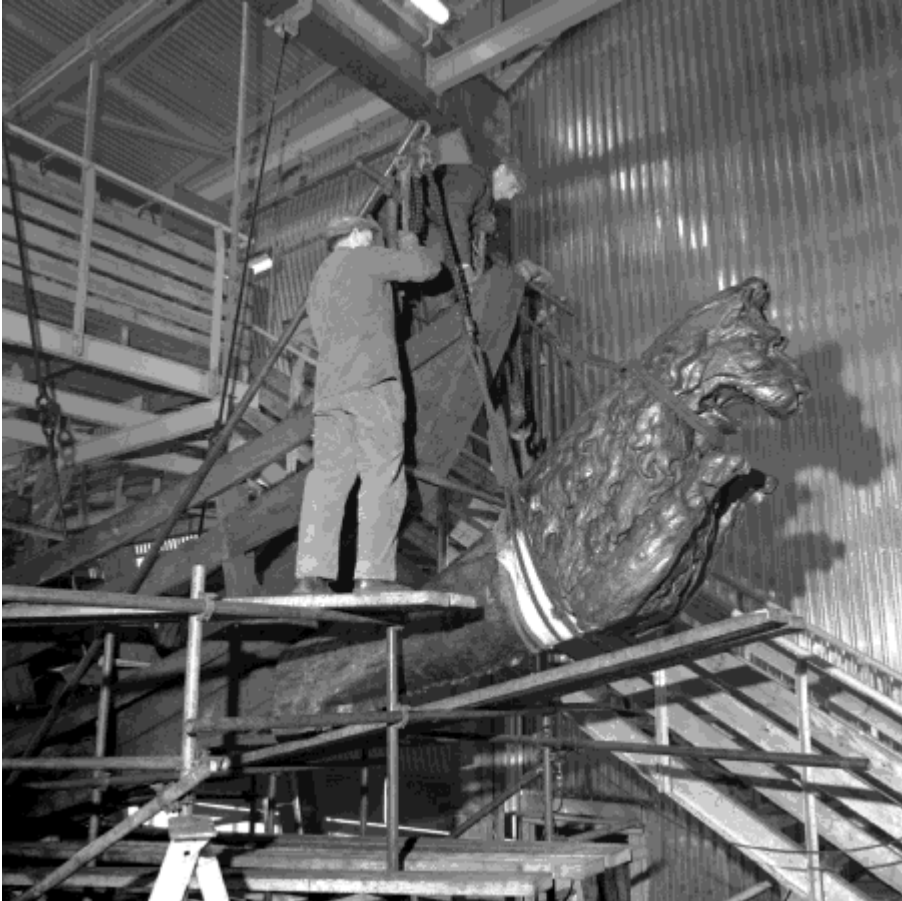
The next part to be reconstructed was the beak-head, with its rows of sculptures along the sides. The rejoining of sculptures was preceded by some strengthening and adjustment work to the beak-head construction itself. The work was concluded in March 1983 with the rejoining of the genuine lion figurehead instead of the plastic replica that had been the beak-head adornment since 1969 (figure 3-19).

Figure 3-19 Rejoining the lion figurehead (photo: Björn Hedin)

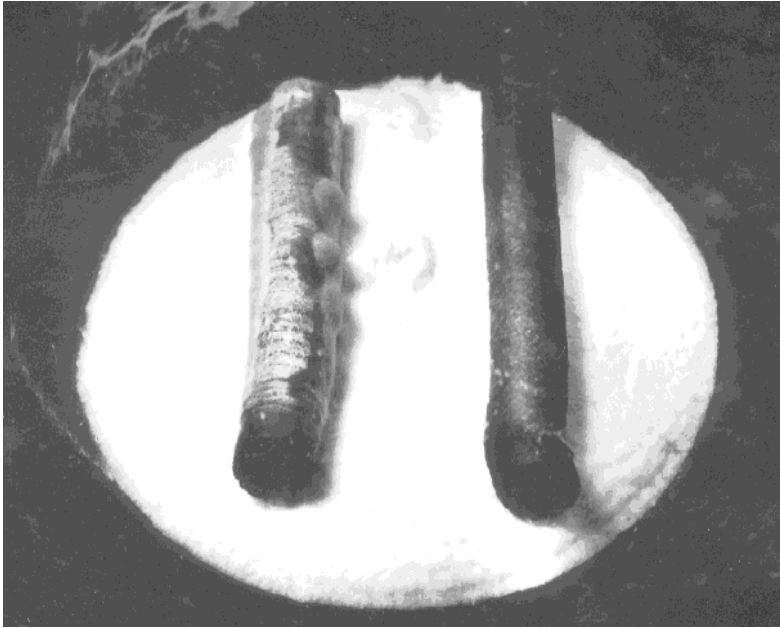
The test series that was finished in May 1966 showed no visible attack on the treated Vasa oak and the weight losses recorded were 2.2 and 3.8% respectively (figure 4-2) (41). oak and the weight losses recorded were 2.2 and 3.8% respectively (figure 4-2) (41).

Figure 4-2 Attack by *Lenzites quercina* on samples of untreated Vasa oak to the left and treated Vasa oak to the right (photo: The Royal College of Forestry)

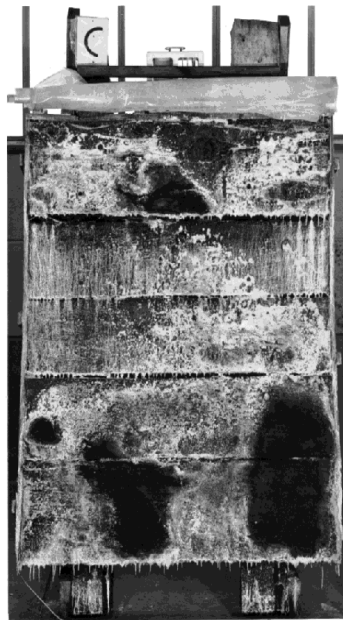
Figure 4-5 Test panel C after conservation treatment (photo: Gerhard Bauer)

The panels were protected by plastic sheets during the treatment period to slow down the rate of evaporation from the surfaces under treatment and thereby promote the diffusion process. The treatment was continued until there was a white precipitate of PEG on the surfaces of the panels (figure 4-5). It took about six months to reach this stage.

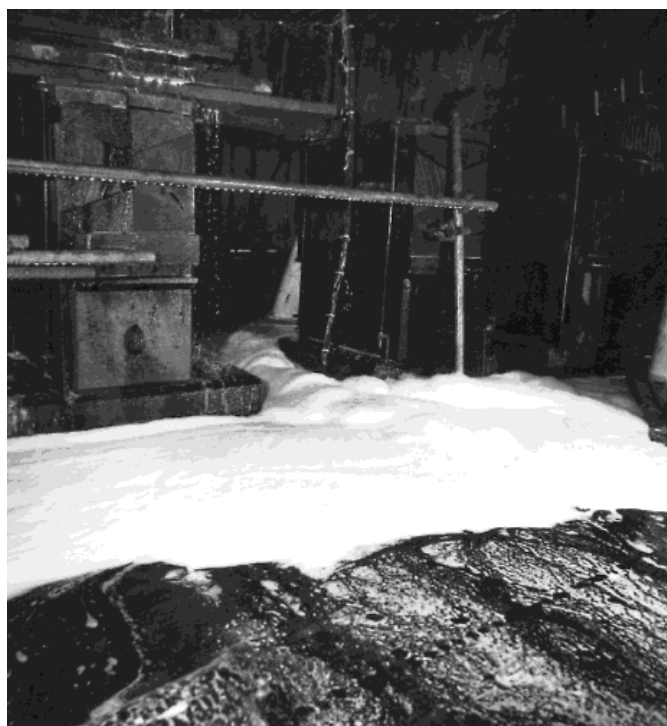
When the spray system was started, a substantial amount of foam was produced that somewhat impaired the drain back to the tank of the preservation solution (figure 4-20).

Figure 4-20 Foam on the top plane of the pontoon produced by the spraying of the preservation liquid (photo: Göran Sallstedt)

The foam production might also have become an obstacle to the diffusion of the preservatives into the wood (figure 4-21). To get rid of the foam, a silicone product (18) was added to the preservation solution.

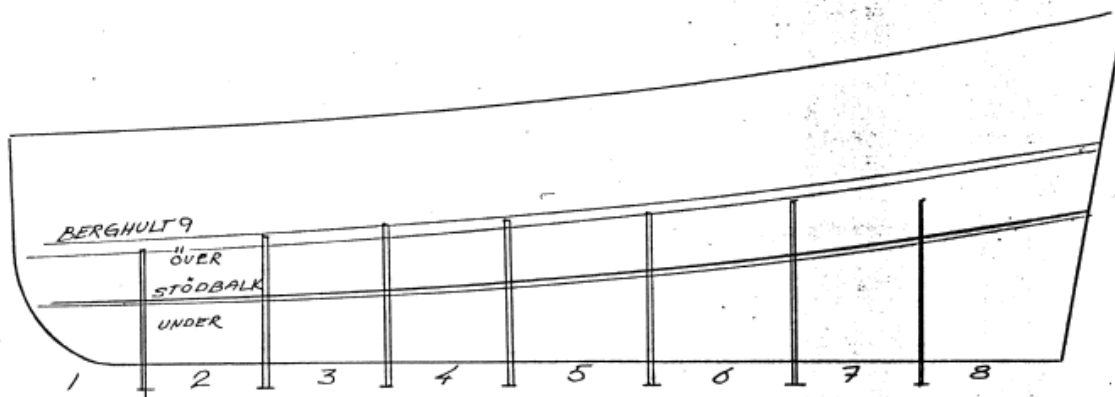
A schedule for performing the investigation was developed, taking into account the possibility of reaching the selected parts of the hull. On those grounds, the lower parts of the hull from the keel up to the lowest wale on both the starboard and port side were chosen. This meant up to four metres above the keel plane. A horizontal beam of the steel cradle divides the areas on each side into parts situated lower and higher up. This beam thus constitutes an obvious border line. The surface areas below and above the beam were separated each into eight fields using the standards of the cradle as border lines. Thus thirty-two areas for investigation were created (figure 4-22).

Figure 4-22 The port side of the Vasa hull with its sixteen areas for investigating the surface of the wood

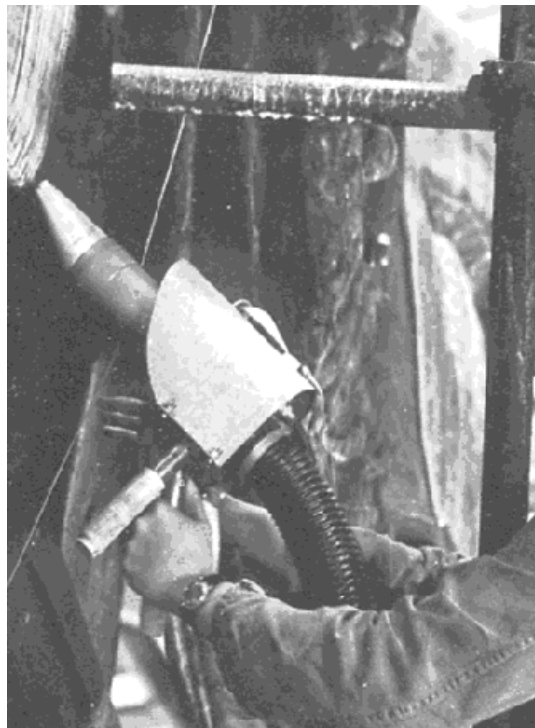
Figure 4-23 Melting PEG with a hot air blower (photo: Sven Bengtsson)

In March 1981, the Conservation Council judged it possible to carry out surface treatment of the upper parts of the hull down to the condensation area (129). The starboard side of the hull was spray-treated during the month of April. After a short drying period of one month, the heat treatment to melt the PEG 4000 into the surface was also accomplished (figure 4-23). The result had been inspected by Rånby, who gave his opinion that the result was excellent (130).

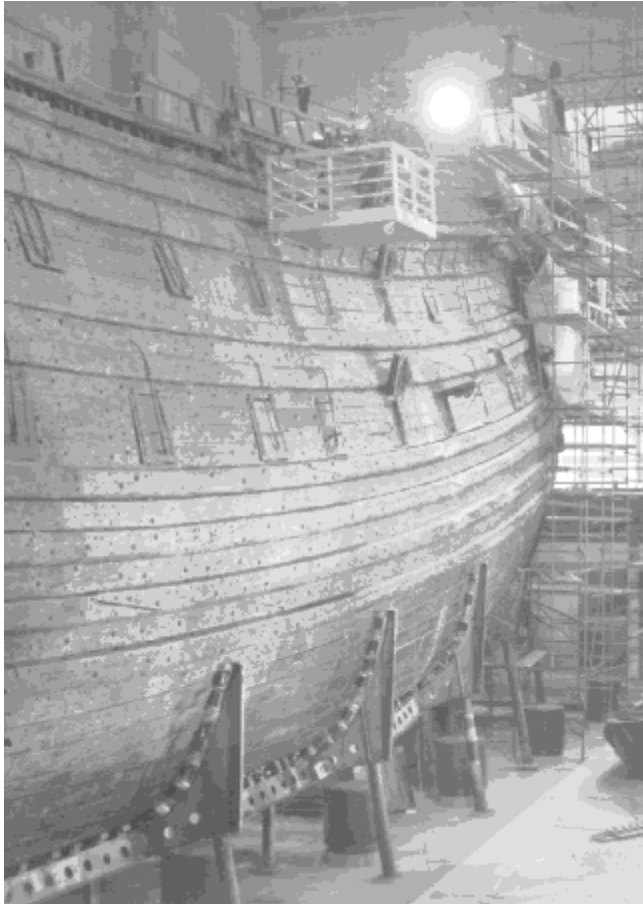
Figure 4-25 Work on the surface of the hull from a hanging work platform and scaffolding (photo: Sven Bengtsson)

Parallel to the work with the heavy sculptured fore and aft parts of the ship, the sides with their rows of gunports adorned with lion masks were treated separately by another work team. Most of the work was performed from a hanging platform (figure 4-25). Apart from the lion masks, about 1200 square metres of the ship's sides had to be cleaned by hand. Although the PEG application was done by spraying, the heat treatment to get rid of the surplus was done by hand from the rather unstable hanging platform.

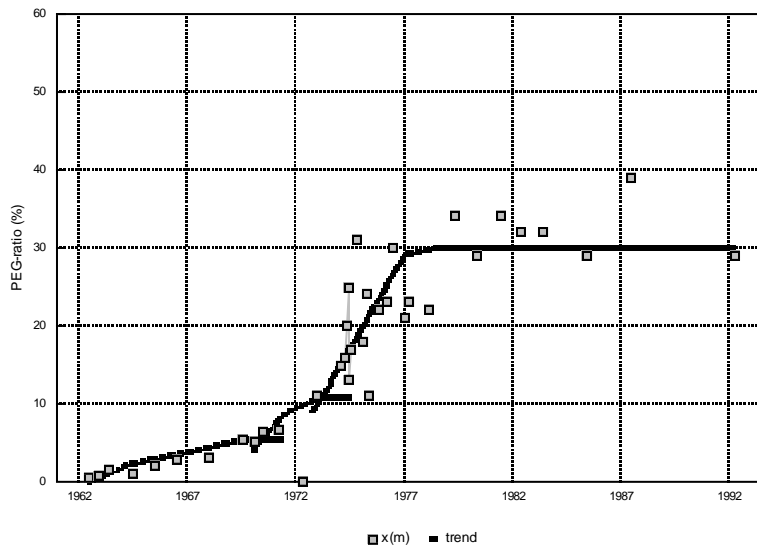
Figure 6-8 Outer planking, PEG-ratio (%) mean values and trend

During the period from 1962 until 1972, which includes the hand spraying and intensive automatic spraying periods (chap. 4), both curves show a very modest development in the degree of conservation. The PEG-ratio levels obtained were 11 and 13% respectively in the outer and inner plankings. During the next five years, when the frequency of spraying was gradually reduced at the same time as the PEG-concentration of the solution was increased, there was an increase in the PEG-ratio up to a level of 30% in the outer planking and 37% in the inner planking.

Because of the finishing surface treatment, there was an increase of PEG-ratio occasionally to mean values of 39% in the outer planking and 46% in the inner planking after the automatic spray treatment was stopped. These high mean PEG-ratios did not last because they were mainly due to a superficial PEG-coating that was applied to protect the wooden surface during the period of transportation into the permanent museum (chap. 4).

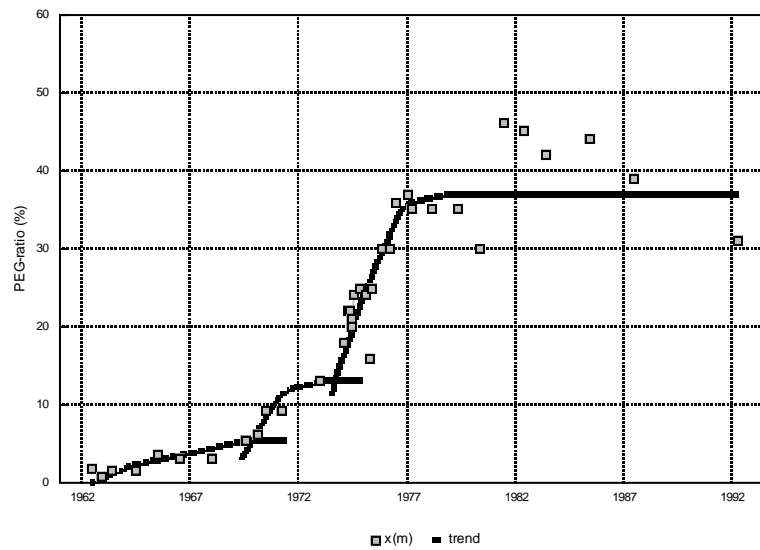
Figure 6-9 Inner planking, PEG-ratio (%), mean values and trend

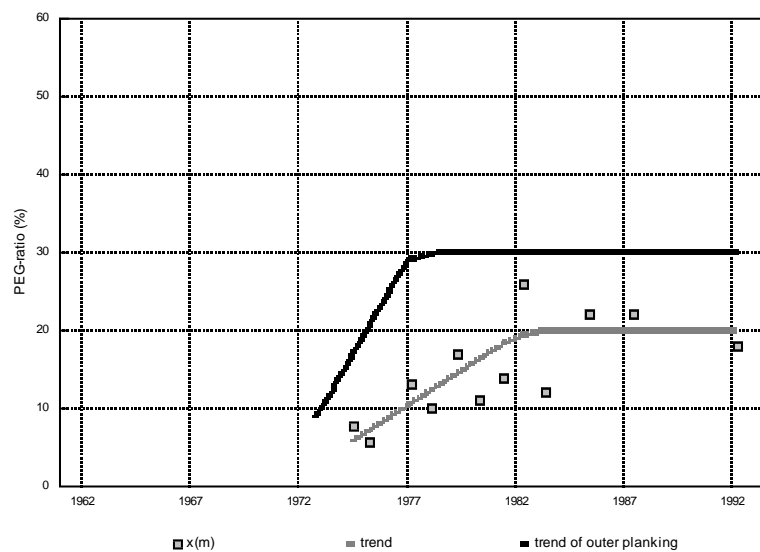
Figure 6-10 Wales, PEG-ratio (%), mean values and trend (grey) compared with the trend for the outer planking

It is noticed that, although the wales have been in the same general climate and subjected to the same treatment as the outer planking, they show lower PEG-ratios. What discriminates one from the other is the difference in thickness of the planks. The thickness of the ordinary planks of the outer planking are from 50 to at the most 100 mm, while the wales are mainly about 150 mm thick with extremes of 130 and more than 200 mm. The difference in PEG-ratios may thus be due to the fact that the planks of the wales are thicker than the ordinary outer planking.

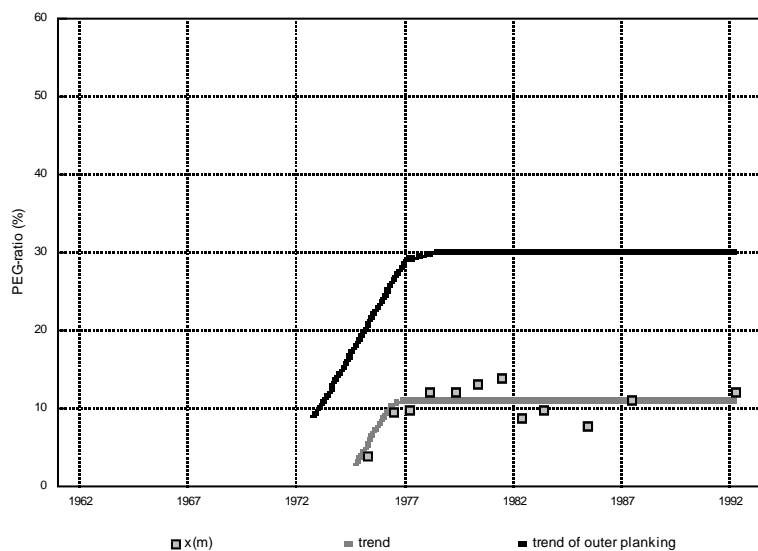
In the same way, the PEG-ratios of the heavy timbers have been compared to the trend curve of the outer planking. In 1975, when the core sampling of the heavy timbers started, the mean PEG-ratio was as low as about 5%. Between 1975 and 1979, the timbers that belong to the spaces inside the hull that are in contact with the surrounding atmosphere of the museum building showed an increase of mean PEG-ratio to a steady level of 11% (figure 6-11).

Figure 6-11 Heavy timbers in spaces in direct contact with the surrounding air of the museum, PEG-ratio (%), mean values and trend (grey) compared with the trend for the outer planking

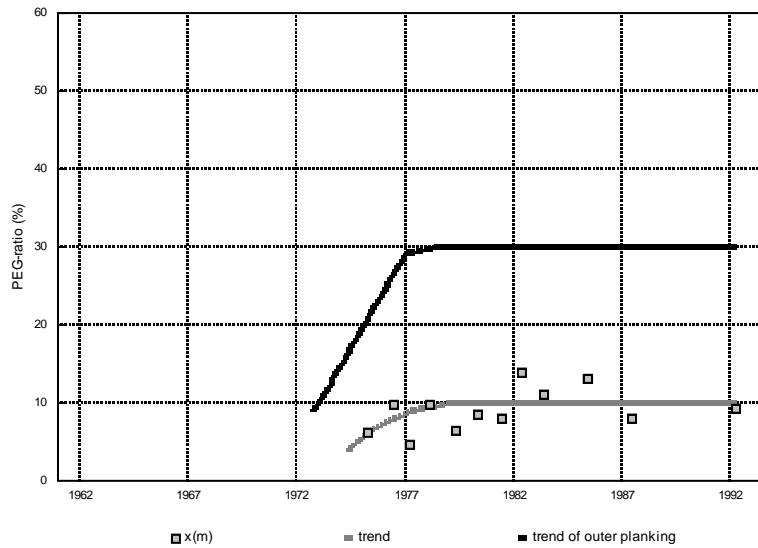
The heavy timbers in the hold and orlop deck compartments that were not in direct contact with the surrounding museum atmosphere showed about the same increase in mean PEG-ratio during the period of automatic spraying as the heavy timbers in the spaces with direct contact with the surrounding museum atmosphere. In these parts, the PEG-level reached was one percentage unit lower than in the spaces with direct contact with the surrounding air of the museum (figure 6-12).

The rather low PEG-ratio levels of the heavy timbers were not increased despite the handspraying programme between 1980 and 1986 (chap. 4).

Figure 6-12 Heavy timbers in spaces without direct contact with the surrounding air of the museum, PEG-ratio (%), mean values and trend (grey) compared with the trend for the outer planking

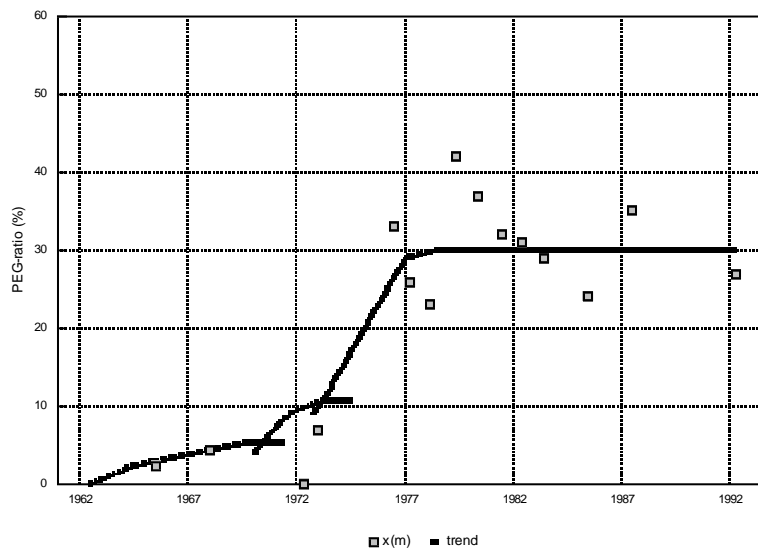
The PEG-ratios of the upper gun-deck deckplanks fit nicely to the trend of the outer planking (figure 6-13). Although there is a considerable scatter, the final level of PEG-ratios seem to be about 30%.

Figure 6-13 PEG-ratio (%), mean values of deckplanks of the upper gun-deck compared with the trend for the outer planking

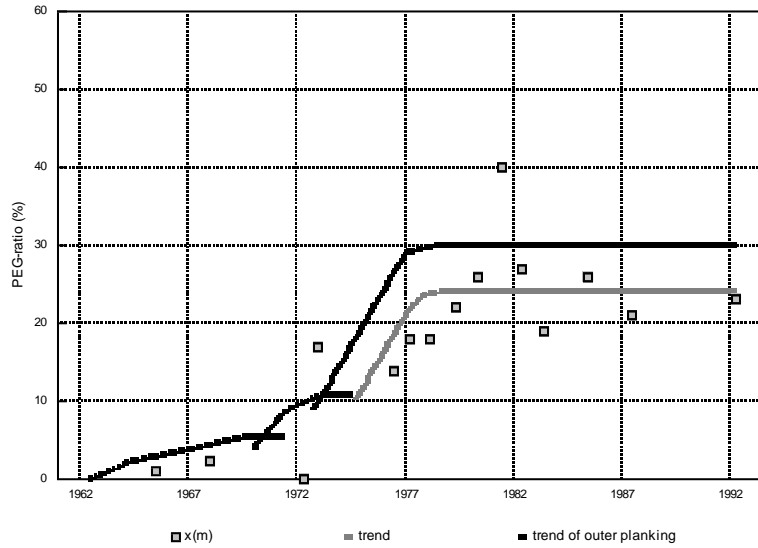
In the case of the deckplanks of the lower gun-deck, the final PEG-ratios trend stays about six percentage units below that of the upper gun-deck, ending at a PEG-ratio level of 24% (figure 6-14).

Figure 6-14 PEG-ratio (%), mean values and trend (grey) of deckplanks of the lower gun-deck compared with the trend for the outer planking

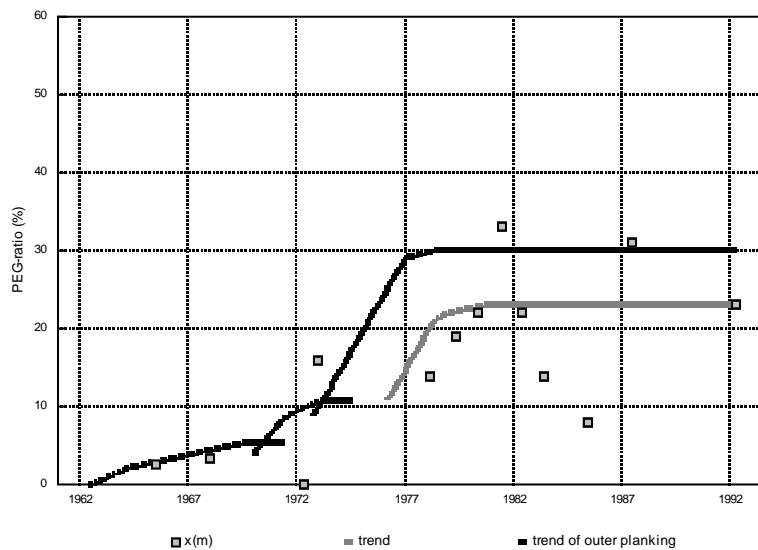
Figure 6-15 PEG-ratio (%), mean values and trend (grey) of oak deckplanks of the orlop deck compared with the trend for the outer planking

The deckplanks of the oak part of the orlop deck show a final PEG-ratio level one percentage unit lower than that of the lower gun-deck, i.e. 23% (figure 6-15). In contrast, the PEG-ratio level of the pine deckplanks of the orlop deck reach the extremely high value of 120% (figure 6-16).

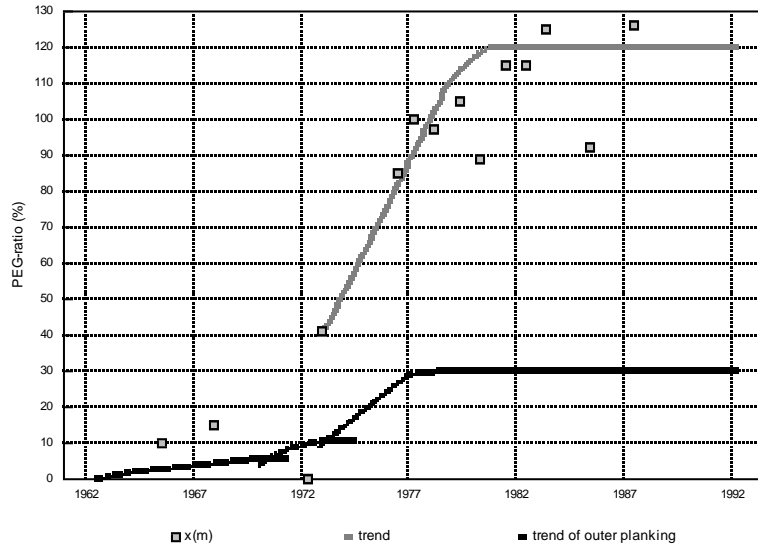
Figure 6-16 PEG-ratio (%), mean values and trend (grey) of pine deckplanks of the orlop deck compared with the trend for the outer planking

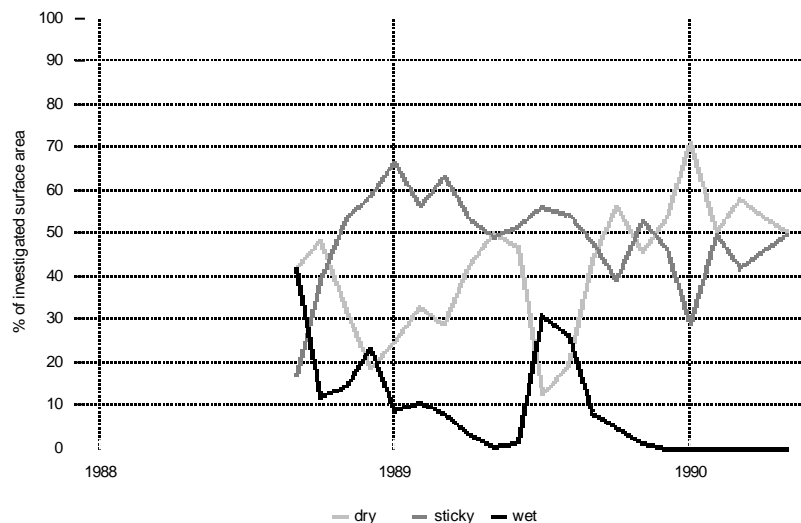
Figure 7-4 Surface investigation, August 1988 - June 1990

There was a substantial variation in the observations during the period in the transportation encasement. There even arose a need for a greater specification of the observations. During the summer of 1989, when the Vasa was exhibited to the public in the half-finished museum, and during the winter and spring periods when the transportation encasement was gradually removed, a stage between "dry" and "slightly moist" was identified. Therefore the notation "very slightly moist" was added to the list.

During the period in the transportation encasement, "sticky" notations were present mostly to an extent of between forty and sixty per cent while the "dry" notations varied substantially from fifteen to seventy per cent. The low percentages of "dry" notations were recorded in December 1988 when the transportation encasement was moved into the museum under construction and then when the encasement was partly removed in the summer of 1989. On these two occasions, the "wet" notations rose to levels of over twenty and thirty per cent (figure 7-4).

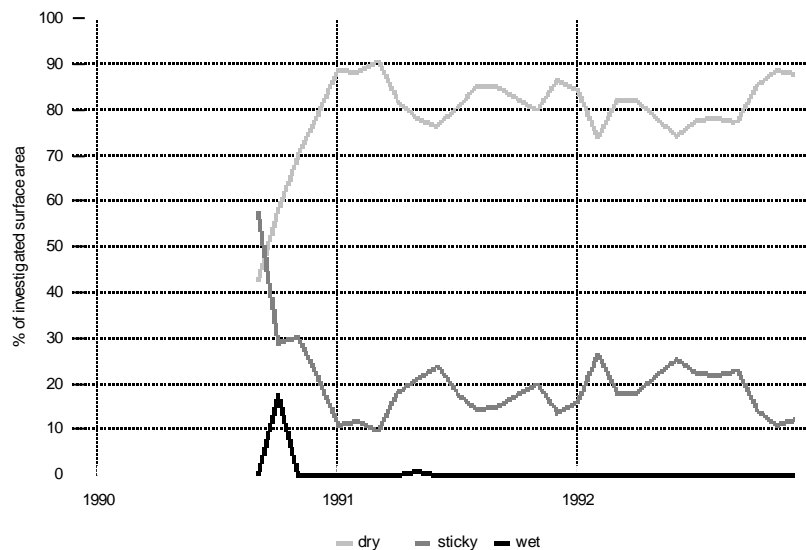
Figure 7-5 Surface investigation from September 1990 to the end of 1992

The same situation as in June existed when the monitoring of the wooden surfaces started again in September 1990. The "sticky" and "dry" notations each ranged from forty to sixty per cent. There were even some "wet" notations during the autumn of 1990. However, the climatic prerequisites seem to have stabilized during the winter period, giving ninety per cent "dry" and ten per cent "sticky" notations. During 1991 and 1992, these notations ranged between seventy-five and ninety per cent and ten and twenty-five per cent respectively. This

indicates that the PEG-treated wooden surfaces react to even mild changes in the surrounding climate (figure 7-5).

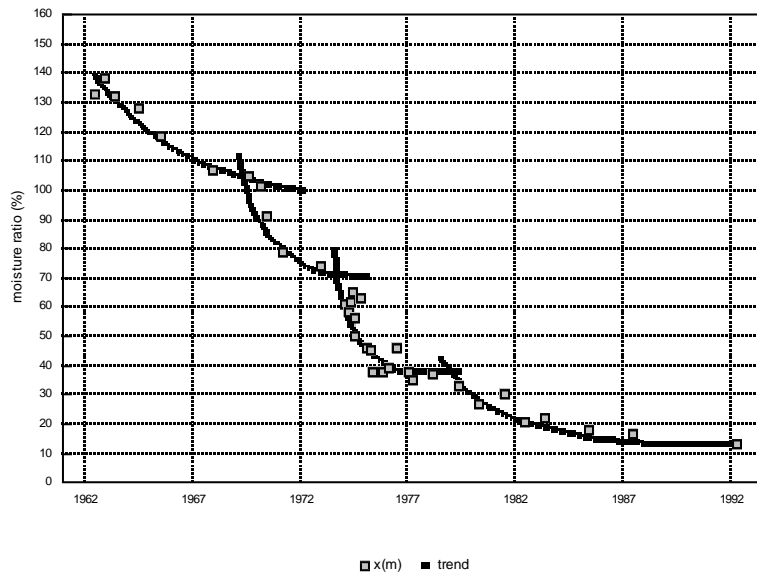
Figure7-6 Outer planking, moisture ratio (%), mean values and trend

of the intensive automatic spraying period (figure 4-24). Two different drying-rates can be identified during this period. The moisture ratio sank slowly from about 130% to 110% in the inner planking and from about 120% to a little less than 110% in the outer planking during the period of about five years of intensive spraying with 10 and 15% PEG-solutions. During the next three years with the same frequency of spraying but with conservation solutions of 20 and 25% PEG-concentration (figure 4-12), the drying was more rapid and the moisture ratio sank to 85% in the inner planking and to a little below 80% in the outer planking (figures 7-6 and 7-7).

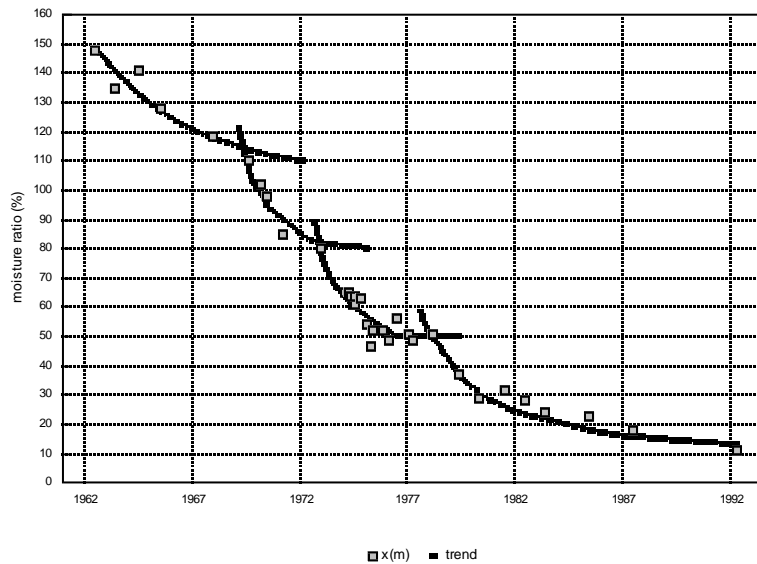
Figure 7-7 Inner planking, moisture ratio (%), mean values and trend

During the period 1973 - 1976 of intermittent spraying, the rate of drying was about the same as during the latter part of the intensive spraying. The moisture ratio levelled out at about 40% in the outer planking and 50% in the inner planking. The drying started again during the finishing surface treatment period when special measures were taken to speed up the drying and reach the end-point of the preservation period (chap. 5). A moisture ratio of about 20% had been established before moving into the permanent museum. During the first two years in the permanent museum, the drying had continued to an equilibrium with the climate in the museum at a moisture ratio of between 10 and 12% for the outer and inner plankings.

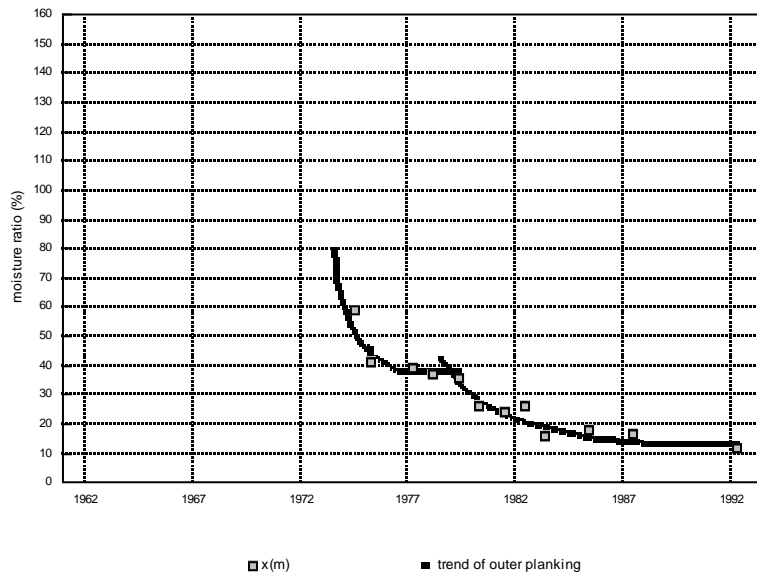
It was expected that the drying process might be slower in the heavy timbers. In the case of the wales, this proved not to be true. The mean moisture ratio values fit well to the trend diagram of the outer planking (figure 7-8).

Figure 7-8 Wales, moisture ratio (%), mean values compared with the trend for the outer planking

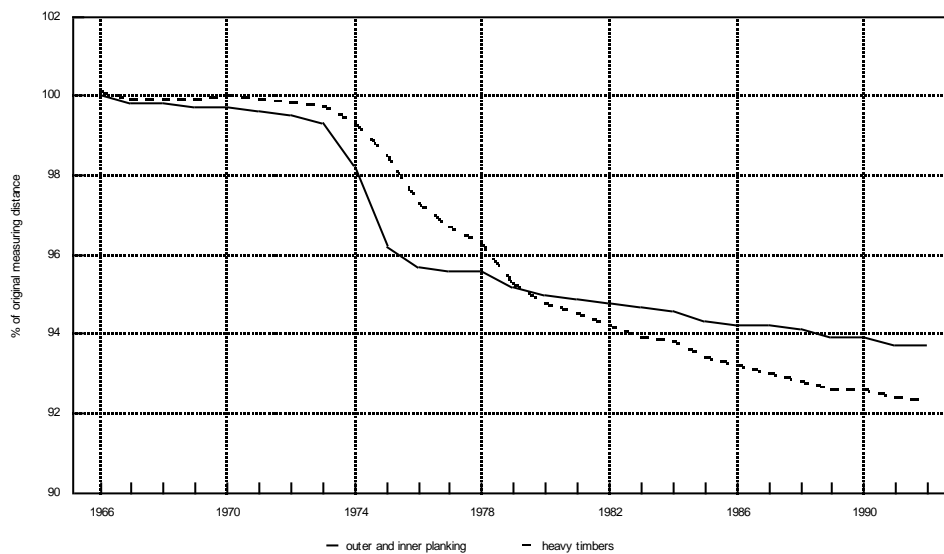
Figure 7-15 Shrinkage of outer and inner plankings (continuous line) and heavy timbers inside the Vasa hull (broken line) 1966 - 1992

To obtain comparable figures, the changes in distance between the measurement probes have been calculated as a percentage of the original distance between the same pair of probes. To provide an overview of the situation, the mean values for the outer and inner plankings have been calculated for each year and also the mean values for the heavy timbers inside the hull (figure 7-15).

From the graph, it can be deduced that there was very little shrinkage before 1973 in either thin or heavy materials although the moisture ratio dropped to about 80% during the period (figures 7-6 and 7-7). However, the next decrease in moisture ratio from 80 to about 40% was accompanied by a shrinkage of the members of the inner and outer plankings of about 4%. From a moisture ratio level of 40% down to the 1992 level of 10 to 12% there was a slow shrinkage of about 1.5%. In all, the mean total shrinkage of the outer and inner plankings has been slightly above 6%.

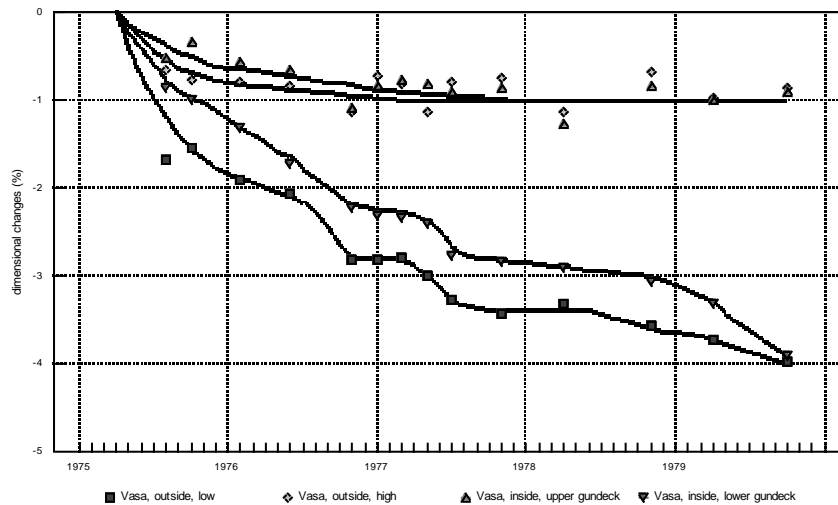
Figure 8-2 Measurements of Dimensional Changes with the E Kjellgren - instrument

The measurement showed a declining shrinkage from the start of the measurements to the end at the two highly positioned measuring points. The total shrinkage amounted to only one per cent in those two cases. The two lower measuring points showed parallel shrinkage patterns, with the highest shrinkage at the lowest situated point. However, at the end of the measurement period, they had each shrunk by four per cent. More than half the shrinkage, 2.2% for the point at the lower gundeck and 2.8% at the low position on the outside, had occurred by the end of 1976. There was then a stationary period during the winter of 1976 to 1977. The shrinkage started again about March 1977 (figure 8-2). This is when the rounds of spray treatment were cut down from two per 24 hour period, which had been the schedule since October 1975, to only one in the same period of time.

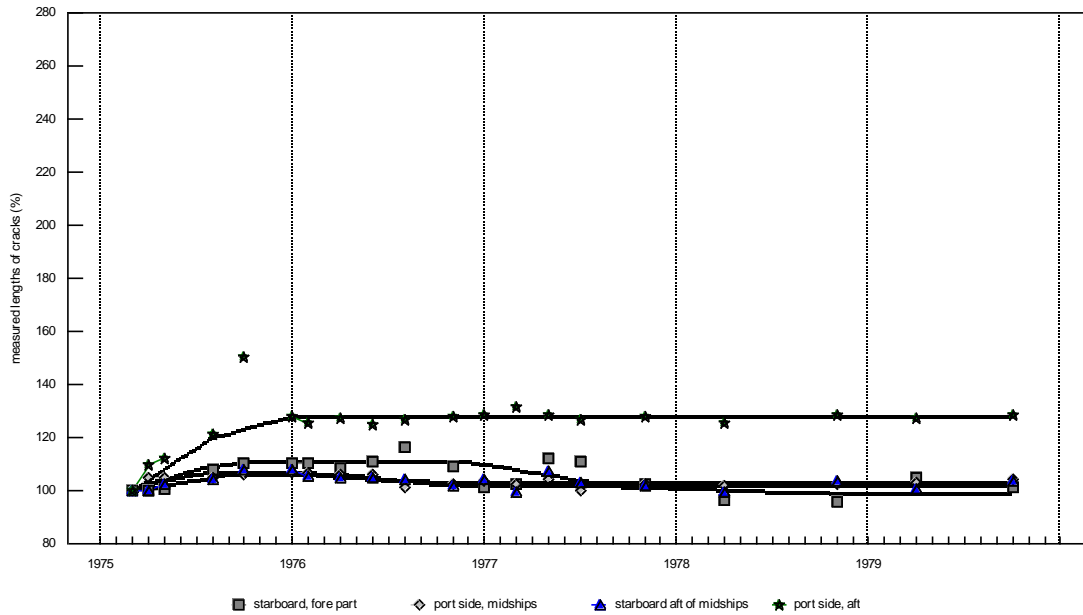
Figure 8-3 Selected sections; change (%) in length of cracks on the outside of the Vasa hull

The lengths of cracks on the outside of the hull seem at first to grow slightly, but the growth came to a standstill late in 1975 or early in 1976. This condition was the same in all four of the selected sections on the outside. From the beginning of 1976, the measured cracks in the midship sections on both the starboard and port sides started to close and they reached a stable state very similar to the starting conditions at the end of 1976. The measured cracks on the starboard, fore part section started to exhibit the same closing movement at the beginning of 1977, which finally led to the same condition as at the starting point. The lengths of the cracks in the section on the port side aft did not, however, change during the rest of the measurement period (figure 8-3).

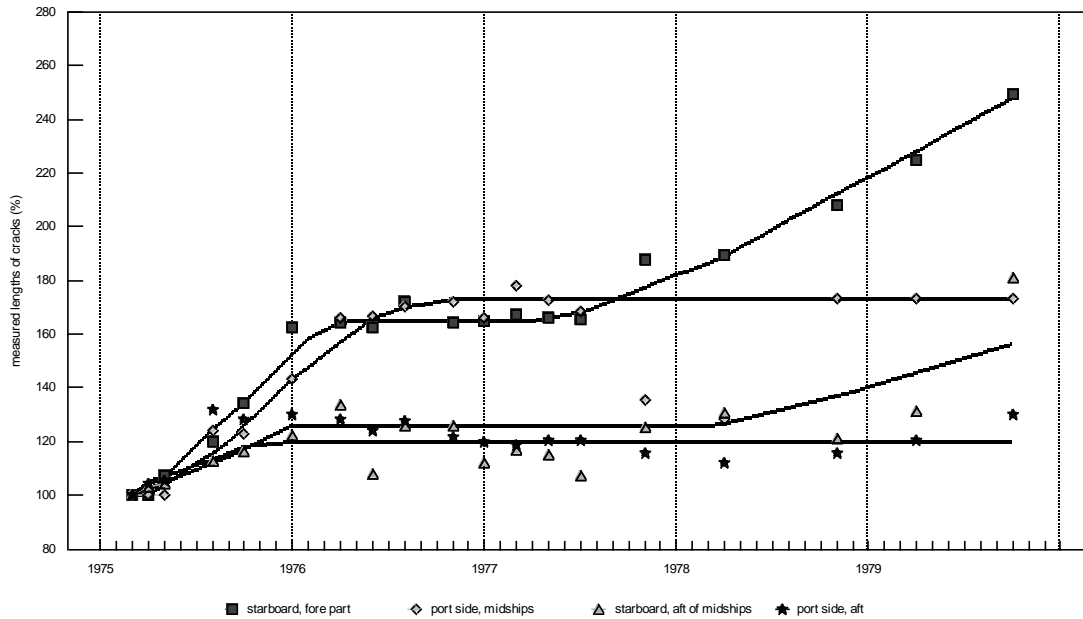
Figure 8-4 Selected sections; change (%) in measured lengths of cracks on the inside of the Vasa hull

The inside sections showed at first a pattern similar to that of the outside sections. The cracks grew in length and then came to a standstill (figure 8-4). This happened late in 1975 in the section on the port side aft, at the beginning of 1976 in the section on the starboard side aft of midships, and a little later in the section on the starboard fore part. The cracks in the section on the port side midships stopped developing in the autumn of 1976.

During the rest of the measurement period, the cracks in the two port side sections remained at the same length as they were before 1977. In the two starboard sections, however, the cracks started to grow again, the one in the autumn of 1977 and the other early in 1978. Close examination of the notations at each deck level reveals that cracks were growing rapidly in the hold and in the orlop deck compartments. This might be a precursor of the recorded growths of cracks in those regions during 1978 and 1979.

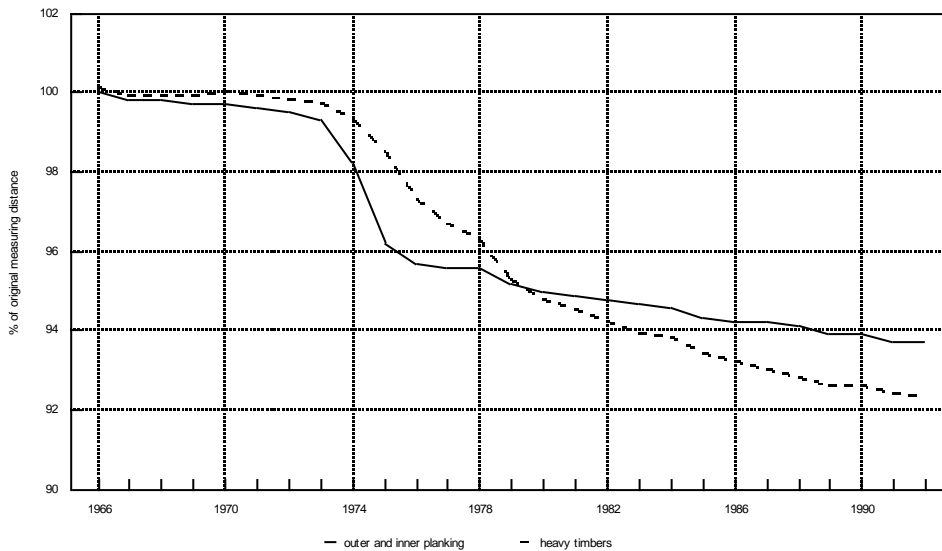
Figure 9-5 Shrinkage of outer and inner plankings (continuous line) and heavy timbers inside the Vasa hull (broken line) 1966 - 1992

The shrinkage registered during the period of continuous spraying was less than 0.5% (figure 9-5). During the period of intermittent, spraying the shrinkage accelerated and reached a mean value of nearly 4% by the end of 1975. During 1976, the rate of shrinkage slowed down and came to a rest at 4.4% which lasted until the spray treatment was stopped in January 1979. During the period of lowering the RH in the pontoon superstructure from 70 to 65%, the plankings shrank rather slowly by another 1.5%. The mean total shrinkage of the plankings was 5.9% when the Vasa was brought into the permanent museum.
