# The Sinking Town:

## The Causes and Effects of Settling Around Linnéstaden

**Degree of Bachelor of Science  
with a major in Earth Sciences  
15 hec**

**Department of Earth Sciences  
University of Gothenburg  
2019 B-1075**

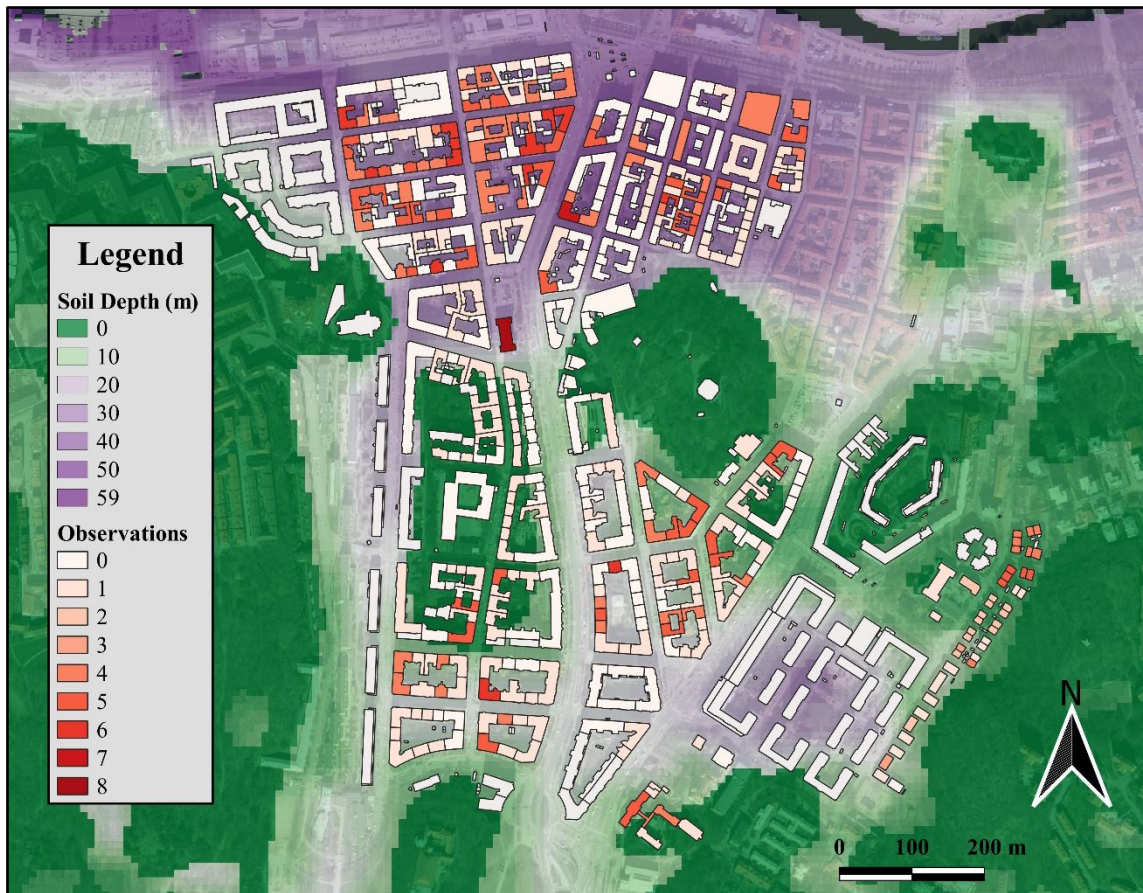
**Figure 3. 1.** Map created in QGis that shows buildings categorized by amount of observations and soil depth in meters.

In figure 3.1 the mapped buildings are presented and categorized by how many observations that were made in total for each one. The amount varies from zero to eight observations. In the background is an orthophoto of the area with a transparent 10x10m layer of soil depth on top. The color scheme varies from green to purple and it clearly shows how the layers evolves between valleys towards the river which connects to the ocean not far north of the figure.

The map illustrates that regions with deeper clay like the northern part around Masthugget and Haga has buildings that experienced more damages than the buildings that stand on the elevated part in Olivedal in the Midwest part of the map.

It also illustrates that many buildings standing on slopes has suffered from more damages from settling. Perhaps the most severe example can be seen in the South and East parts of the map in Annedal (see fig 3.12, 3.13 and 3.14).

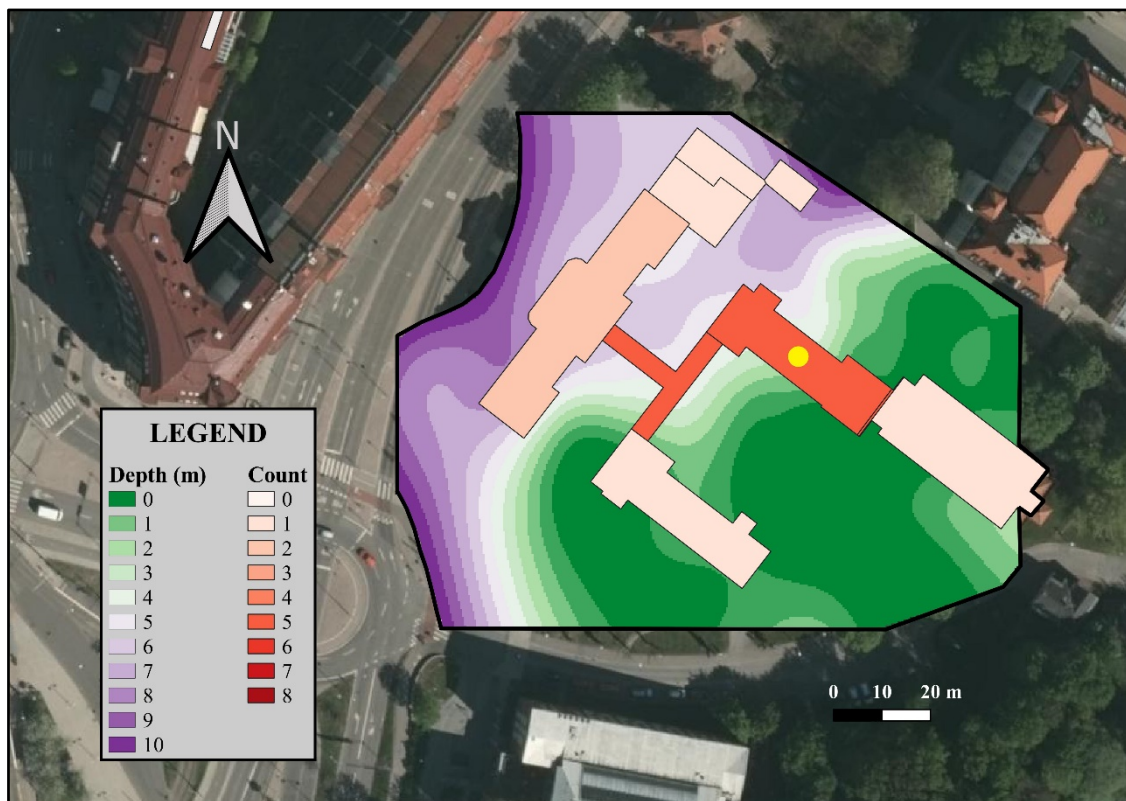
**Figure 3. 12.** Interpolated map of the area with the depth ranging from zero to 10 meters.

In figure 3.12 we see an interpolated map of 82 points of depth from the original construction map of the area whereas parts of it can be seen in figure 3.13. The points were gathered by connecting contour lines of the surface with contour lines of the soil depth and the interpolation was made with the *Spline* interpolation tool in ArcMap. On the southern to western parts of the interpolated area the bedrock goes along with the surface and the depth gradually increases towards the west. The case study focuses on the building marked with a yellow dot and as seen the depth underneath varies from zero to about six meters.

The picture taken in figure 3.13 demonstrates how the building looks like from the northeast side where the damages was clearly observed. The interpolation proves that the building stands on a heel of the bedrock and the location of the damages correlates to where the most graduated depth lies underneath. The picture has been taken quite far away so to see the observations clearer, the sliding bricks has been highlighted inside the red rings. The building also shows deformed sills and skirts, tilted windows and in figure 3.14 below we see that steel beams has been mounted in the left corner to steady up the weight.

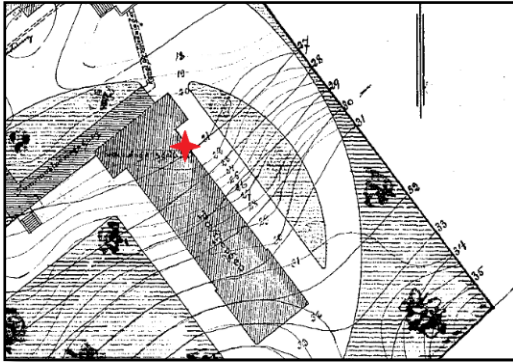
**Figure 3. 15.** Part of original construction map showing two sets of contour lines. The red star marks where the picture in fig 3.9 was taken (Stadsbyggnadskontoret, 2019).

When looking at the documents from 1898 when it was built (see fig. 3.15 and 3.16) we see that there was no evidence that piling was made in the region between the thin layer of soil in the right part to where the piles are shown of the deeper left side of fig 3.15. Instead the building hang free in the soil where settling can happen. At other regions in Linnéstaden buildings tend to show the same pattern and a surprisingly new observation of sliding bricks was seen on a façade in Kommedantsängen East of Linnégatan. This building will be further discussed in chapter 4.2.

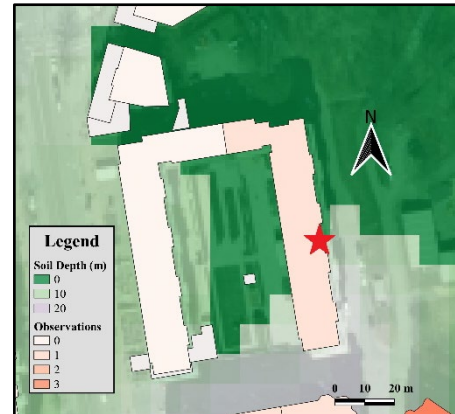
It is a modern building made in 1968 with a better technique of piling. The buildings made from around the 70's and onward used concrete for piling which has proved to be a more liable method (Persson, 3rd of May 2019). The mentioned building has damages in form of sliding bricks (see fig. 3.13). No other modern building shows this strong indication of settling in the studied area which makes this an interesting case. It is our theory that since it lies on a slope close to an elevated bedrock, soil movement has occurred, and in the process, it has detached the end of the pile since it hasn't been piled down into the bedrock.

**Figure 4.2.** Fixed map of the centre of fig 3.1 that illustrates the soil depth where the damage occurs at the red star. Lilla Risåsgatan 22, Code: KA0110
